6.0 INSPECTIONS

6.3 INSPECTIONS: VISUAL SITE INSPECTIONS

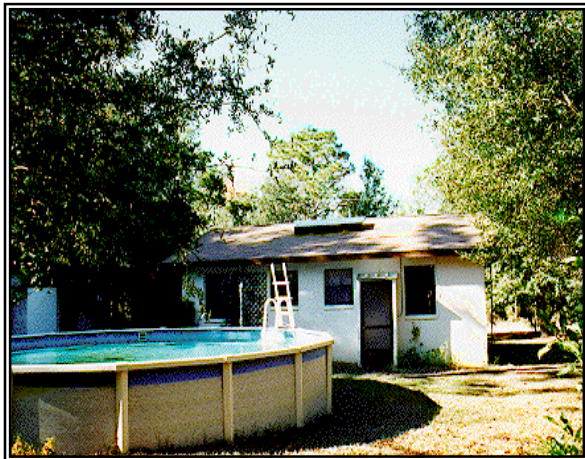
Figure 6.3-4a. Collector is shaded during much of the day.

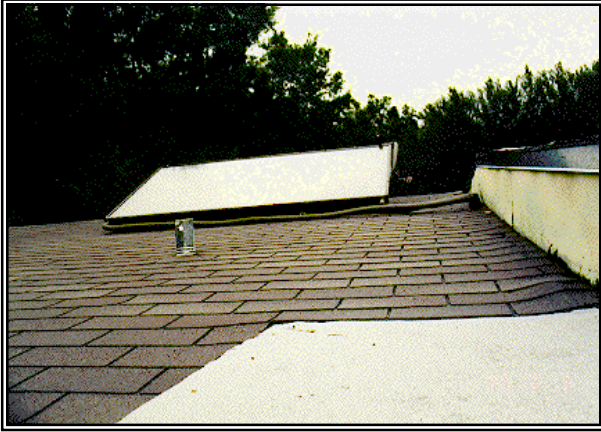
Figure 6.3-5a. Collector return line can not be completely drained due to upswing in piping. At times, this is unavoidable due to the layout of the roof and access locations.

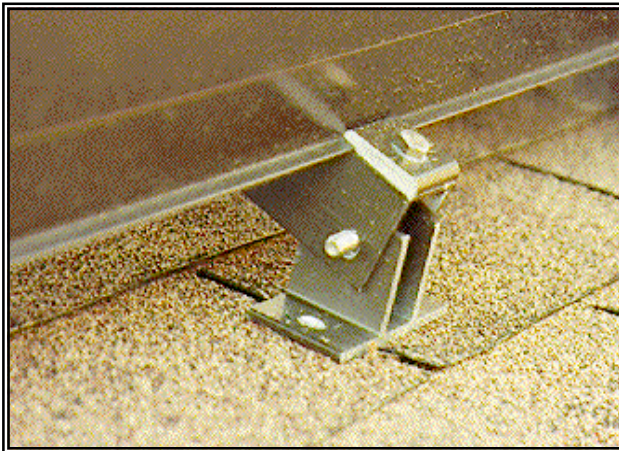
Figure 6.3-6a. Simple oversight while installing the collector without hardware

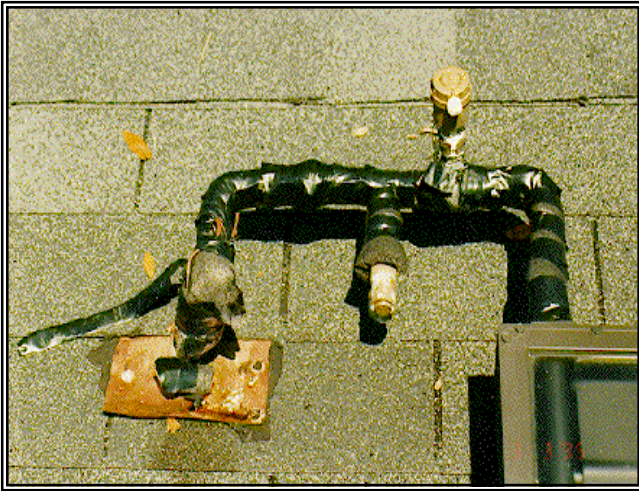
Figure 6.3-7a. Roof flashing is exposed and improperly sealed.

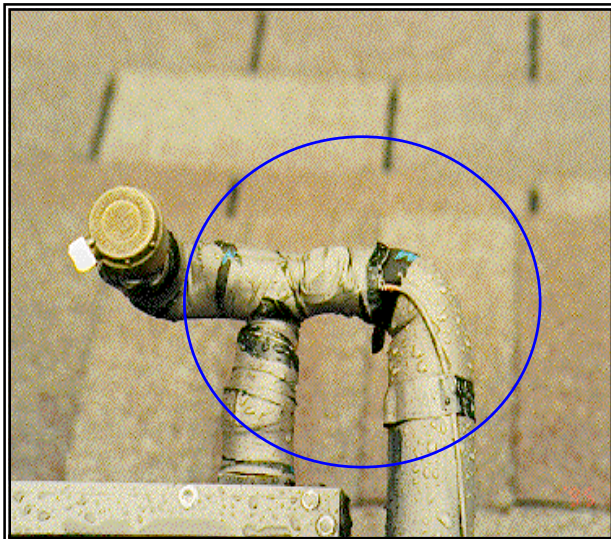
Figure 6.3-8a. Sections of insulation and sensor wiring have not been protected from ultraviolet rays.

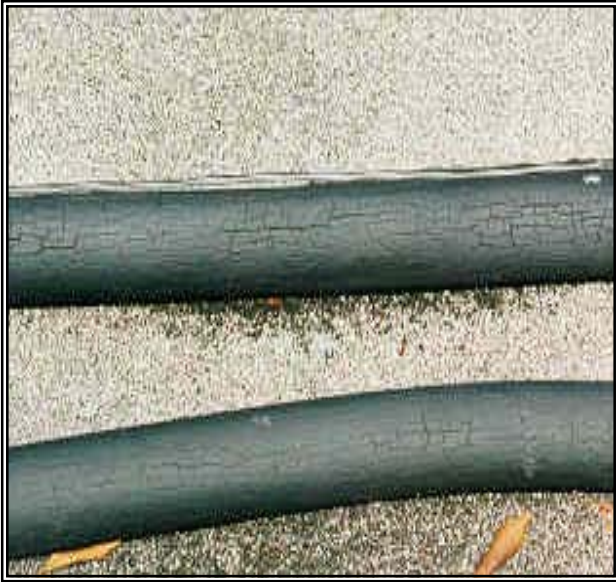
Figure 6.3-9a. Cracking and eventual deterioration will occur if insulation is not ultraviolet ray

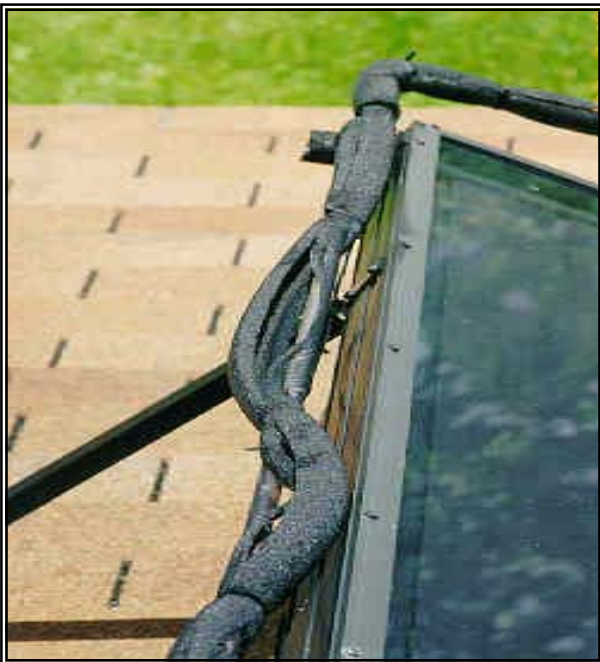
Figure 6.3-10a. Plastic-based insulation should not be used for exterior piping.

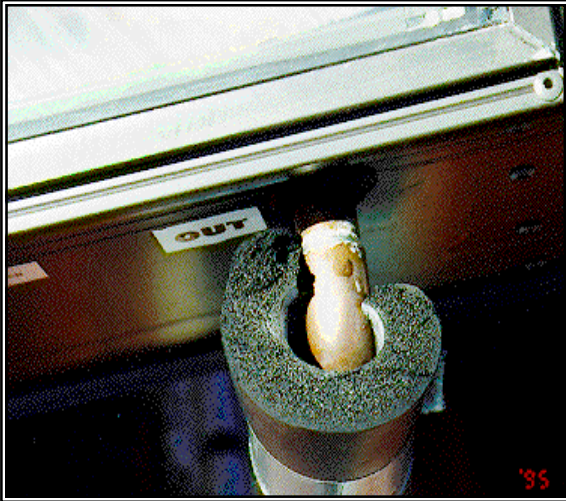
Figure 6.3-11a. Ends of pipe runs should be well butted.

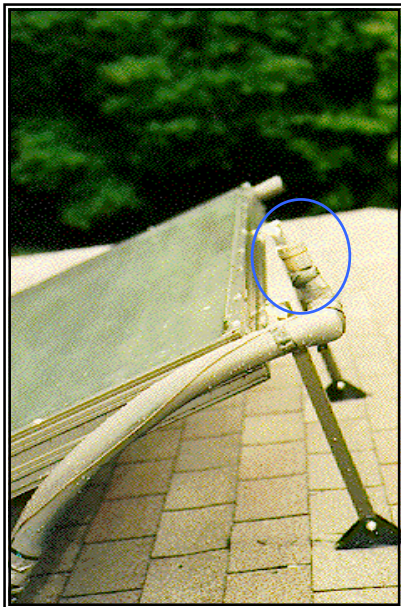
Figure 6.3-12a. Air vent installed in plane of collector instead of vertically true north.

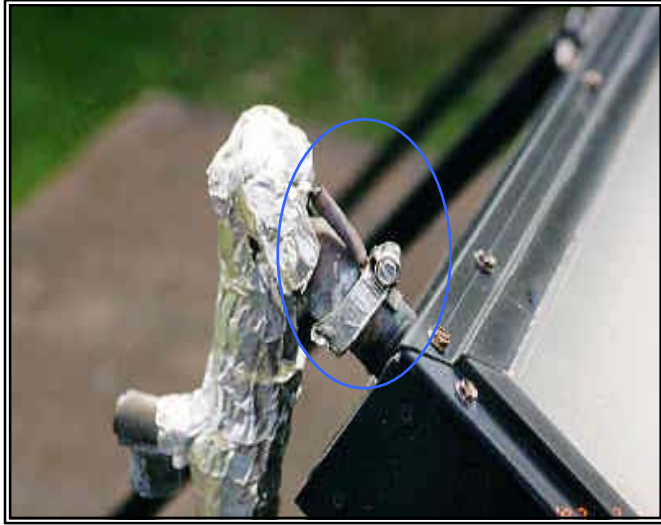
Figure 6.3-13a. Collector sensor secure but not insulated or protected from environmental degradation.

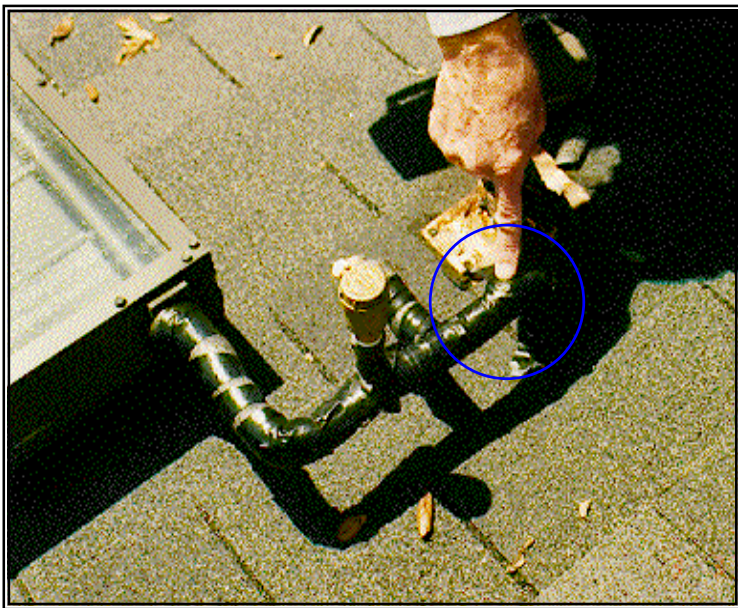
Figure 6.3-14a. Collector sensor installed too far from collector.

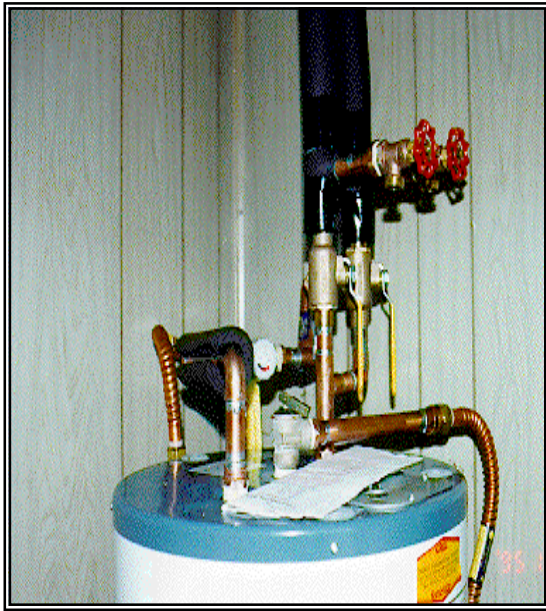
Figure 6.3-15a. External tank piping not completely insulated from heat losses.

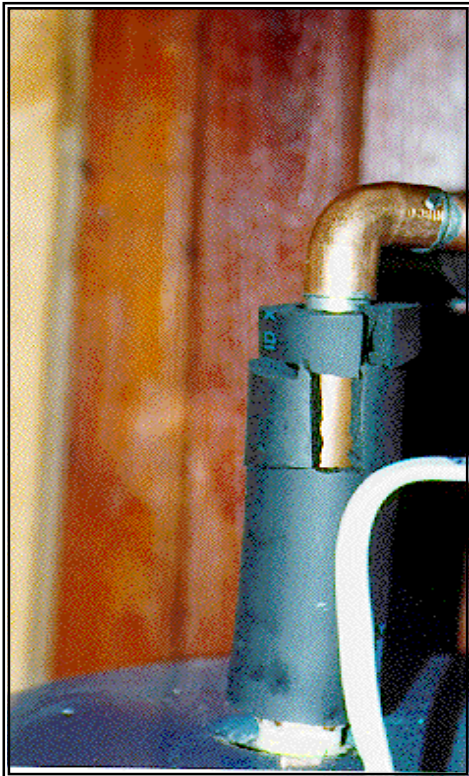
Figure 6.3-16a. Little pride of work reflected in this insulation job

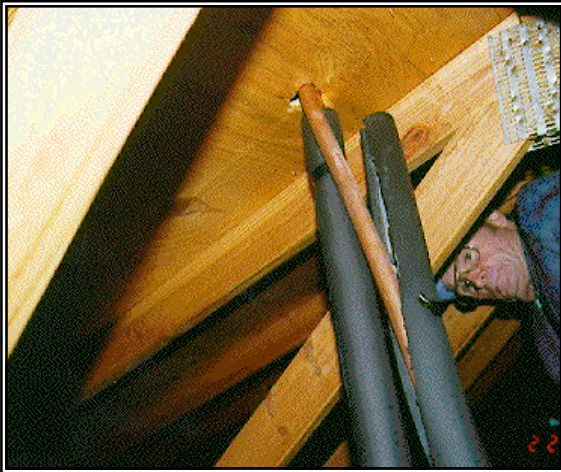
Figure 6.3-17a. Attic insulation must be secured.

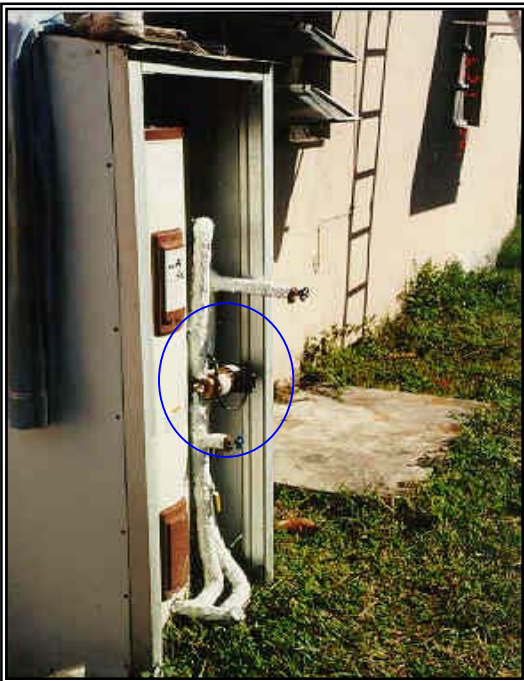
Figure 6.3-18a. Top and sides of water heater protected, but not front. Pump is exposed to elements.

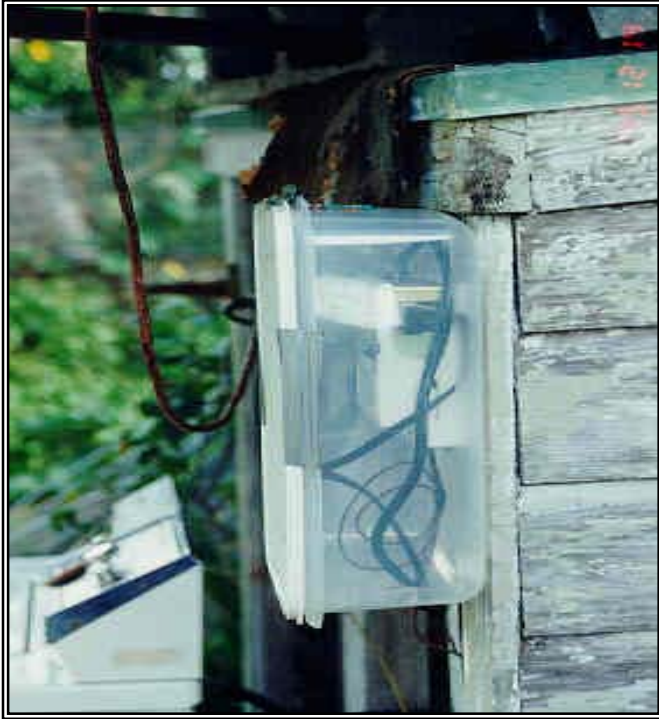
Figure 6.3-19a. System controller protected by common Tupperware enclosure.

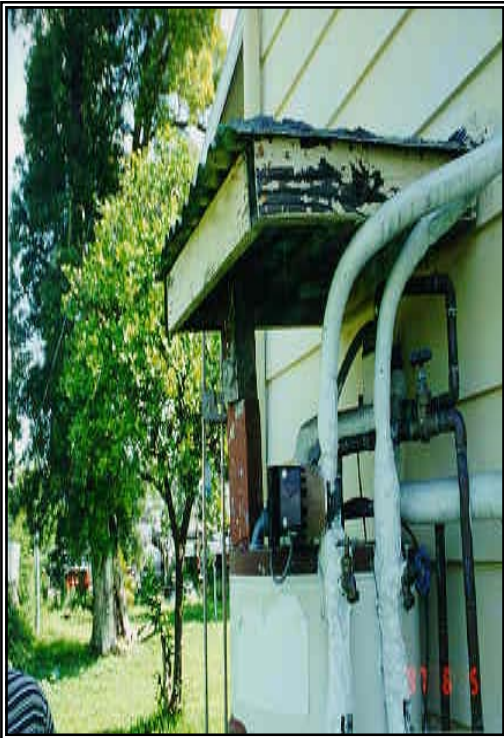
Figure 6.3-20a. Minimal water heater and component protection.

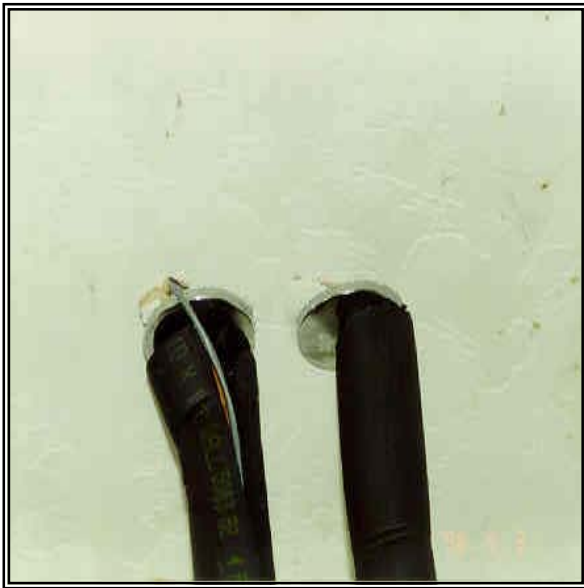
Figure 6.3-21a. Ceiling penetration left bare.

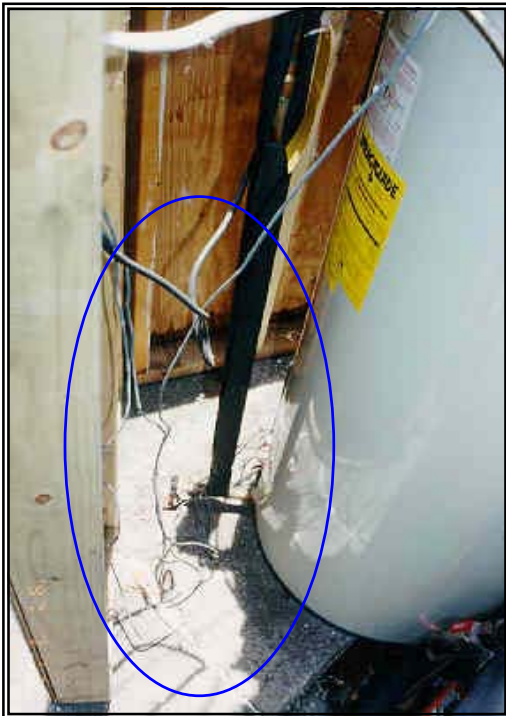
Figure 6.3-22a.. Extra sensor wiring left dangling on floor.
