## Final Report

### **Investigating Solutions to Wind Washing Issues in 2-Story Florida Homes; Phase 1**

FSEC-CR-1842-09

December 31, 2009

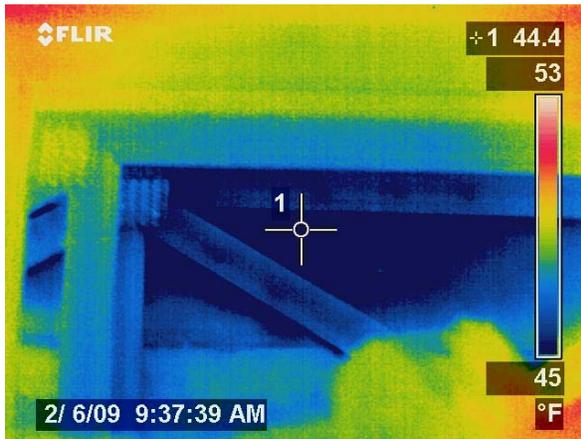
**Figure E-3** IR scan inside (H7G) bonus room floor cavity facing west. Coldest area is plywood.

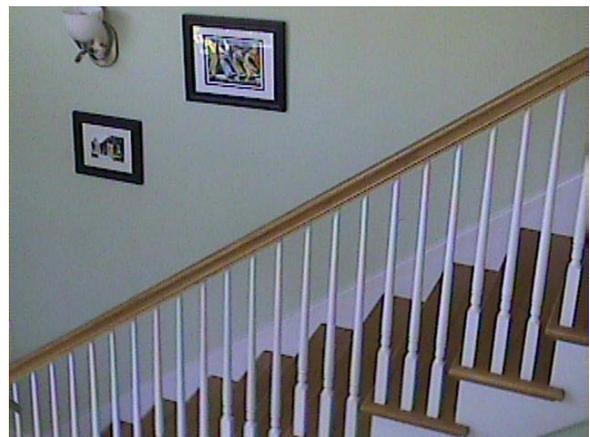
**Figure E-10** There are conditioned rooms on the other side of this wall above and below the floor space that runs along the lower picture hung on wall.

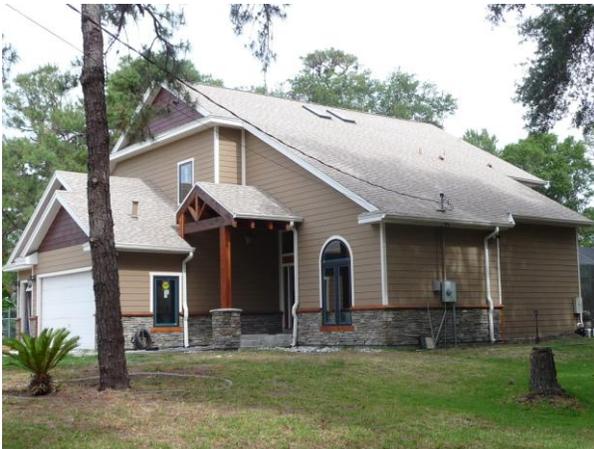
**Figure E-11** Attic over garage faces south in house H16B.

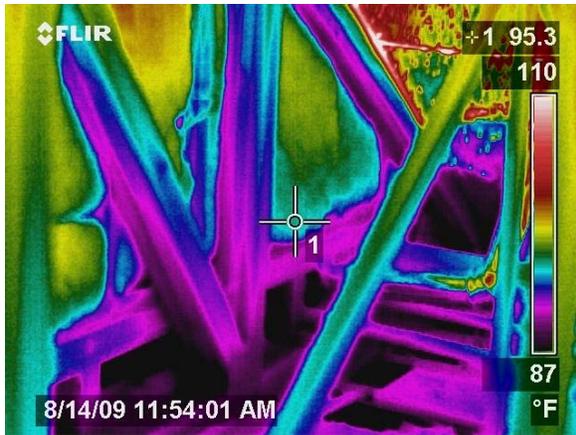
**Figure E-13** IR view inside the hot attic shows cooled surfaces low in attic in H16B before repair.

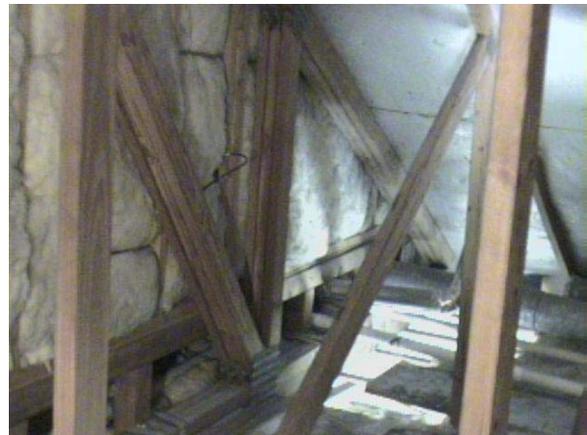
**Figure E-14** Photo of IR image to the left. The floor cavity at the bottom of the wall is open to attic space.

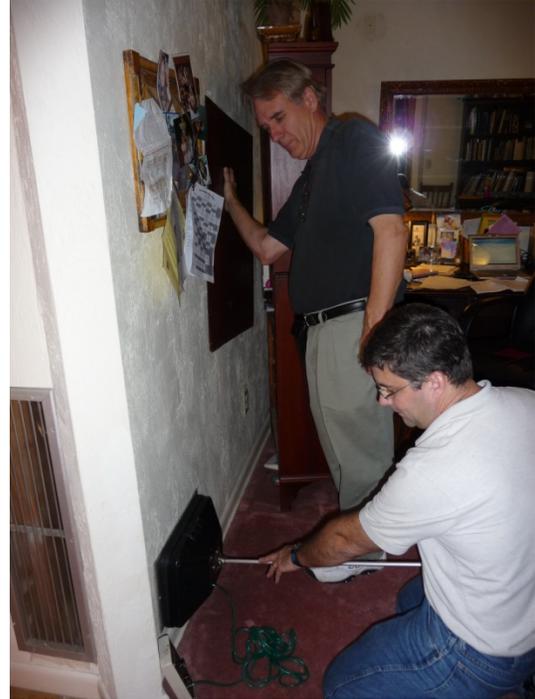
**Figure 9** In House H5, a pressure pan measures return leakage in a wall cavity indicating substantial return leakage.

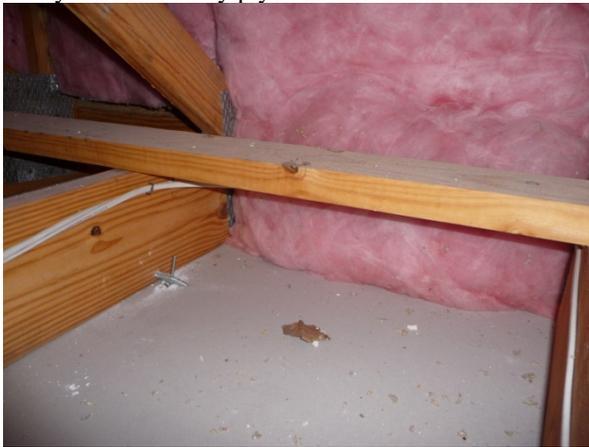
**Figure 13** Good quality insulation batt installation blocks opening to floor cavity in House H22. No insulation on top of ceiling since garage is below.

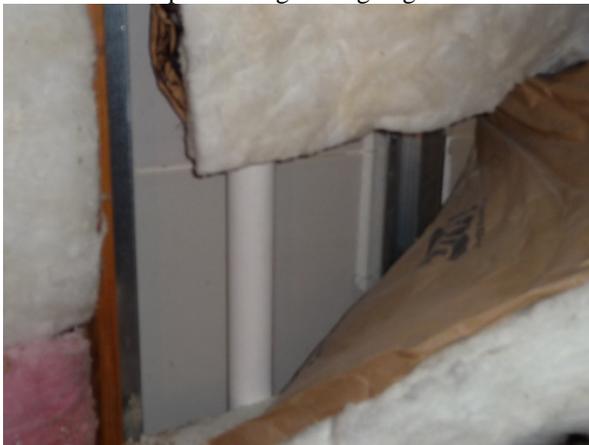
**Figure 15** In House H22, an area of fallen batt on kneewall allows hot attic air to transfer heat through wallboard into conditioned space.

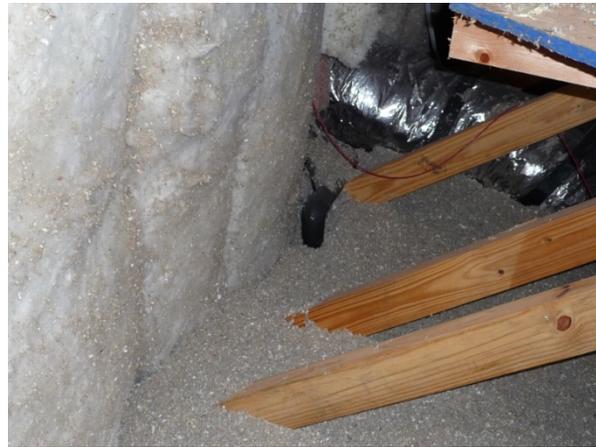
**Figure 14** In House H22, batts and blown insulation cover the opening to floor cavity.

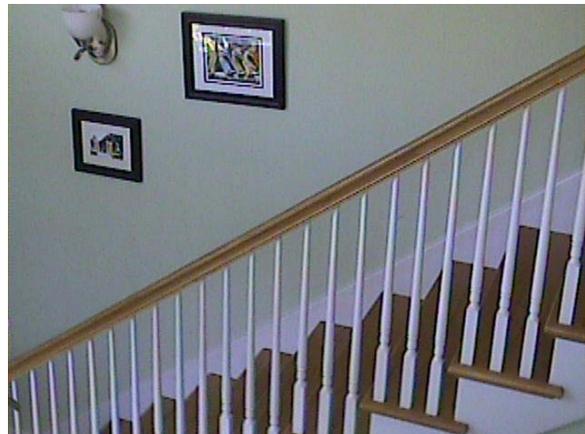
**Figure 20** There are conditioned rooms on the other side of this wall.

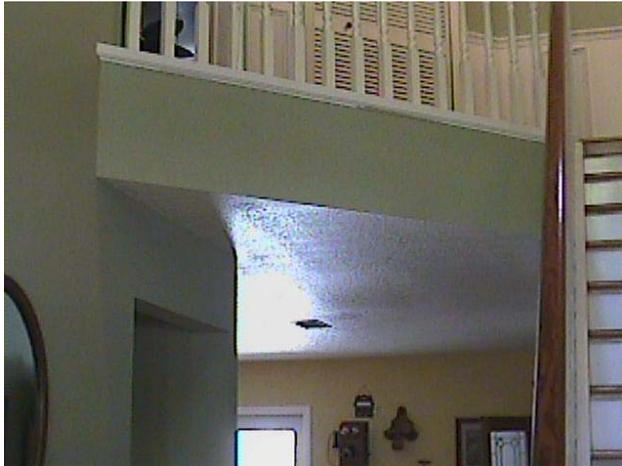
**Figure 35** Second story floor space

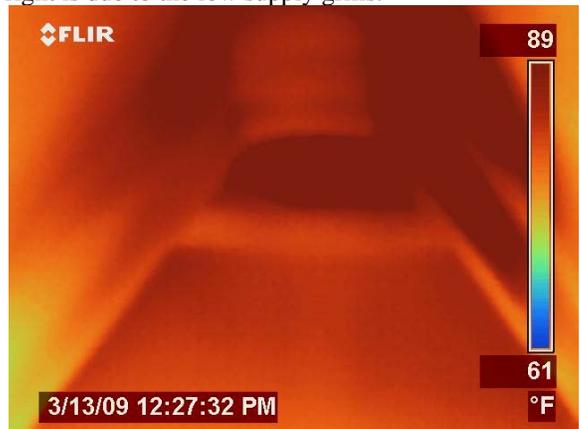
**Figure 34** IR image showing very hot areas of ceiling and air infiltrating from the garage attic.

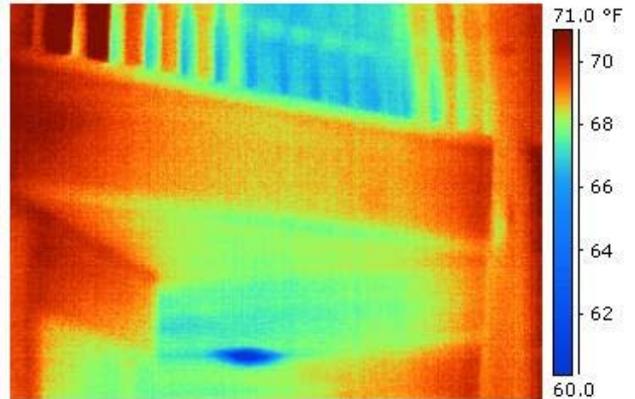
**Figure 36** Infrared image of 2<sup>nd</sup> story floor cavity which is partially open to the attic. Slightly warmer temperatures in proximity to the attic.

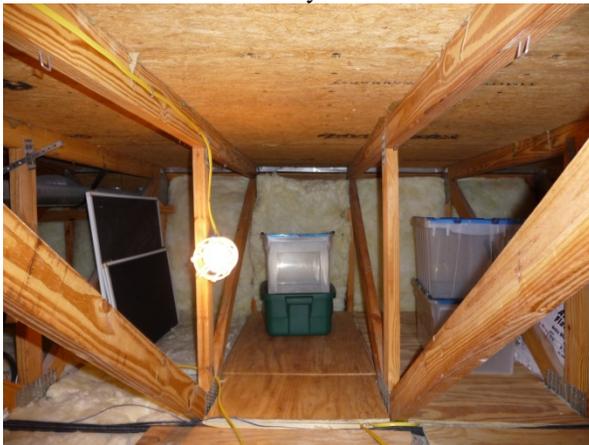
**Figure 48** H7 inside bonus room floor space facing south. Batts separate floor space from a small vented attic area.

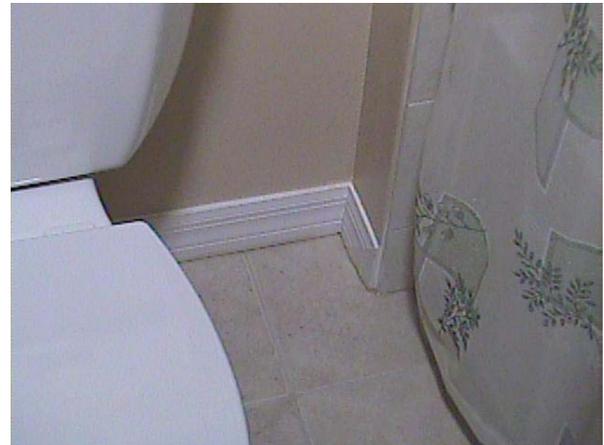
**Figure 58** Tile floor surface temperature before repair in the area box is in a location shielded from the supply vent and is about 79.5F when indoor air temperature is about 77F.

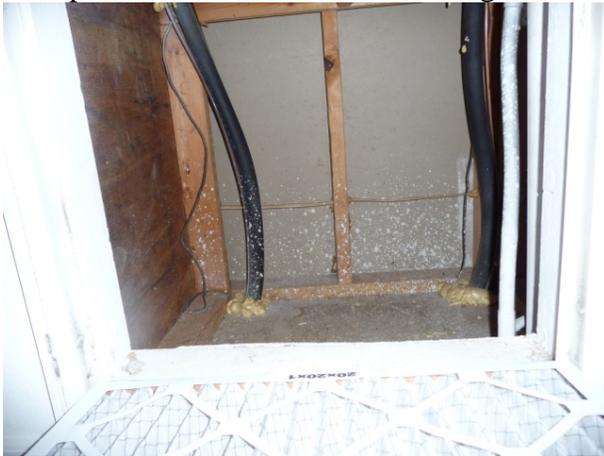
**Figure 75** Leaky return plenum.

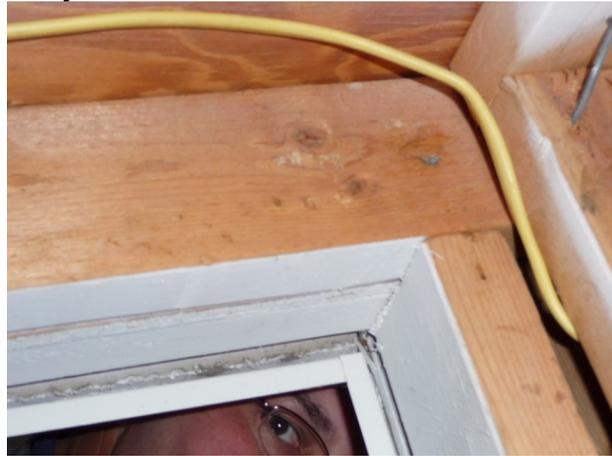
**Figure 76** A view from inside the return plenum shows a lack of sealant or air barrier in return plenum.

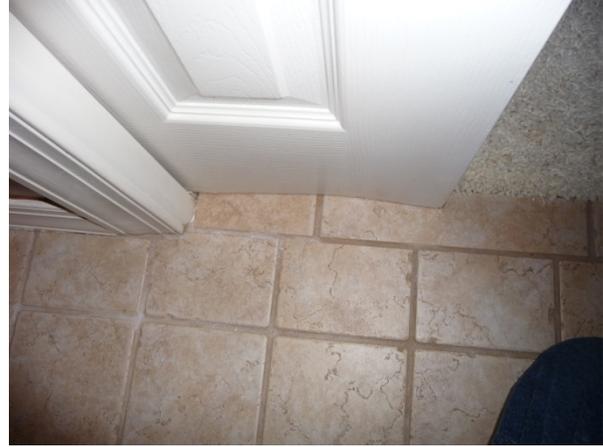
**Figure 84** Warped pocket door from air infiltration from north attic area.

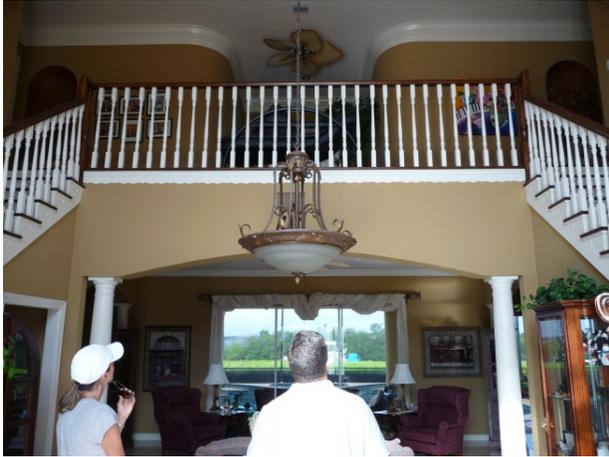
**Figure 95** Foyer grand staircase had more cracking on the right side stairs which is closer to most of wind washing areas.

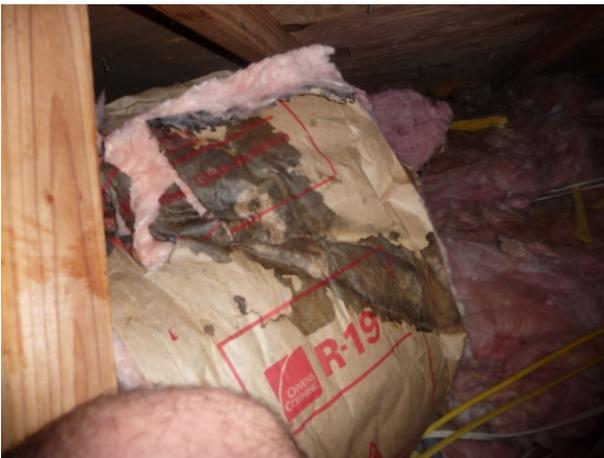
Prior to installation of the open-cell foam product, condensation-damaged fiberglass batts in the attic were removed. These batts had been recently installed by the homeowner in an attempt to stop air flow into the interstitial floor cavities. Where the batts were in contact with supply ducts, considerable moisture condensation had occurred (Figure 97). Moisture condensation on ducts is an especially common problem in homes where the homeowner sets the thermostat to a low temperature or in cases where the system is set to a lower temperature for a portion of the day, such as at this house. Colder supply air leads to a colder outer duct jacket, which in turn increases the rate of condensation.

**Figure 97** Moisture damaged batt.

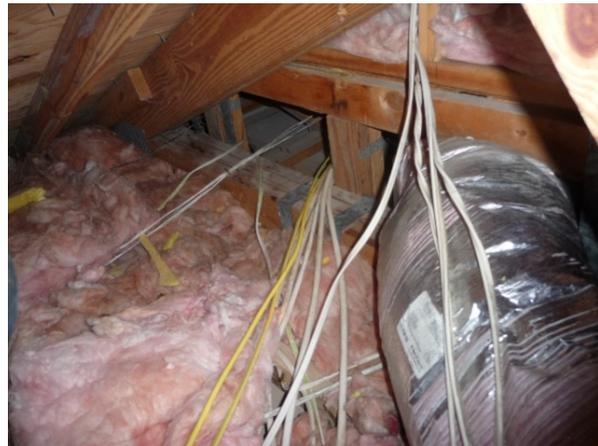
**Figure 98** Supply duct running into an open floor cavity in garage attic kneewall.

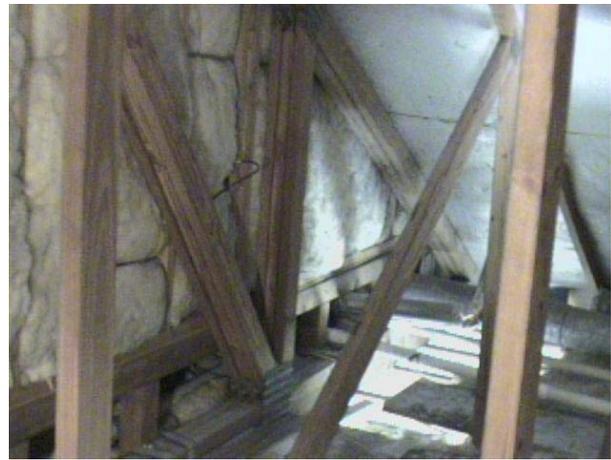
**Figure 107** Photographic view of IR image to the left. The interstitial floor cavity at the bottom of the wall is open to garage attic space.

The opening between the second story floor cavity and the garage attic is about 25 ft<sup>2</sup>. This opening is facing south into the garage attic. The open area of space from the soffits into the attic is very small since batts are located on top of the garage attic floor close to the roof deck. We estimate that the total soffit-to-attic opening is only about 1 ft<sup>2</sup>. The soffit vent net free area is estimated to be about 1.6 ft<sup>2</sup>. Therefore, the opportunity for wind driven air entry into the interstitial floor cavity is small. There are no complimentary holes or pathways on the other side of the house to allow air to flow freely through the interstitial floor cavity. Note, however, that passive, stack-effect air flow between the attic and the floor cavity may be occurring, as is suggested in the IR image of Figure 108, where there is considerable stratification of temperatures from top to bottom of the floor cavity.

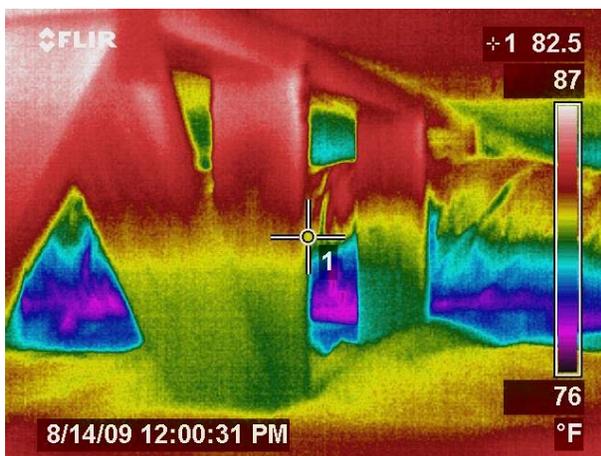
**Figure 108** IR inside floor space shows stratification before foam retrofit.

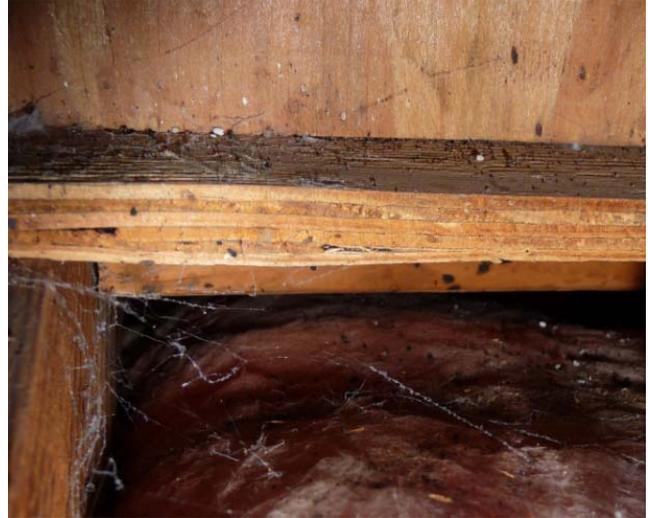
**Figure 120** View of air leakage between batt and floor deck on north side facing South. Air leakage estimated to be about 2"x 22" in each bay.

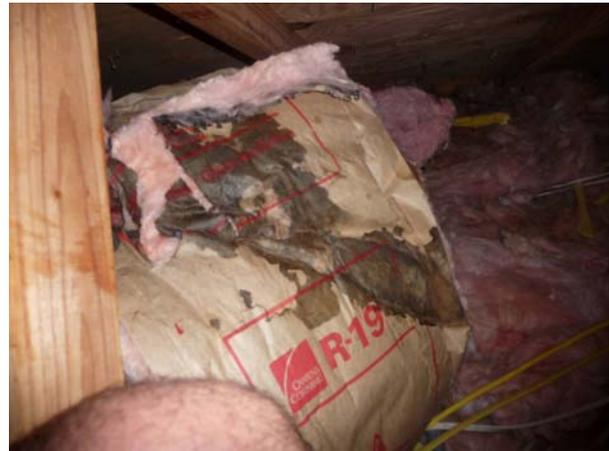
**Figure 130** Batt pulled away from duct shows it is soaked where dark areas are seen on paper facing.

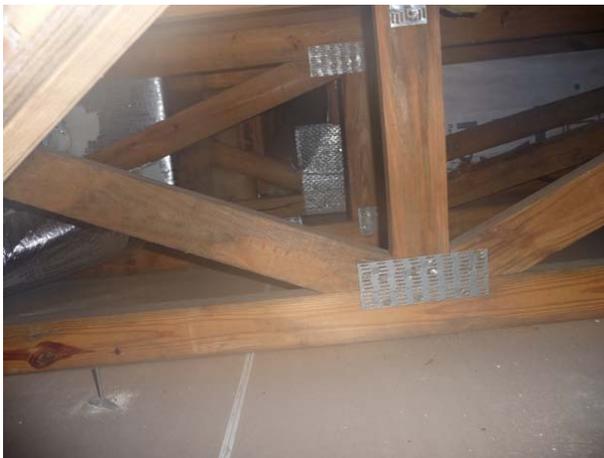
**Figure 136** Open floor cavity area in the east attic. (view looking toward the west into the floor space)

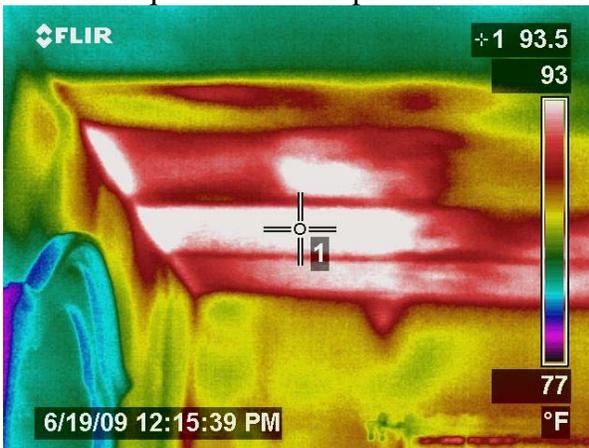
**Figure 163** Area of front left 2<sup>nd</sup> fl. bedroom with very hot ceiling due to inadequate insulation placement.

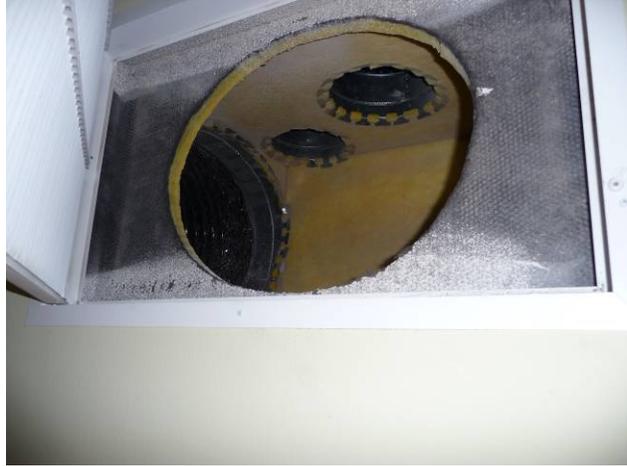
**Figure 173** Main return for first floor with undersized opening into return junction. View inside box shows return ducts (from left to right) 20" diam. flex to main plenum, office, and master bedroom.

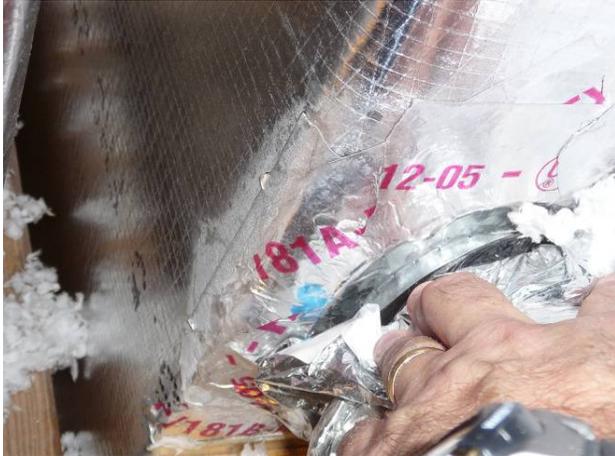
**Figure 174** Flex duct connection with no mastic on first floor return plenum. Flexduct is mechanically fastened, but not airtight.

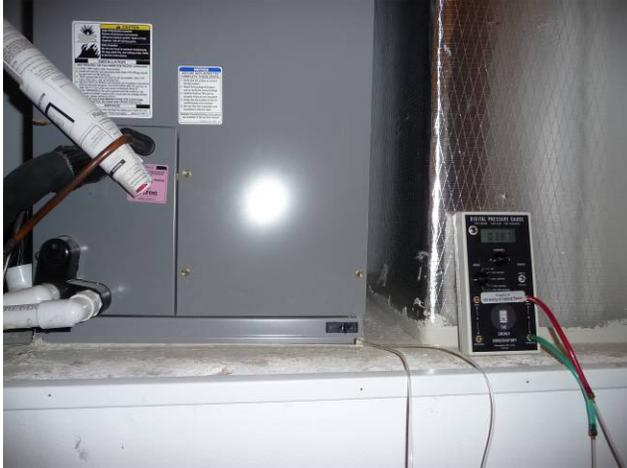
**Figure 176** Air handler in garage has typical panel leakage at seams and penetrations.
