## Partnership for High Performance Housing Draft Final Report

FSEC-CR-1911-12

March 12, 2012

Building America

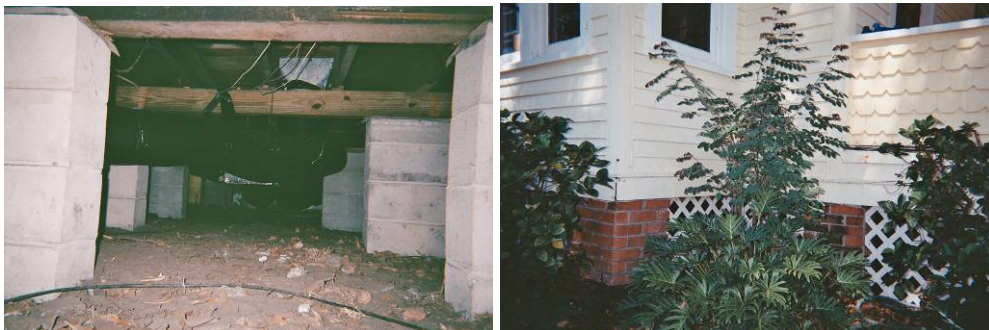
The frame floor is uninsulated. The crawlspace created by the open pier foundation has no ground cover, but it is very well ventilated at this time. The skirting around the crawl space is made of vinyl, lattice panels rather than a more solid barrier such as a vented, masonry stem wall or perforated vinyl panels (Figures 4-5).

**Figures 4-5. EH-01 pier foundation (left) skirted with vinyl lattice panels (right) provide excellent venting of the open crawl space.**

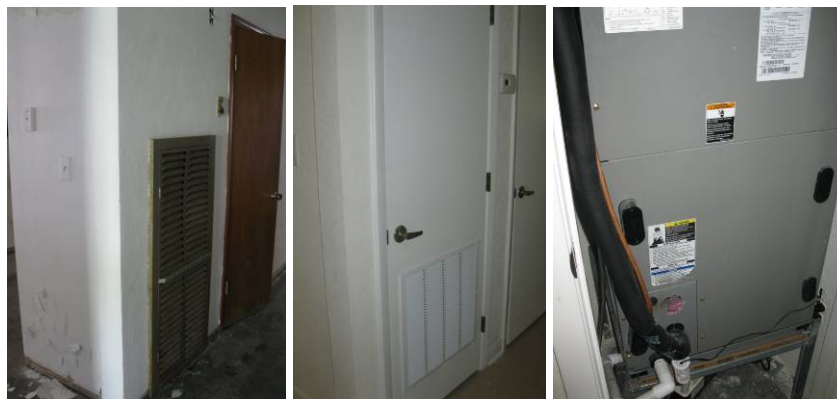
The removal of the old furnace (Figure 13, left) provided the space for the new split system air handler unit. As noted in Table 9, a highly efficient mechanical system was chosen. However, the mechanical closet was poorly designed, with an open return in the closet and airflow-restricting door allowing air passage only through the bottom grille (Figures 14-15, center and right).

**Figures 13-15. EH-02 pre-retrofit abandoned heater (left), post-retrofit closet (center), post-retrofit open return with airflow-restricted louvered doors (right)**

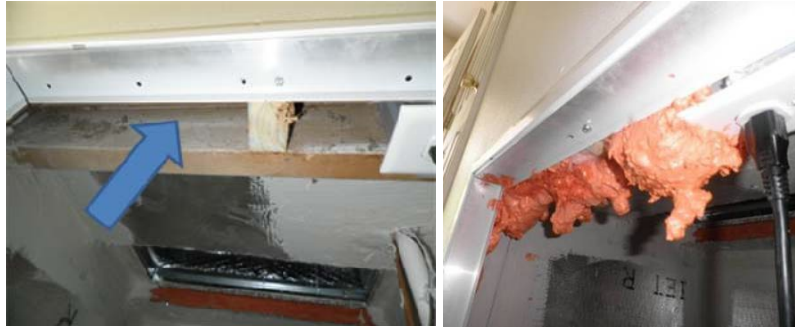
In order to install the new air handler, the closet was reconfigured, and a new return plenum with a ducted plenum was constructed. When the return grille and filter were removed for the duct leakage test during the post retrofit audit, fiberglass insulation from the attic was observed in the return plenum. Further investigation led to the discovery that the interior wall cavity forming the front of the air handler closet was not sealed (Figure 29, left). Attic air and insulation were being pulled through this leakage pathway when the air handler was operating. The project manager left the site and returned with fiberglass insulation and a can of expanding foam insulation to seal the opening (Figure 30, right).

**Figures 29-30. EH-04. An open wall cavity connecting the return plenum to the attic was discovered during the test out (left photo with arrow marking air pathway). The opening was sealed using a combination of fiberglass (filler) and expandable foam sealant/insulation (photo right). The excess foam was trimmed before reinstalling the air handler filter and grille.**

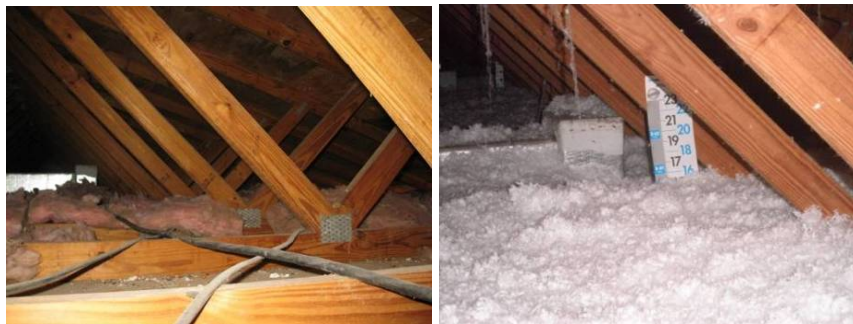
The fiberglass batt ceiling insulation was matted and compressed throughout the attic and completely missing in many areas (Figure 31, left). The insulation contractor did an excellent job of ensuring the new insulation was evenly distributed and at the depth required to attain R-38 thermal performance (Figure 32, right).

**Figures 31-32. EH-04 pre-retrofit compressed fiberglass insulation (left) was improved to R-38 with blown-in fiberglass.**

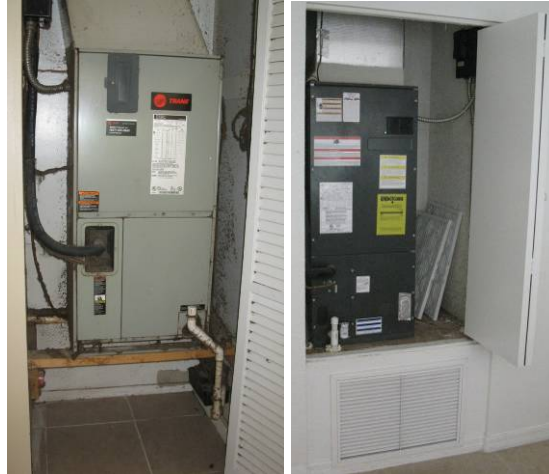
**Figures 35-36. Retrofit EH-06. Air Handler Closet: Pre-retrofit without return plenum and installed behind airflow-restricting louvered doors (left), Post-retrofit platform return plenum with filter access on same plane as wall (right).**

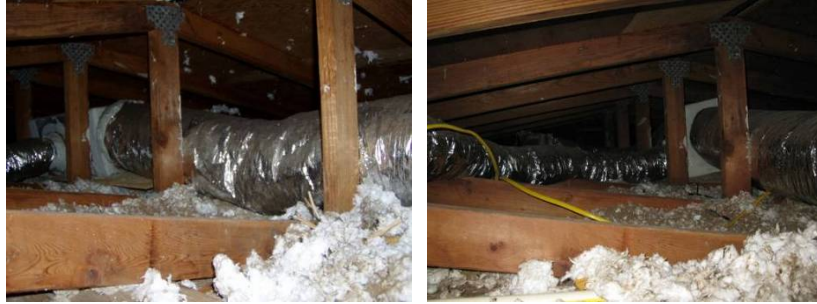
During the test-out audit, researchers observed no change in the attic insulation, which was previously estimated to be an average of R-11 (Figures 37-38). Our partner understood the insulation contractor had completed this work before scheduling our post-retrofit audit. Ultimately, fiberglass was blown-in to achieve R-38. However, this measure would have potentially been skipped had it not been for our involvement in this retrofit.

**Figures 37-38. EH-06 ceiling insulation: Pre-retrofit estimated average of R-11 (left), post-retrofit no additional insulation (right)**

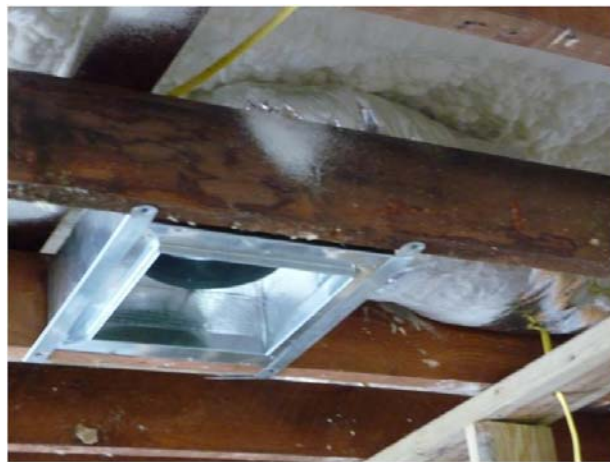
**Figure 55. EH-14. A very shallow unvented attic with foam insulation at roof deck resulting in duct compression and an area of thinner insulation.**

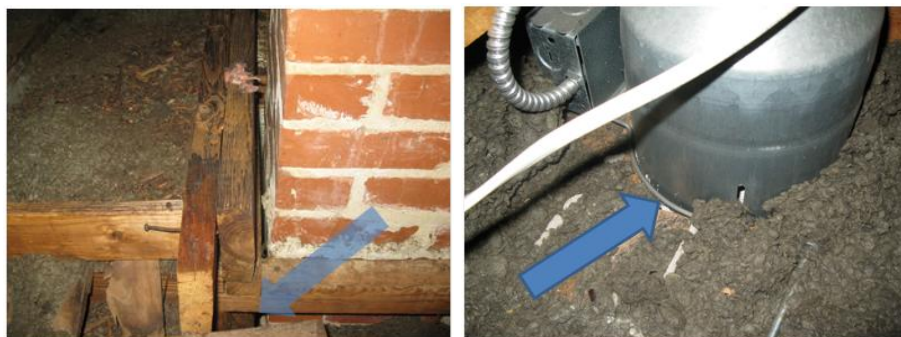
**Figures 58-59. EH-15. Air flow pathway from the attic into conditioned space along the fireplace wall (left) and through and around numerous recessed lighting fixtures (right).**

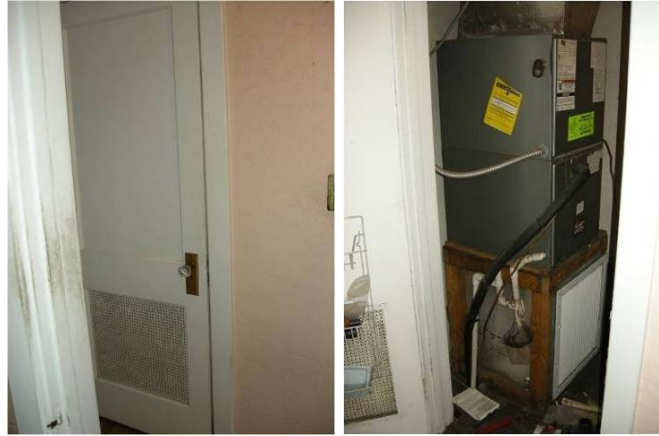
**Figures 60-61. EH-15. Air handler located in the central hallway has a door with a small perforated panel for return air (left). Inside the closet (right) is a filter back grille connected to a small return air duct below an up-flow air handler.**

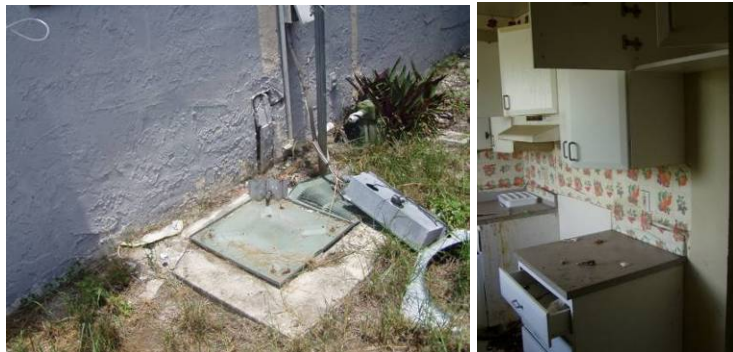
**Figures 87-88. Retrofit EH-20 pre-retrofit sight of missing compressor (left), pre-retrofit kitchen missing appliances (right)**

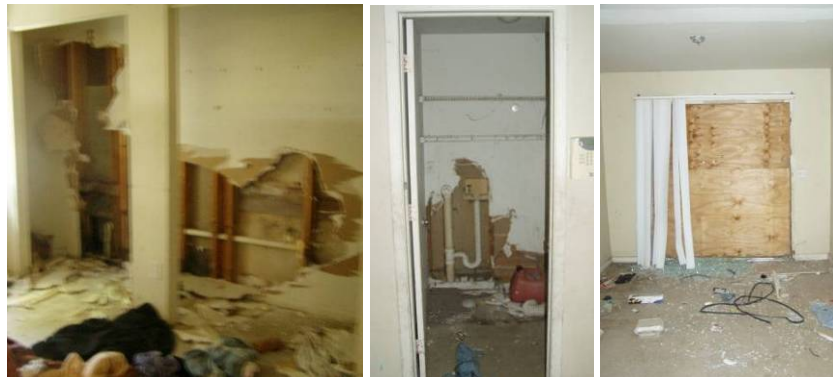
**Figures 89-91. EH-20 pre-retrofit vandalized walls (left & center), broken sliding glass door (right)**

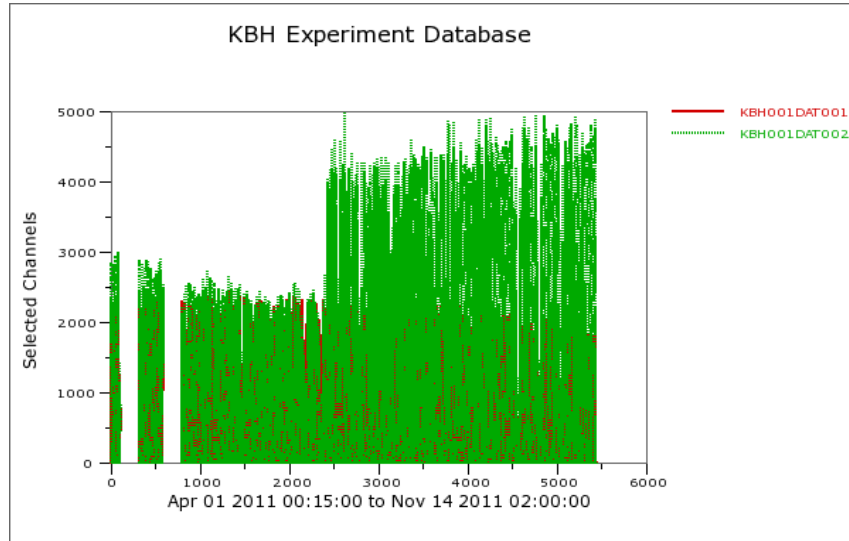
**Figure 125. Measured inverter 1 (red) and inverter2 (green) output at KB Home site showing the impact of the string repair on July 12th. Some missing data is seen in April and May.**

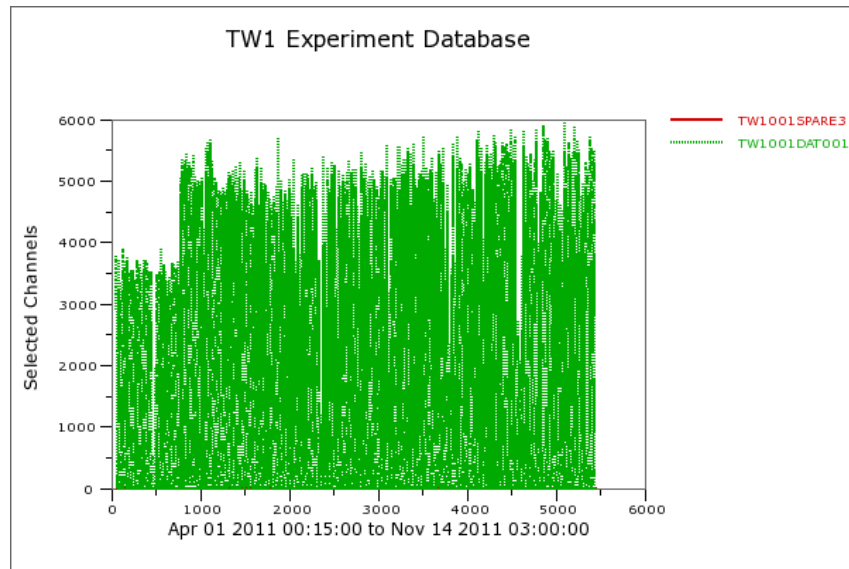
**Figure 126. TW1 showing the impact of repairing an inoperable string on May 5th.**
