# **Opportunities for Energy Conservation and Improved Comfort From Wind Washing Retrofits in Two-Story Homes - Part II**

FSEC-PF-450-10

September, 2010

Charles Withers  
James Cummings

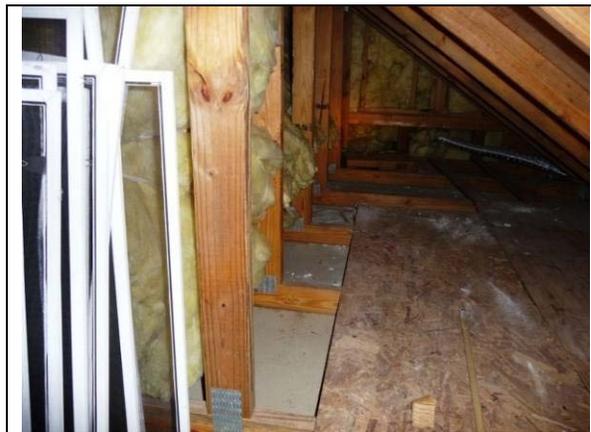
This 2,760 ft<sup>2</sup> slab-on-grade, frame construction residence was built in 1997. The first floor has 2,030 ft<sup>2</sup>. An attached two-car garage faces east. The second floor has 730 ft<sup>2</sup> including a small bonus room located above the unconditioned garage space. There is approximately 82.5 ft<sup>2</sup> of conditioned floor area above unconditioned space. The bonus room construction is traditional gypsum board on the interior, and is insulated with R-30 kraft-faced batts with the fiberglass side facing into the garage attic. The underside (floor cavity) of the bonus room is unsealed allowing hot air to move through the floor cavity.

Figure 1 View of kneewall and main floor space (far), and bonus room wall and floor cavity (left).

Foam insulation product was applied to the floor cavity openings and the kneewall separating the garage attic and the main house. Foam insulation was also applied to the walls of the bonus room and to the floor cavity openings beneath the bonus room. The

repairs required 2.25 man-hours (2 person crew for just over 1 hour) to cover 113 ft<sup>2</sup> of area.

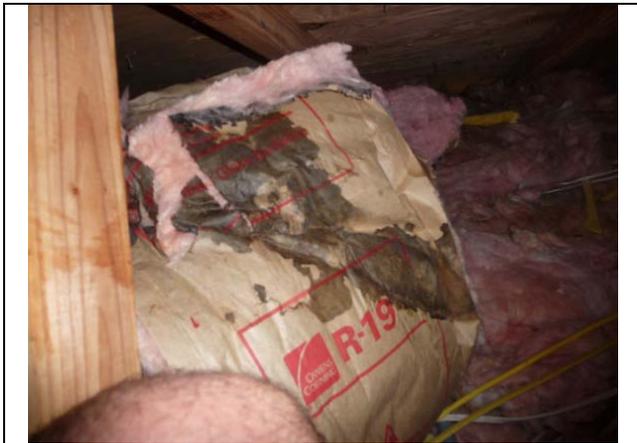
Prior to installation of the open-cell foam product, condensation-wetted fiberglass batts in the attic were removed. These batts had been recently installed by the homeowner (prior to our involvement with the house) in an attempt to stop air flow into the interstitial floor cavities. Where the batts were in contact with supply ducts, considerable moisture condensation had occurred (Figure 4).

Figure 4 Moisture condensed on flex ducts and accumulated on insulation materials placed in contact with the supply ducts by the homeowner. (Withers)

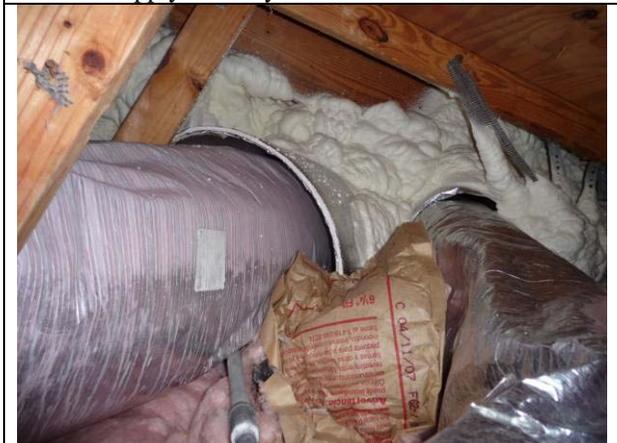
Figure 5 East side floor cavity isolated from the garage attic; a protective vapor barrier/thermal barrier sleeve isolates the foam from the exterior of the supply ducts to reduce the condensation potential. (Withers)

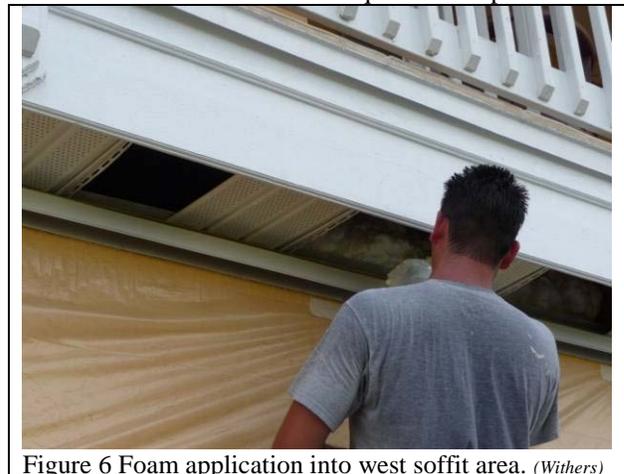
Figure 6 Foam application into west soffit area. (Withers)

Foam insulation product was also used to seal air pathways into the interstitial floor cavities on the north and west sides of the house. The application of foam on the north and west sides of the house was particularly difficult since it required removing the soffit face material and then building a foam barrier in the space between the top of the block wall and the roof deck, one bay at a time over a 40 foot length (Figure 6). A total of 10.0 man-hours were required to implement wind washing repair at this house, covering a total surface area of 108 ft<sup>2</sup>. The time required to remove and re-install soffits substantially increased the amount of time required for repair.

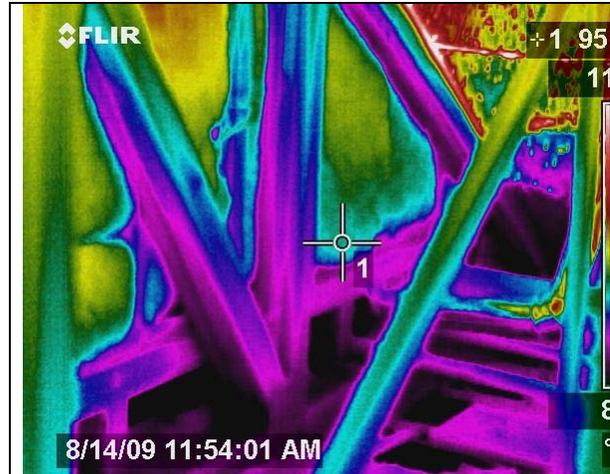
The infrared image in Figure 7 was taken in the attic during our field visit August 14, 2009 prior to repairs and shows cooler air displaced into the lower attic area next to the open floor space. Figures 8 and 9 show the floor cavity and knee wall prior to and after application of foam insulation. Figure 10 shows a relatively homogenous temperature plane across the foam.

Figure 7 IR view inside the attic shows cool temperatures in the floor space and cooled surfaces low in attic. (Withers)

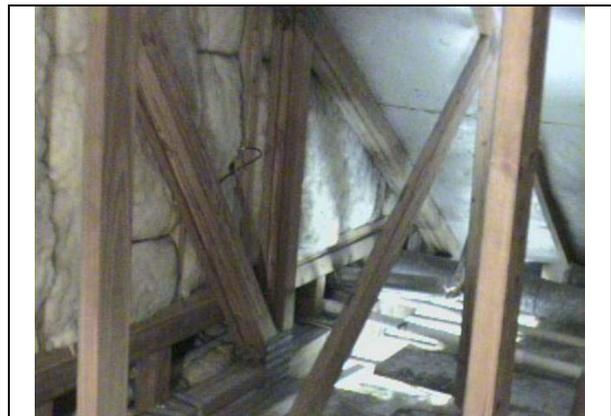
Figure 8 Photo of IR image above. The floor cavity at the bottom of the wall is open to garage attic. (Withers)

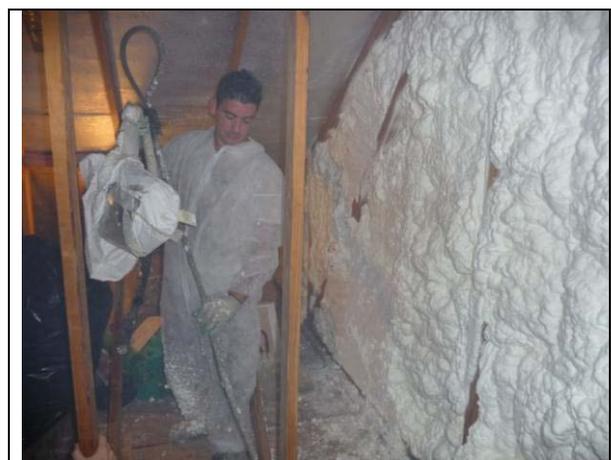
Figure 9 Technician finishes up kneewall and floor cavity insulation/air tightening. (Photo credit Ian LaHiff)

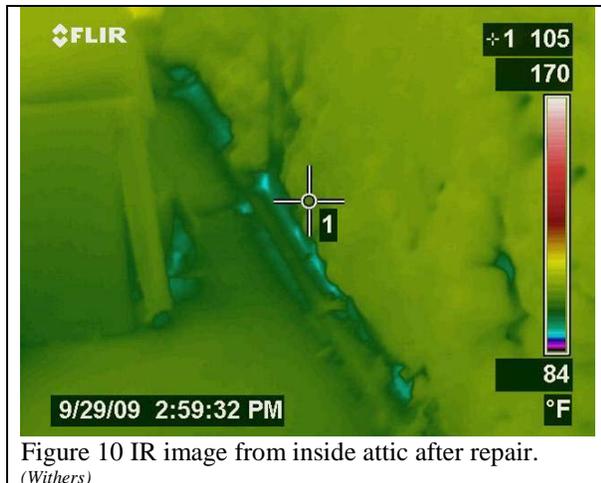
Figure 10 IR image from inside attic after repair.  
(Withers)

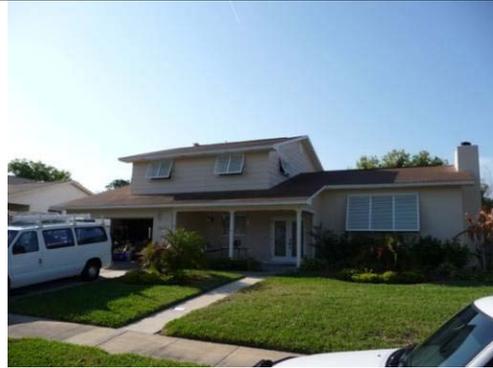
Figure 11 Front of split level home faces north. There is a small attic space above the front porch and garage which is open to the interstitial floor cavities.

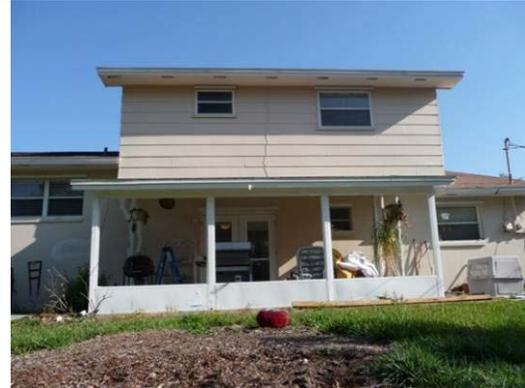
Figure 12 Back of home (facing south) with top story floor space cantilevered and vented over back patio.

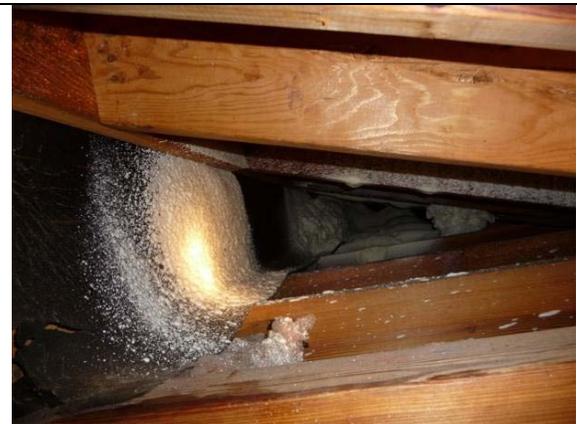
seals off further access. Figure 13 shows wind washing repairs just underway on the opening of the floor cavity within the north side attic space.

Figure 13 Beginning of north side sealing. (LaHiff)

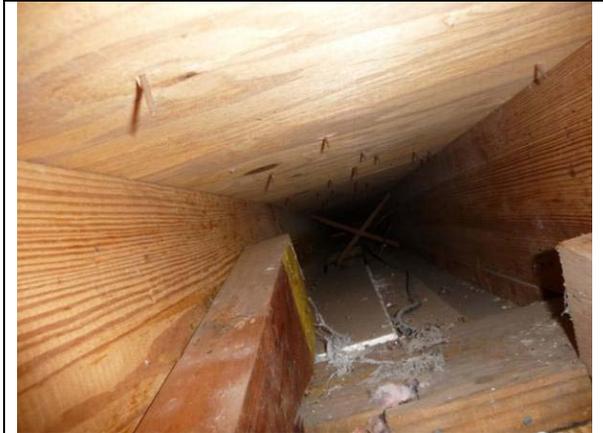
Figure 14 View from soffit vent looking inside towards floor space in area having no batts. (Withers)

Figure 14 shows the interior of the south side floor space after placing a camera into the soffit opening outside the house before sealing the floor opening. Open cell foam was sprayed inside the south vents to separate floor cavity from vented area. The south side was sealed 100%. Average foam insulation thickness was about 3 inches. We estimate that overall, the repair effort at this house resulted in sealing about 90% of openings to the interstitial floor cavities. Note that 100% sealing of wind washing leaks on one side alone can achieve much of the effectiveness of sealing both sides, because it eliminates the complimentary pathway through which wind can be pushed.

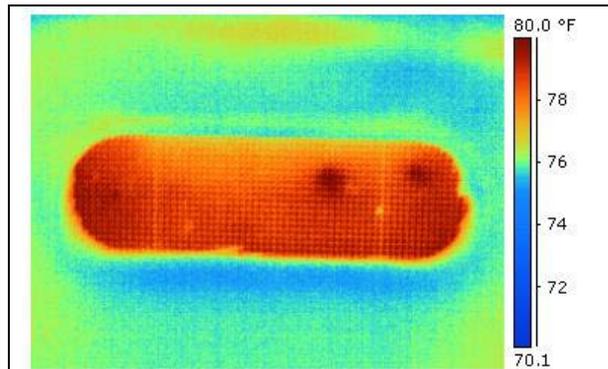
Figure 15 With 10 mph wind from the north, the north soffit vent shows interior surface temperatures about 78-80°F. Outside air temperature =80.1°F and interior air temperature=71.0°F. (Withers)

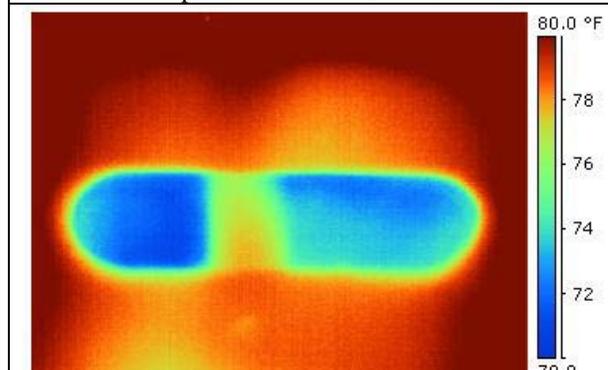
Figure 16 With 10 mph wind from the north, the south soffit vent shows average of 71.9 °F on interior surfaces in left bay and about 73.2 °F on right bay indicating cool house air being pushed through the house by means of the floor cavity and the force of the wind. (Withers)

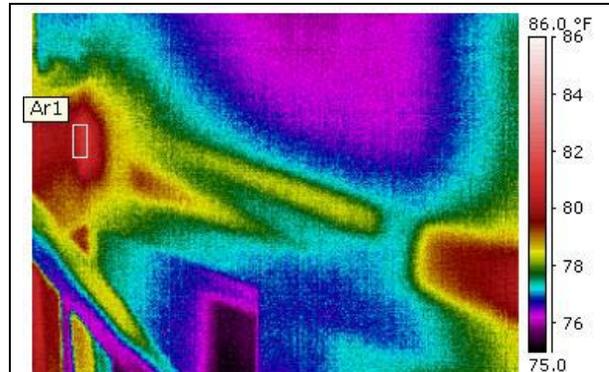
Figure 19 IR image of floor space area at stairwell shows areas of elevated surface temperature before retrofit. Area in box "Ar1" is about 81.4°F while the indoor set point was 77.3 °F on average. (Withers)

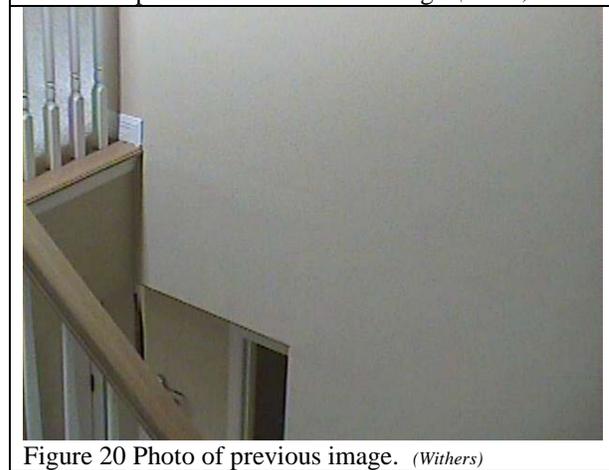
Figure 20 Photo of previous image. (Withers)

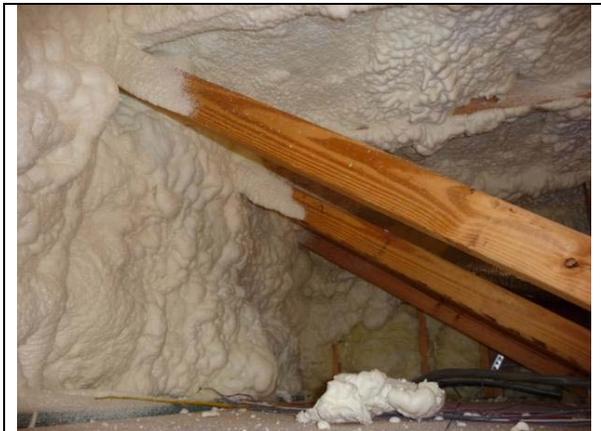
Figure 21 Foam applied to wall and ceiling of the bonus room floor cavity (3' high). (Withers)

Foam insulation product was applied to the floor of the bonus room and to the interface between the bonus room floor cavity and the floor cavity of the main part of the house. There was also a large opening between the large cavity below the bonus room and the south attic space; this was sealed to isolate the two spaces from each other. Figure 21 shows wind washing repair under the bonus room just before it was completed.

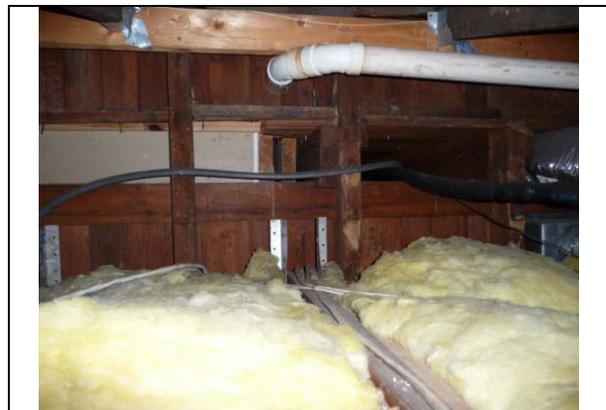
Figure 24 Floor cavity connected to attic space before repair. (Withers)
