# Effective Floor Cavity and Knee Wall Construction Techniques in Two-Story Homes in Hot Climates

FSEC-PF-467-16

ASHRAE Thermal Performance of the Exterior Envelopes of Whole Buildings XIII  
International Conference, Clearwater, FL – December 2016

Charles R. Withers, Jr.

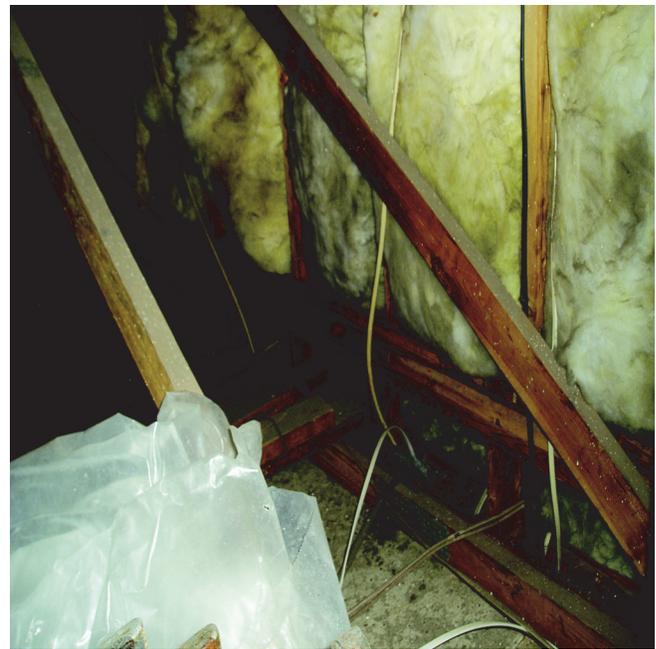
**Figure 1** (a) Conceptual illustration of wind washing through floor cavity shown on a floor plan. (b) View from within attic of poorly insulated knee wall and floor cavity with areas of missing and compressed batts. Batts were dirty from years of air movement across them. Attic soffit vent is nearby in dark left region of photo.

A comprehensive visual inspection completed within the attic focused around floor cavities or dropped ceiling areas was found to be the most important and effective method of identifying homes needing floor cavity repair. Figure 1b shows a commonly found issue of poorly fit knee wall insulation and areas of floor cavity open to attic spaces commonly over garage areas. Inspections should focus efforts on locating an effective air and thermal barrier over the floor cavity. Some homes have very small attic areas that were either inaccessible or had limited accessibility for inspection. Equipment such as a bore scope may be needed

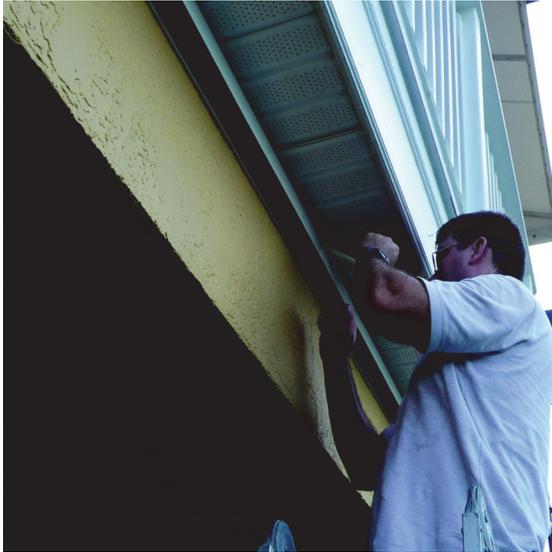
in such cases, or material disassembly may be warranted in some instances, such as moisture damage issues. Figure 2 shows an example where soffit venting was removed for inspection in areas where floor cavities terminated nearby in a home with severe moisture damage found to be related to floor cavity wind washing. Spray foam applications can also

**Figure 2** (a) Sections of vented soffit were removed to inspect floor cavities not accessible from attic space. (b) View within cavity sections found pathways about 0.05 m (2 in.) high under floor joist supports that connect to small attic space beyond.

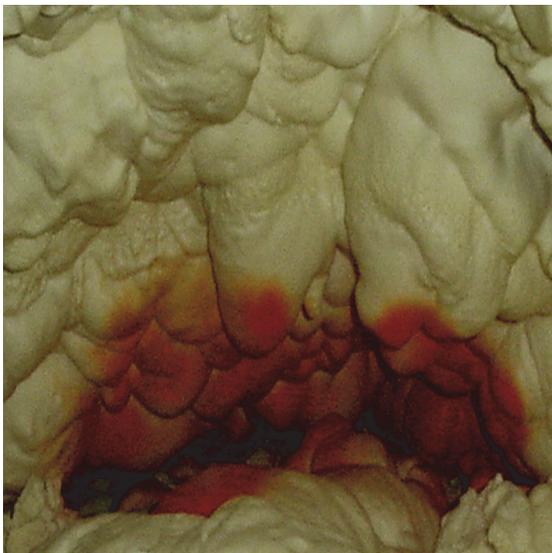
have failures if not applied carefully. Figure 3a shows an area of leakage within an attic that was found and painted so the contractor could come back to seal it.

**Figure 3** (a) Air leak in spray foam painted for contractor to come back and seal it. (b) Inspection using IR camera shows elevated wall temperature at floor cavity area.

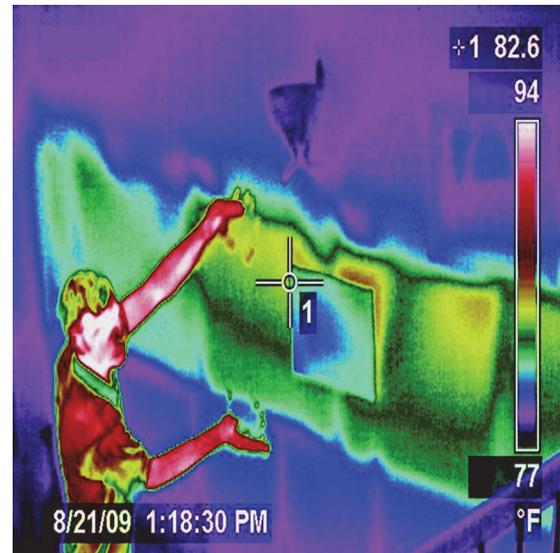
(b)

differentials occurring between attic and indoors for at least a few hours. Figure 3b shows warm summer indoor wall temperatures due to wind washing into the floor cavity. This is the same home of the floor plan shown in Figure 1a. At times this author found it more useful to use the IR camera from within the attic looking at knee wall and floor cavity areas instead of from indoors.

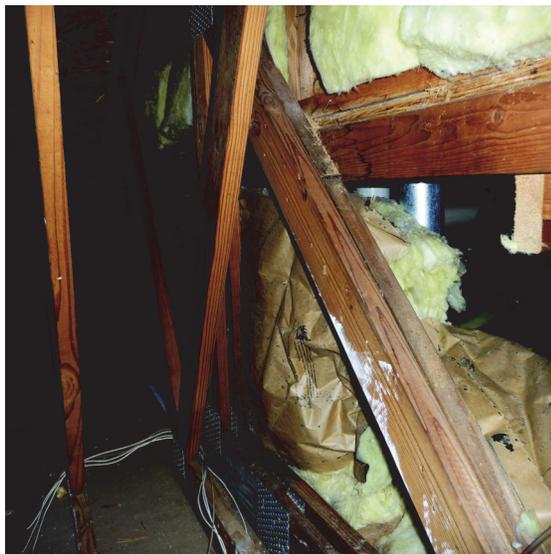
**Figure 4** (a) Existing construction showing multiple truss sections tightly against each other and the knee wall and floor cavity structure that does not allow sheet stock to simply be applied continuously as cover. (b) New construction shown uses plywood sheet over knee wall and floor cavity sections with room to seal seams and add insulation to improve wall R-value.

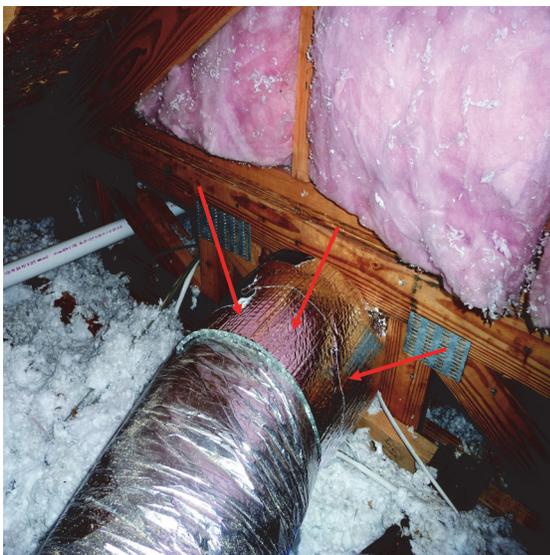
**Figure 5** (a) The cold air supply duct is first wrapped using a thin insulative sheet with a vapor barrier on the exterior face. (b) Then insulation can be placed around and in contact with the barrier wrap, where a low-density spray foam was used.
