Achieving Airtight Ducts in Manufactured Housing

Janet McIlvaine, David Beal, Neil Moyer,
Dave Chasar and Subrato Chandra

FSEC-GP-234-03

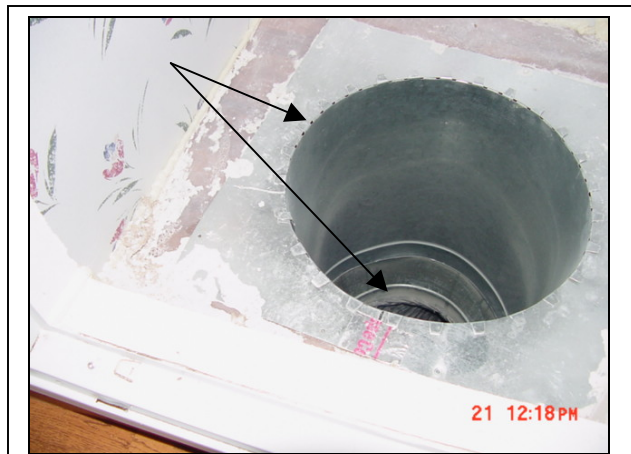
Figure 4 No mastic on return duct in plenum serving packaged heating and cooling unit. Mastic used elsewhere in the plenum and throughout house.

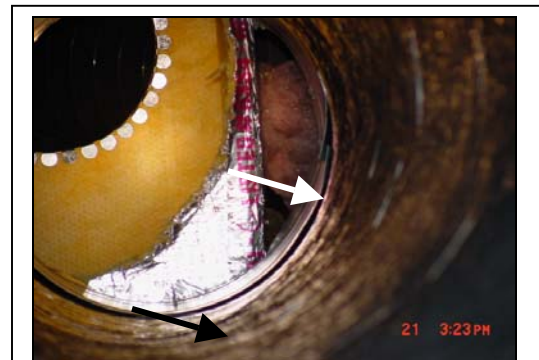
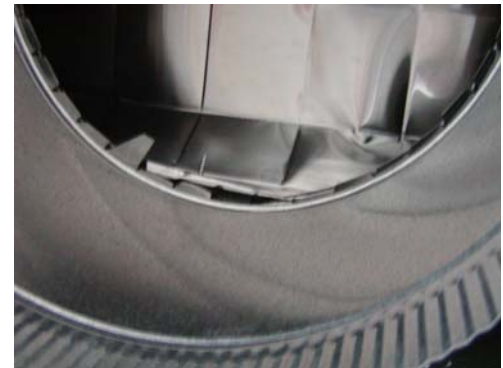
Figure 5 Above Misalignment of round duct to round cutout. Arrow shows where components should mate. Below Misalignment/insufficient connection surface at round duct collar to rectangular duct.

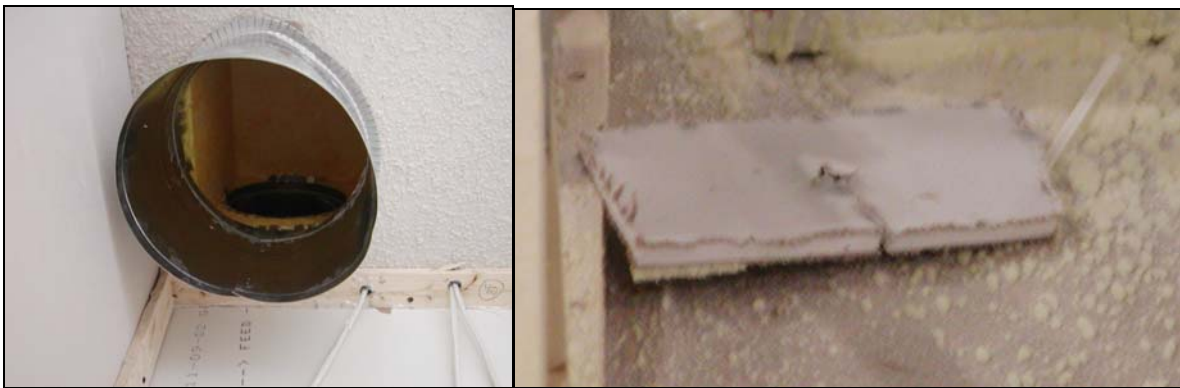
Figure 6 *Left* Holes cut free hand do not mate well with duct system components. Note round duct is jammed into an oval shaped cut out. *Right* Imprecise rectangular cutout for ceiling register creates poor joint.

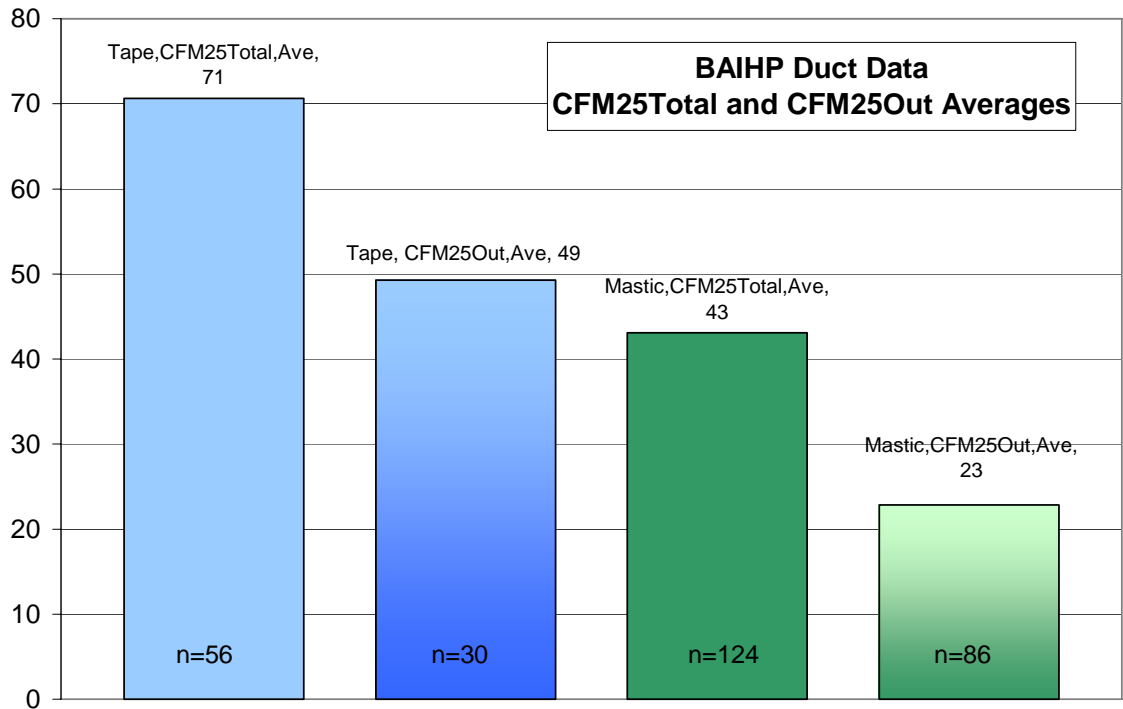
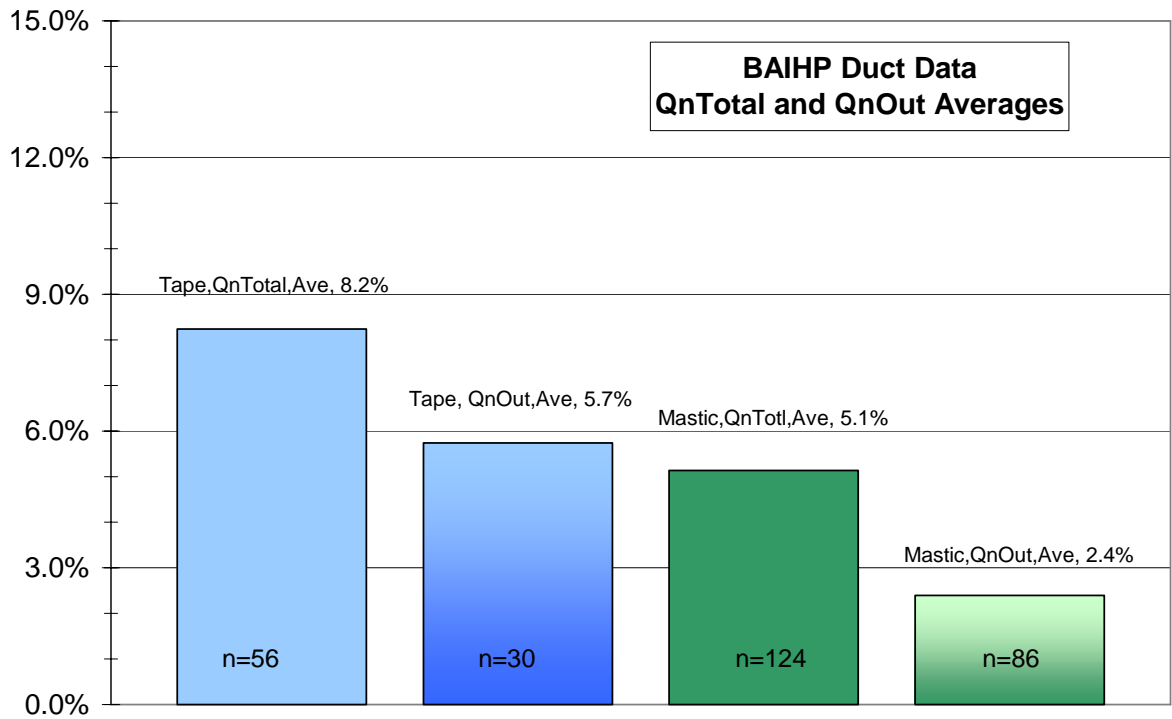
Figure 7 BAIHP Duct Data Averages

Top: Averaged CFM25_{Total} and CFM25_{Out} data show that mastic sealed systems were tighter than taped systems in both total leakage and leakage to the outside.

Bottom: Averaged Qn_{total} and Qn_{out} data show that mastic sealed systems, on average, met both the total leakage and leakage to outside goals whereas the taped systems met neither.

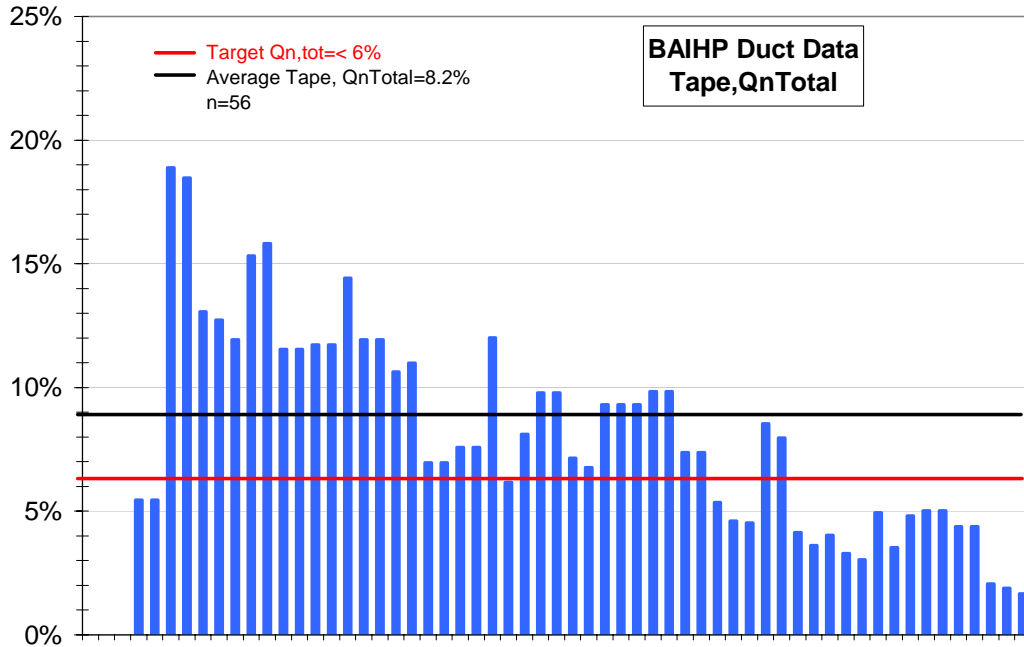
Figure 8 All Q_{nTotal} data points for taped systems. Note that average (black line) is well above target (red line). 19 tape sealed systems met the 6% Q_{nTotal} goal.

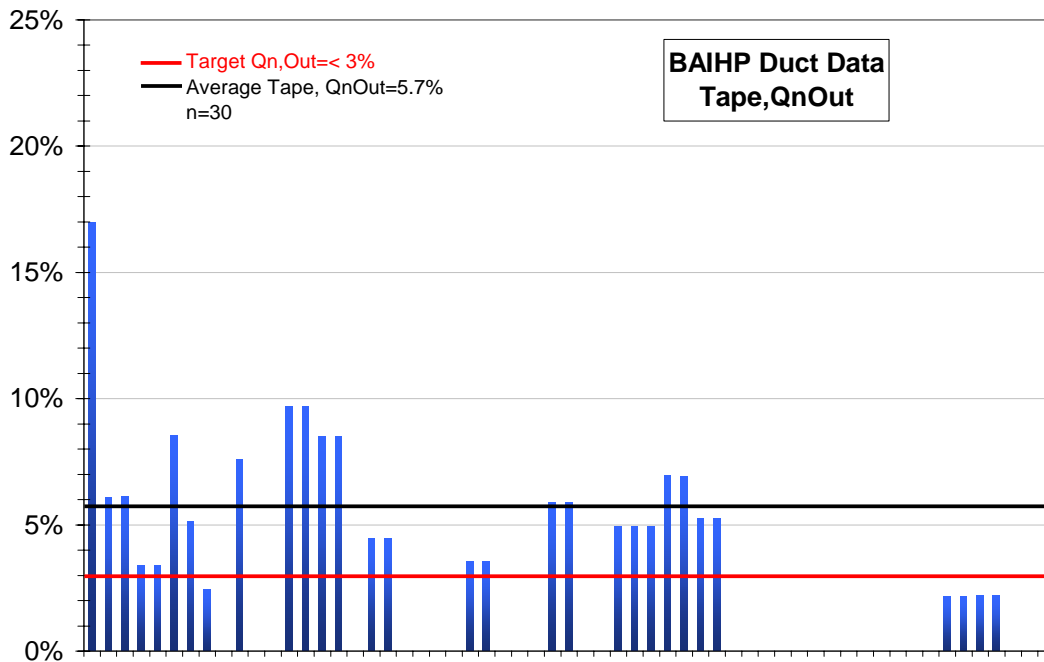
Figure 9 All Q_{nOut} data points for Taped systems. Note that 5 taped systems met the 3% Q_{nOut} goal.

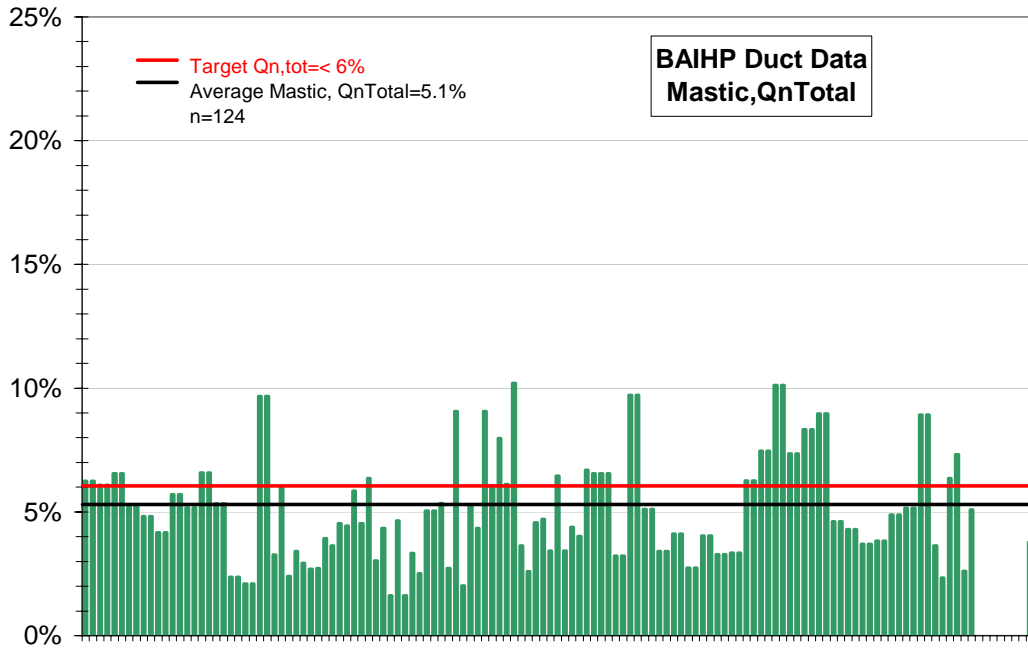
Figure 10 All QnTotal data points for mastic systems. Red line signifying target QnTotal<=6%. Black line shows the average QnTotal (5.1%) for mastic sealed systems. Data points exceeding the target are listed in Tables 7 and 8.

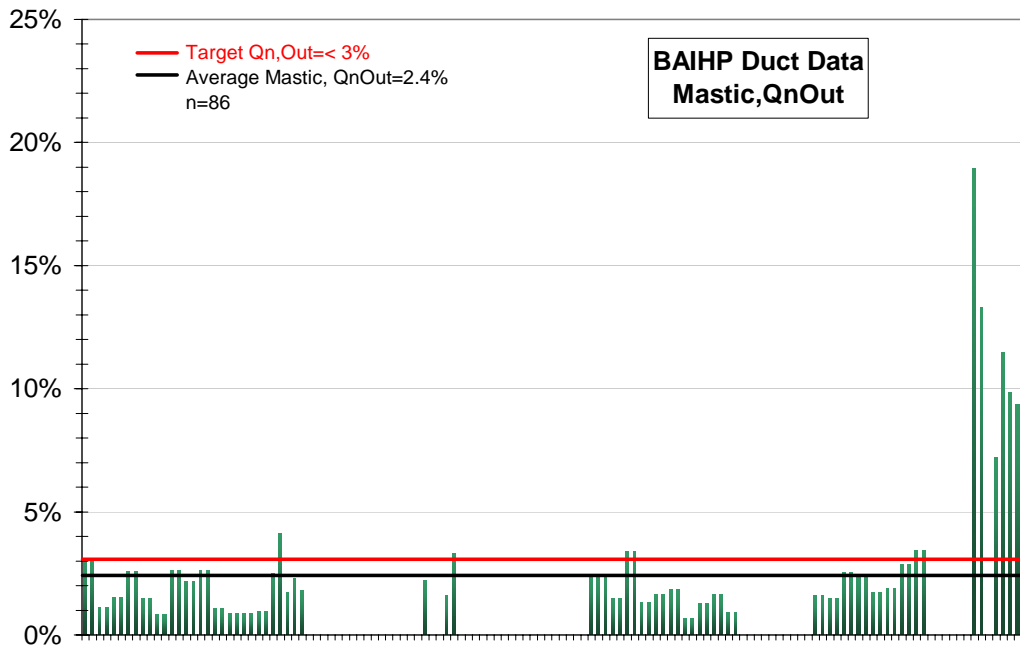
Figure 11 All Qn_{Out} data points for Mastic systems. Instances of CFM25_{Out} being too small to measure accurately are reported as 0% leakage (n=12) and do not show up on this graph. Data points exceeding the 3% Qn_{Out} target are listed in Tables 8 and 9.
