High Performance Existing Homes Partnerships and Research

Janet McIlvaine

Retrofit Case Study: Sarasota Home

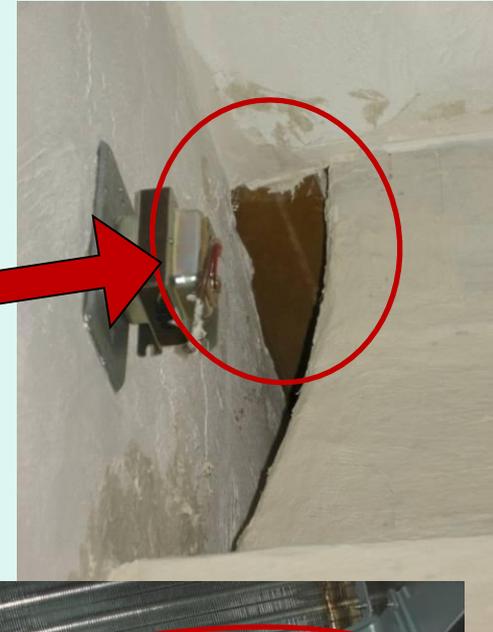
*Holes connecting
AHU closet to attic*

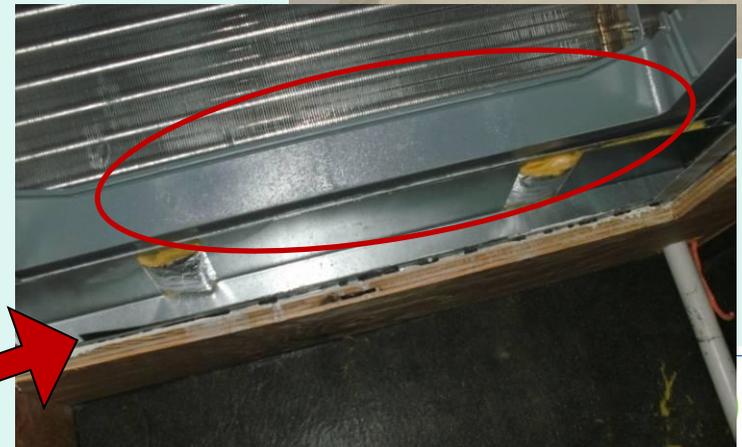
*Unsealed joints in
return plenum*

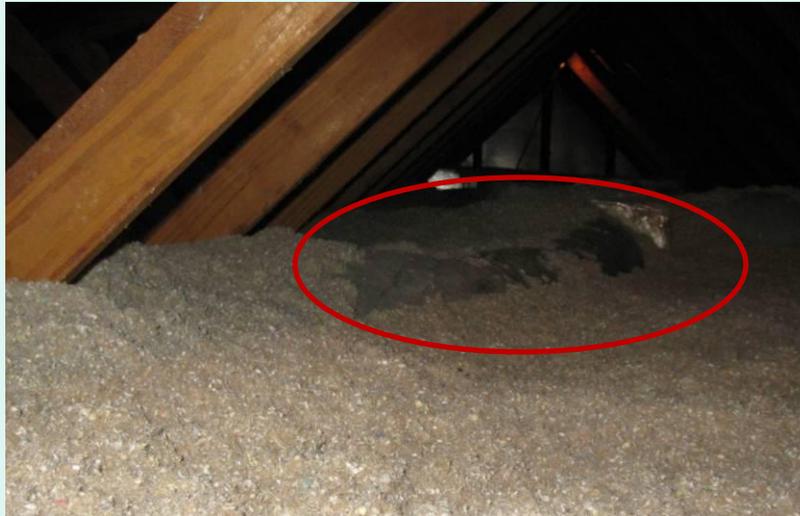
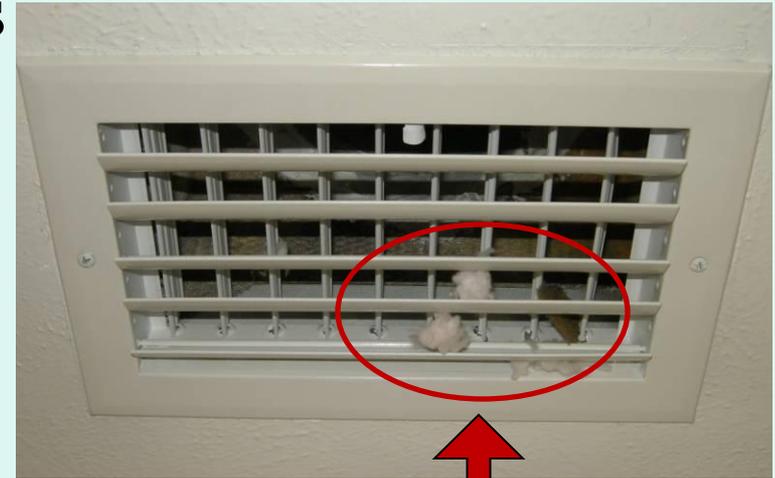
- Unsealed/Poorly Sealed Ducts
- Ducts Buried by Insulation

Insulation pulled from
attic, through supply
register during
depressurization test

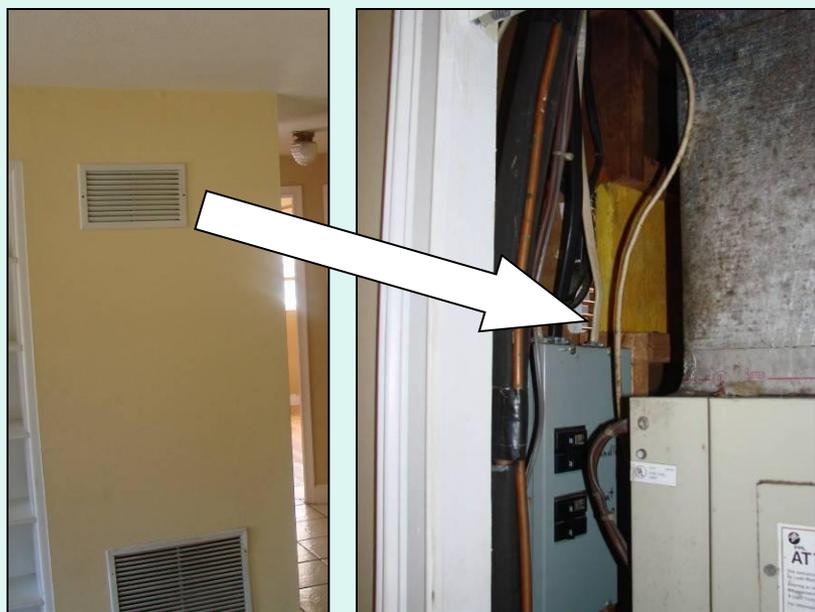
LR side of
AHU closet

Sparse ceiling in AHU
closet, connected to
attic & LR

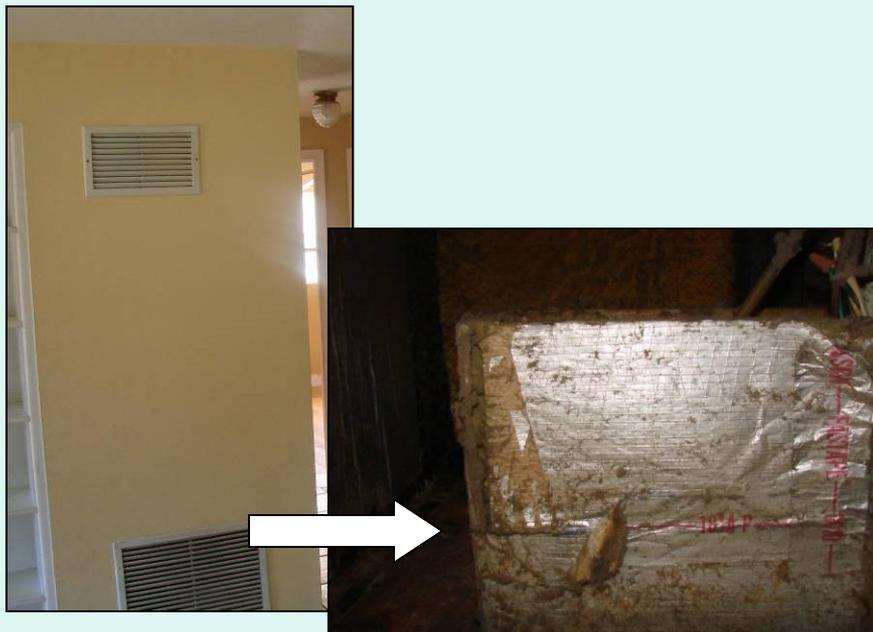
LR side of AHU closet

Mysterious return plenum

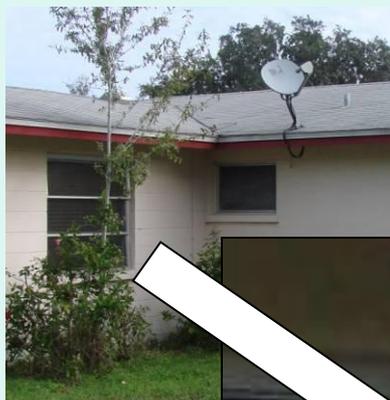
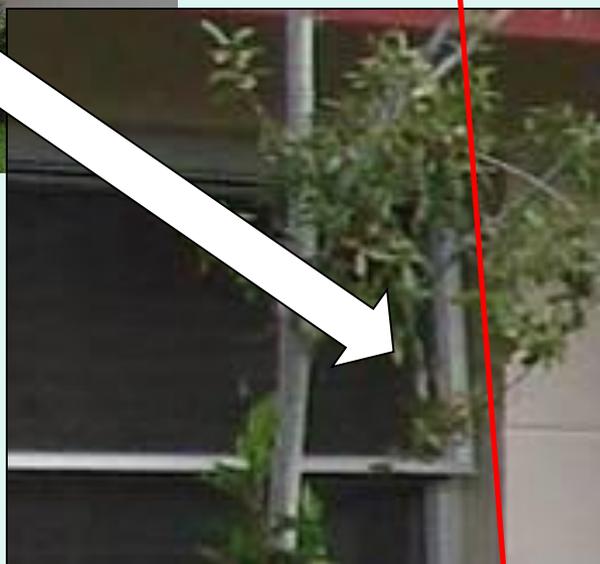
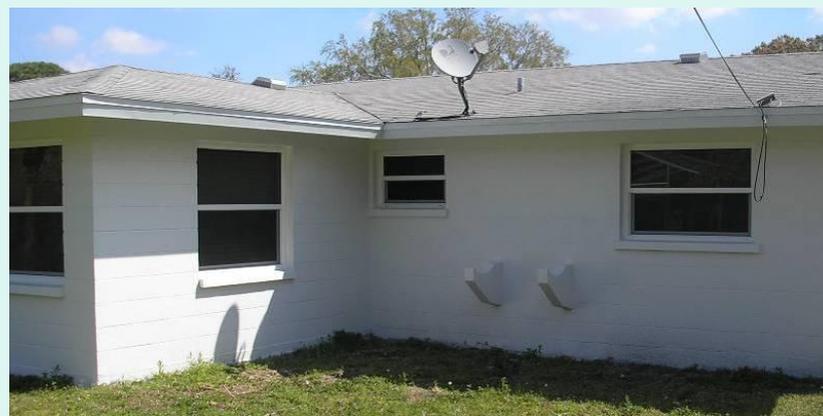
Note angle of window in 'closed' position

New *Windows Exceed EnergyStar®*
U-Value = 0.47, SHGC = 0.37
