Uncontrolled Air Flow in Non-Residential Buildings

Final Report

FSEC-CR-878-96 April 15, 1996

Hondo Solar Energy Center 1679 Clearlake Road Cocoa, FL 32922-5703 Prepared by: James B. Cummings Charles R. Withers Neil Moyer Philip Fairey Bruce McKendry

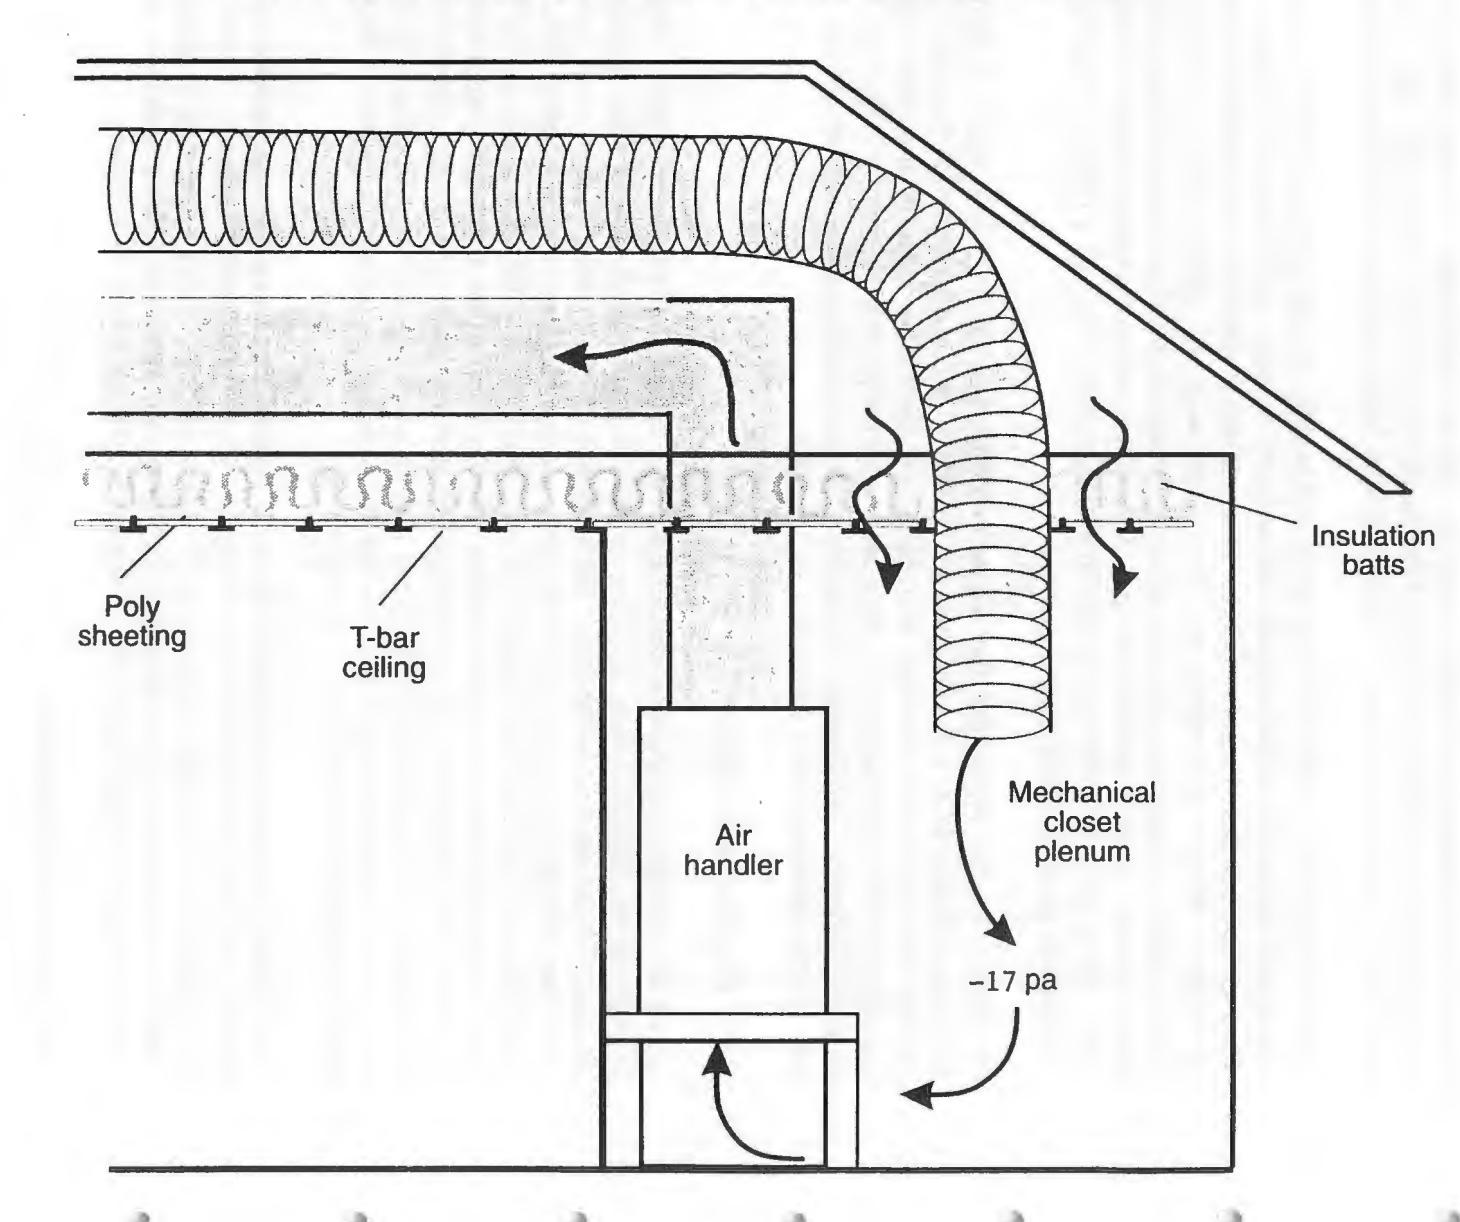
Figure 5.5

Serious Return Leakage Through T-bar Ceiling of a Closet Used as a Return Plenum

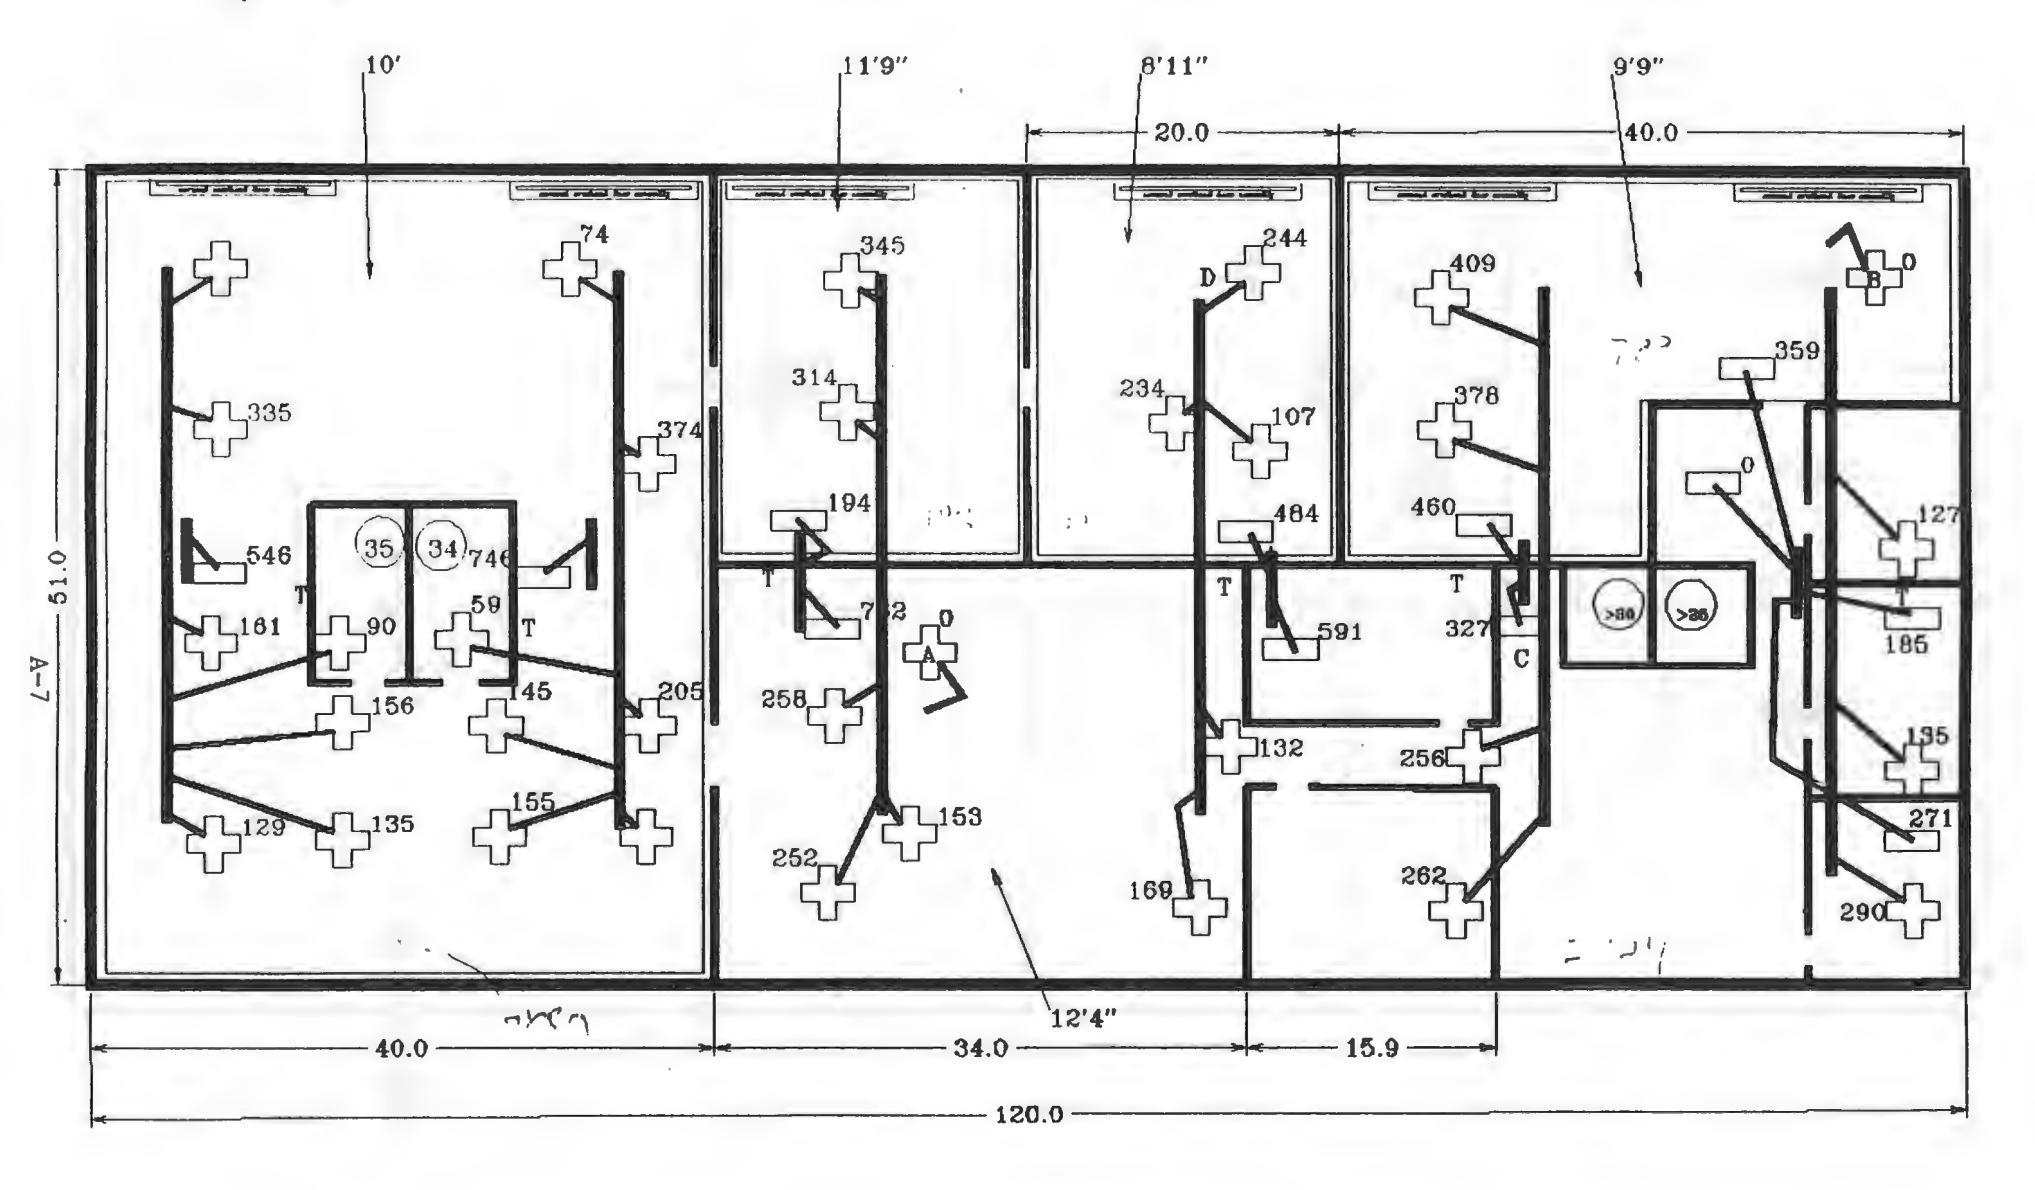
A: Duct never connected-no connector in main

C: Return main flex 50% disconnected from unit

B: 12" flex dropped from main supply duct Measured flow from main = 785 cfm D: Flex duct with many kinks
