Energy Retrofit Field Study and Best Practices in a **Hot-Humid Climate**

J. McIlvaine, K. Sutherland, and E. Martin Building America Partnership for Improved Residential Construction

March 2013

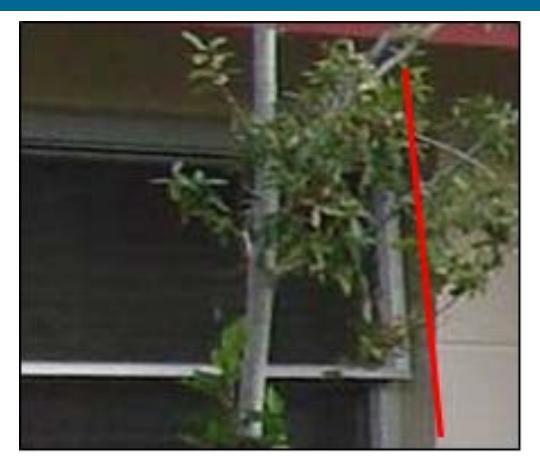
As a final note on window replacements, the window type sometimes had great impact on wholehouse airtightness. Jalousie and awning windows often did not close completely at pre-retrofit, creating extensive air infiltration paths (see Figure 10). The window in its most closed position is still slightly open. The red line indicates the pitch of the closed pane. If the window closed completely, the frame edge and red line would be vertical rather than pitched. In addition to efficiency gains from reducing solar heat gain and thermal conductance, replacing such poorly closing windows has the added benefit of large infiltration reductions. Air sealing between the window frame and rough opening likewise enhances the infiltration reduction. This third airtightening benefit of window replacement is reflected in the whole-house airtightness testing at the test-out audit (see Section 2.3); however, it is not accounted for in the cost associated with the infiltration reduction measure.

Figure 10. Pre-retrofit awning window in its most closed position is still slightly open, as indicated by the pitch of the red line.

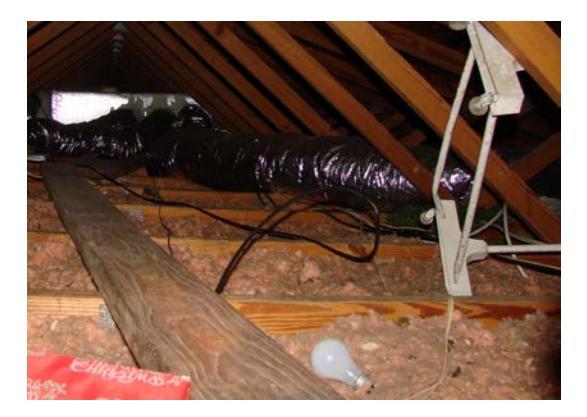
With few exceptions, homes had vented attics with some level of batt or blown insulation (Figure 13) applied to the attic floor, except in two cases that had no insulation. The pre-retrofit R-value was not precisely known and had to be estimated based on visual inspection. Typically, a section of the ceiling insulation depth could be measured. Researchers' estimates of pre-retrofit ceiling insulation values ranged from R-0 to R-34 (average R-16), with about 75% between R-9 and R-25. Improving the ceiling insulation level was among the most common retrofit measures included in 58 retrofits (83%) (Table 8).

Figure 13. Typical pre-retrofit ceiling insulation condition

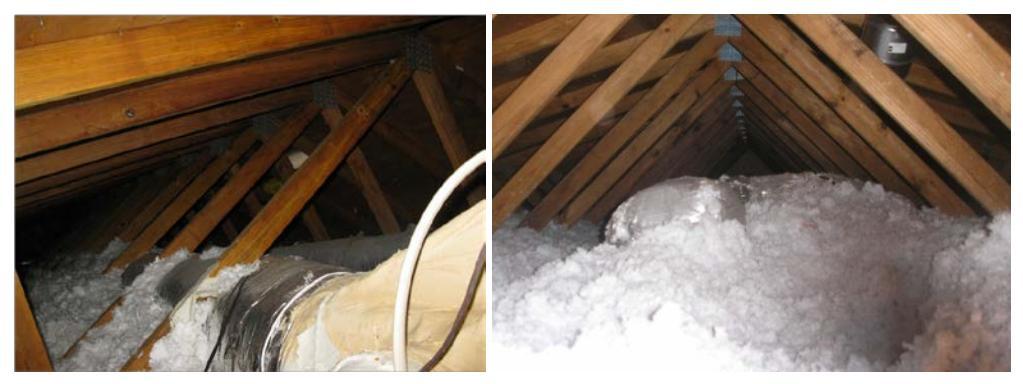
Typically, ceiling insulation retrofit consisted of blown-in fiberglass on top of existing insulation of various types to achieve the total desired insulation value, rather than removal of existing insulation. Often, researchers observed forced-air ductwork that was not strapped in place above the insulation and was partially buried after insulation was blown into the attic. Although strapping is required by the Florida Residential Mechanical Code for new construction, it is not required for mechanical system change-outs. Where ducts are partially or completely buried under insulation (Figure 14), moisture may condense on the outer surface of the duct if the insulation causes the surface temperature to drop below the dew point of the humid attic air. Duct leakage can increase this risk. Based on these durability concerns, researchers included the mechanical code guidelines for supporting flexible ducts above attic insulation that are required for new construction in the best practices. In other research, the Building America program is investigating the effects and benefits of covering attic-mounted ducts with insulation.

Figure 14. Post-retrofit ducts buried by blown-in fiberglass

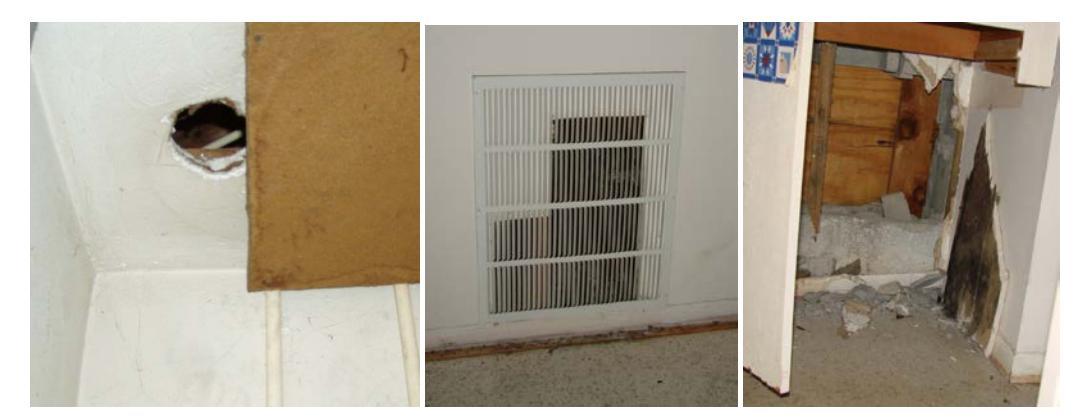
For the 59 homes, pre-retrofit ACH50 ranged from 3.6 to 41.8 with an average of 10.5. All but one home had ACH50 < 25. When test-in results were high, auditors identified airflow pathways and provided that information to the partner. In Florida's hot-humid climate, high infiltration rates are less detrimental than they are in climates with larger temperature differentials between outside and conditioned spaces. It is less beneficial and less cost effective to expend labor on *extensive* air sealing efforts in the hot-humid climate. Air sealing efforts necessary to achieve the target ACH50 test result include sealing around drywall penetrations (for supply and return registers, dryer vents, wiring, lighting and fan fixtures, and plumbing), replacing missing plumbing access panels, correcting poor window and door closure, eliminating recessed lighting, and installing gaskets at attic access panels in the conditioned space (Figure 10 and Figure 16).

Figure 16. Pre-retrofit drywall penetrations: The ceiling fixture was removed, but penetration to the attic was unsealed (left); plumbing access in the wall covered with a return grille rather than a solid cover or patch (center); large opening beneath the bathroom vanity where block and drywall were removed as part of an incomplete renovation (right).

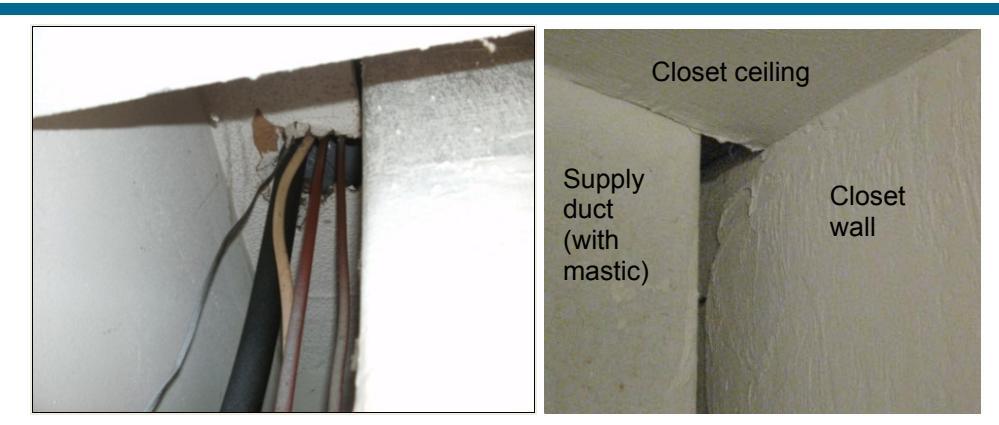
A common infiltration path that sometimes remained post-retrofit was located at the ceiling of the air handler unit (AHU) closet (Figure 17). Contractors often did not seal the gap around the supply plenum at the ceiling drywall. Access to this gap is complicated by closets that were designed for smaller AHUs.

Figure 17. Gaps or holes at ceiling of AHU closet

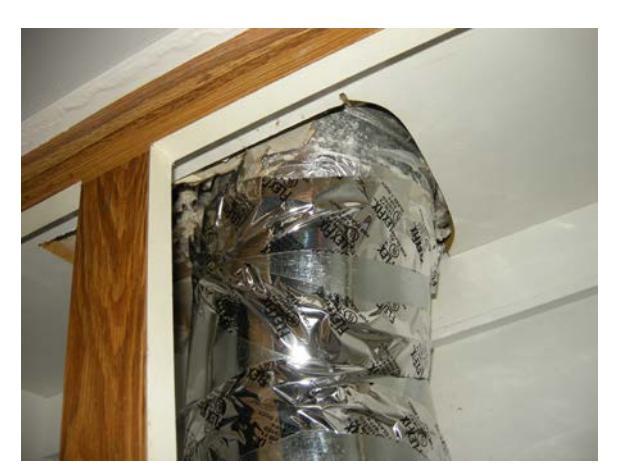
In two cases where whole-house airtightness was not improved it was virtually unchanged. In five cases, the leakage was marginally increased ($\leq 6\%$); however, in one home the leakage nearly doubled. The airflow paths included unsealed penetrations near the new bathroom vanity and the kitchen exhaust hood (Figure 18).

Figure 18. Post-retrofit: Unsealed range hood penetration through top of cabinet into the attic

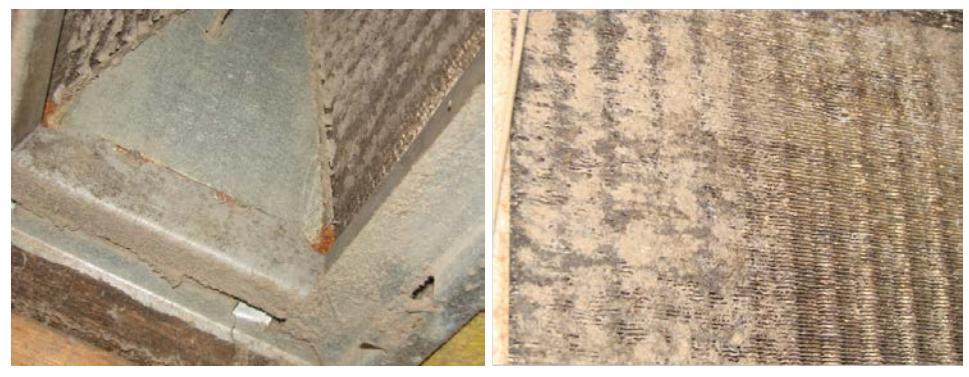
Figure 19. Looking up at pre-retrofit clogged, dirty cooling coils in the AHU (left); corroded and clogged cooling coil (right)

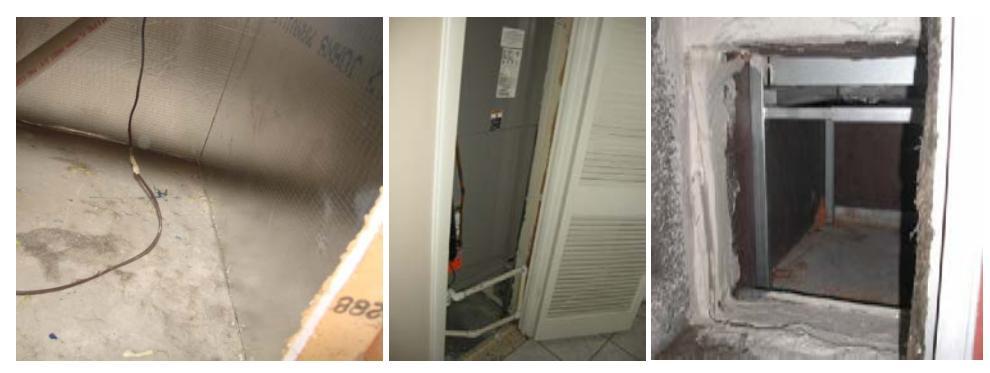
Of the 53 houses tested before and after retrofit, duct leakage was reduced in 42 (79%) and stayed the same in one (2%). In 10 homes, ducts were leakier after renovation. In three of those, new ductwork had been installed. Six had a noticeable lack of return plenum sealing (Figure 30, left). Five had no dedicated return plenum; rather, the whole AHU closet with a louvered door (Figure 30, center) or door-mounted return grille served as the return plenum surrounding an AHU mounted on a metal stand (Figure 30, right).

Figure 30. Return air plenum lined with duct board without sealant at edges and seams (left). Narrow AHU closet functioning as return with uncontrolled airflow (center). Attempt to make a sealed return plenum around a metal AHU stand (right), with noticeable unsealed gap at bottom edge of duct board.

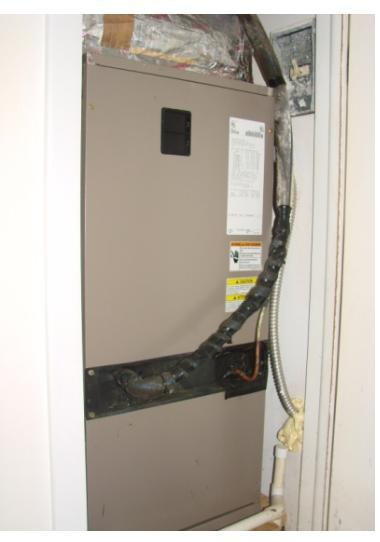
One problem encountered in many homes was that an AHU was being replaced with a larger one in a relatively small AHU closet (Figure 31). The larger AHUs are coincident with higher efficiency equipment, even within the same or smaller capacity. Contractors had a difficult time reaching the areas that needed to be sealed, including the return plenum (construction joints and connection to the AHU), the supply plenum connection to the AHU, and the gap around the supply plenum in the closet ceiling.

Figure 31. Crowded AHU closet with little room to access and seal duct connections to cabinet

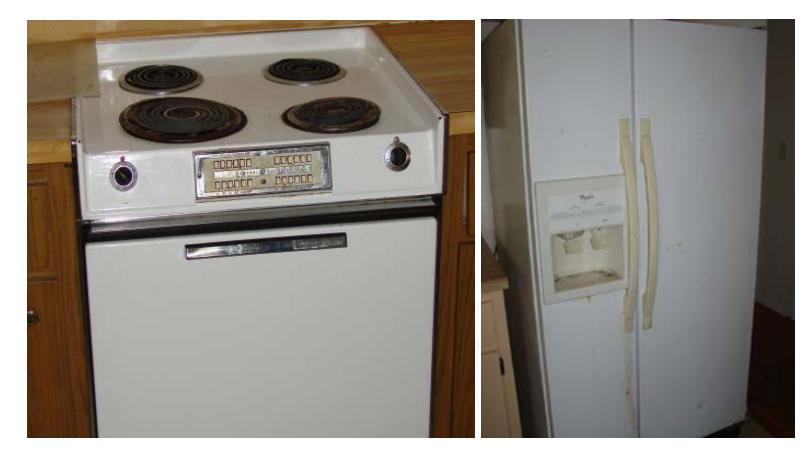
Before renovation, appliances were typically missing, old, or in poor condition (Figure 32). Many of the homes were not equipped with dishwashers. Researchers attempted to use manufacturers' rated efficiencies; however, often model numbers were illegible or the equipment had been removed before the pre-retrofit audit. Thus, to define efficiencies for the appliances at pre-retrofit, researchers relied almost exclusively on estimates which likely overestimated the efficiencies, making improvement projections conservative.

Figure 32. Typical pre-retrofit appliance condition for range (left) and refrigerator (right)

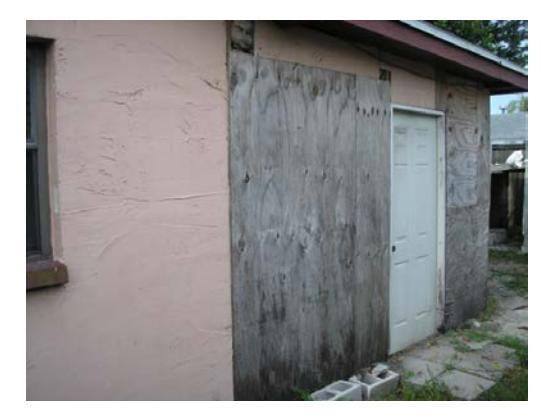
During pre-retrofit audits, researchers found that many homes had porches and garages enclosed and made part of the conditioned space (Figure 33). These were retained as part of the conditioned space in all but five homes. Returning those spaces to their original use reduced conditioned floor area, volume, and thermal envelope area. Conditioned floor area reductions ranged from 140 ft² to 696 ft² and were, with one exception, coincident with a reduced window area (Table 14). Rather than include this envelope change in every energy-saving measure, researchers adjusted the pre-retrofit simulation model to reflect the change. This effectively focuses savings on efficiency improvements rather than on size adjustments that are relevant to a small number of renovations. The analysis reflects the savings from the package of improvements if the house had been the same size at pre-retrofit. From a homeowner perspective, though, reducing the size of a home would likely produce annual savings.

Figure 33. Pre-retrofit exterior wall of porch converted into conditioned space
