2.0 OVERVIEW OF INSTALLED SYSTEMS

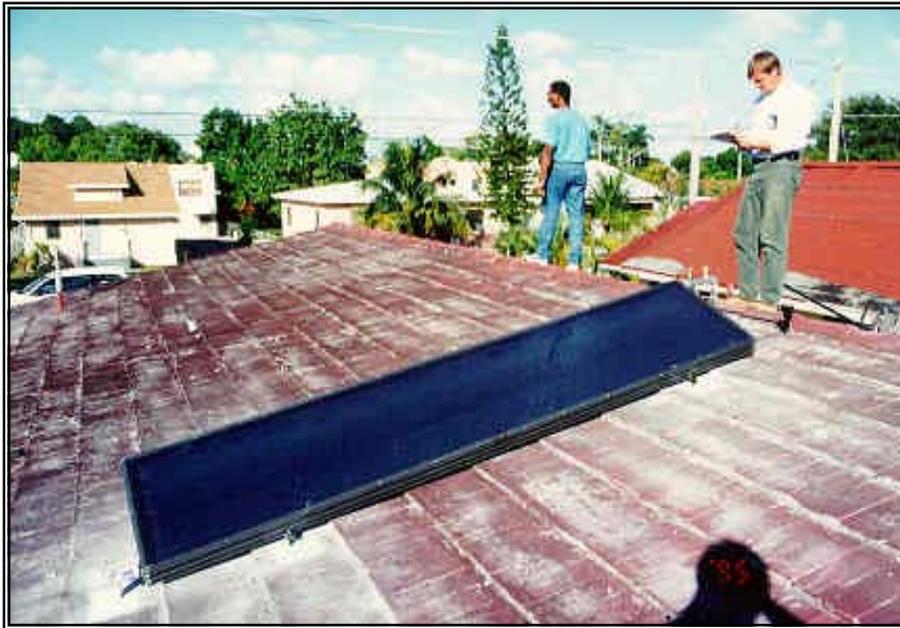
Figure 2.0-1. Twenty-square-foot collector installed on tile roof.

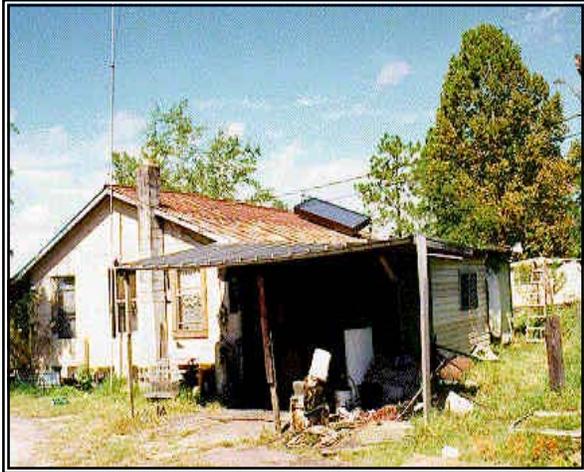
Figure 2.1-1. ICS system installed on a rural residence in North Florida.

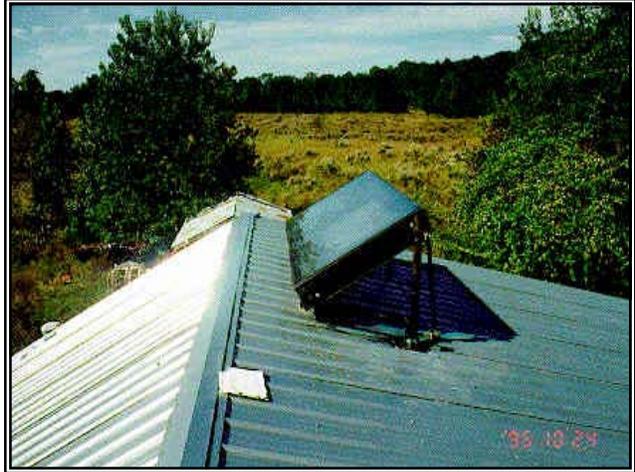
Figure 2.1-2. ICS collector installed on metal roof in rural area.

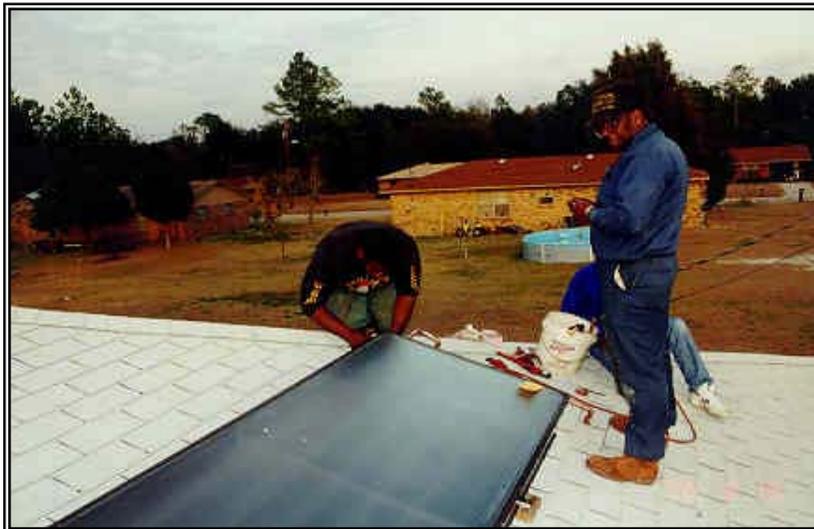
Figure 2.1-3. Local plumber installing ICS system.

Suwannee did solve some of this problem by having FSEC train a local licensed plumber in the installation of the ICS unit. This provided the local agency with additional contractors from which to choose. Plumbers are, by Florida construction licensing regulations, allowed to install solar water heating systems. This will also serve to provide Suwannee with a local craftsman in the event of required service calls.

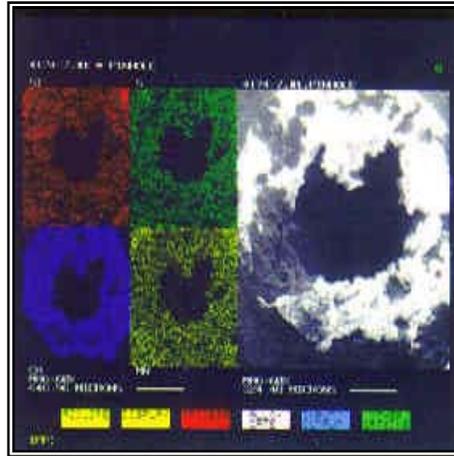
Figure 2.1-4. Analysis of pin holes with Energy Dispersive Spectroscopy analysis of pin holes.

Several systems installed in a specific neighborhood in Jasper, Florida, developed pinhole leaks in the absorber tubes. After detailed laboratory analysis, it was determined that the most probable cause of the leaking appeared to be localized pitting corrosion. This was the result of iron precipitation from the incoming city water supply. The severe iron content in the water supply was creating adverse galvanic corrosion in the copper tubing. This iron came from old iron pipes or/and pumps used in that specific neighborhood. A final report developed for FSEC on this problem is attached in Appendix 3.

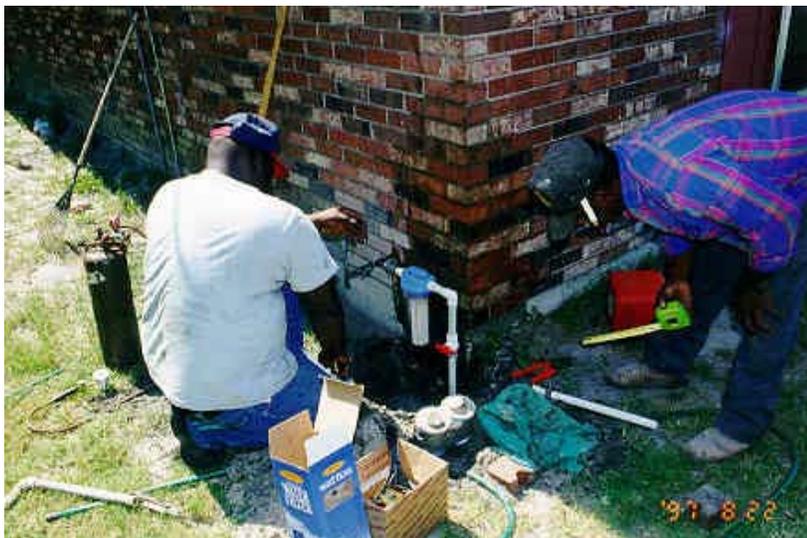
Figure 2.1-5. Whole house filter being installed.

The ICS units were repaired and whole-house water filters were installed. Since that time, there have been no further problems at the sites. The clients later remarked that their water was now much better with the filter. (Filters were purchased at a local hardware store that always stocks the filter replacement cartridges. Cost is \$5 for 2 cartridges. An FSEC follow-up indicated that cartridges should be replaced every 4 to 6 months.)

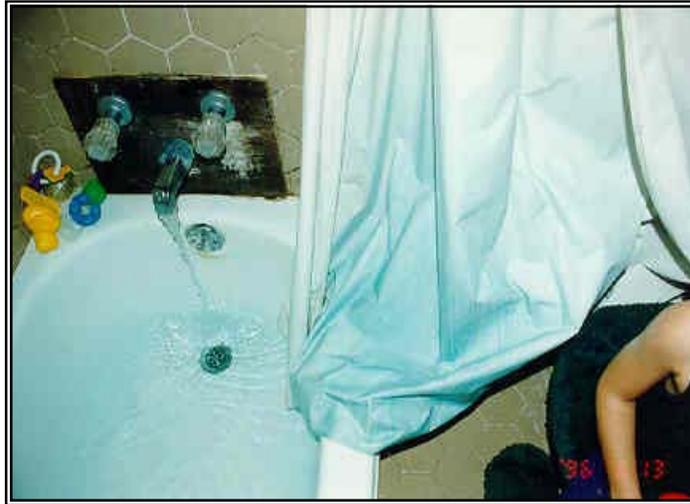
Figure 2.1-6. Blue residue from copper leaching due to very acidic well water.

At two rural sites in the Tri-County area of North Florida, two clients started noticing that their tubs, shower curtains, and, at times, laundry had a blue color to it. FSEC investigation determined that these systems were installed on wells where the pH of the water was below 5.0. This very acidic water was leaching the copper, which in turn, caused the “blue water” syndrome. It was also noted that neither house had copper piping before the solar installation. The original piping was either short runs of metal pipe and/or PVC piping. Local plumbers must have known about this problem and therefore did not use copper in the potable water system.

The problem was solved at one residence when the client decided to switch to the city water system. The other resident was not as fortunate. The system had to be removed and installed at another residence. The drilling of a new well may have provided better quality water, but this was cost prohibitive. In the end, FSEC sent the agency in that area a simple pH meter and instructed the agency to test the water prior to qualifying a site for a SWAP system. Sites with water pH levels less than 7.0 were excluded from the program.

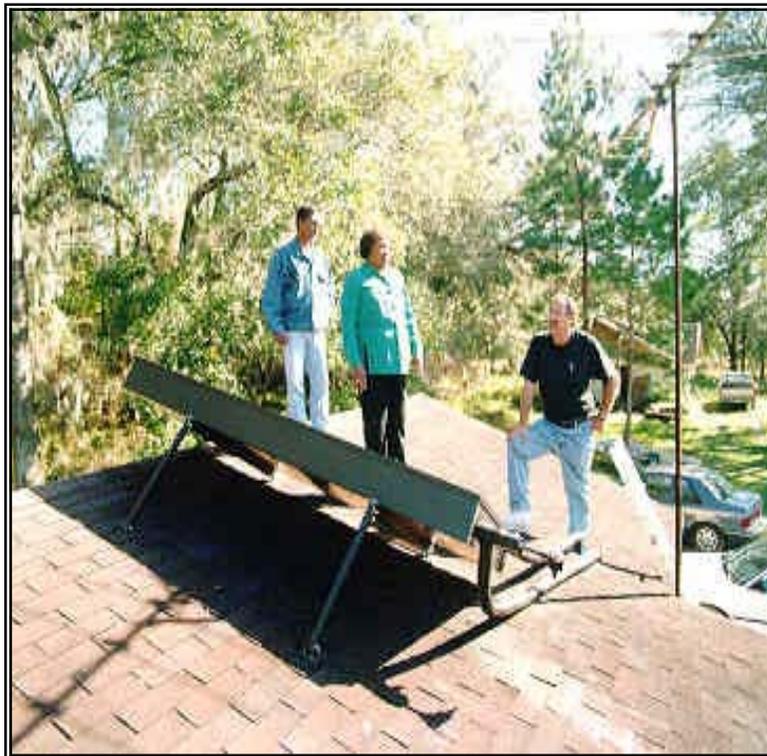
Figure 2.2-1. Brenda Mobley of the Mid Florida Community Services discusses a ICS installation with FSEC's John Harrison and Patrick Robinson.

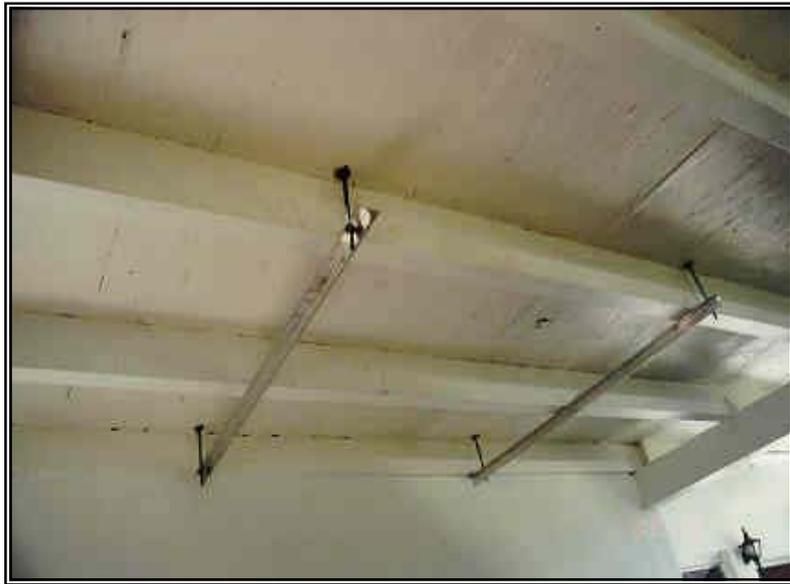
Figure 2.2-2. Spanner mounting of solar collector.

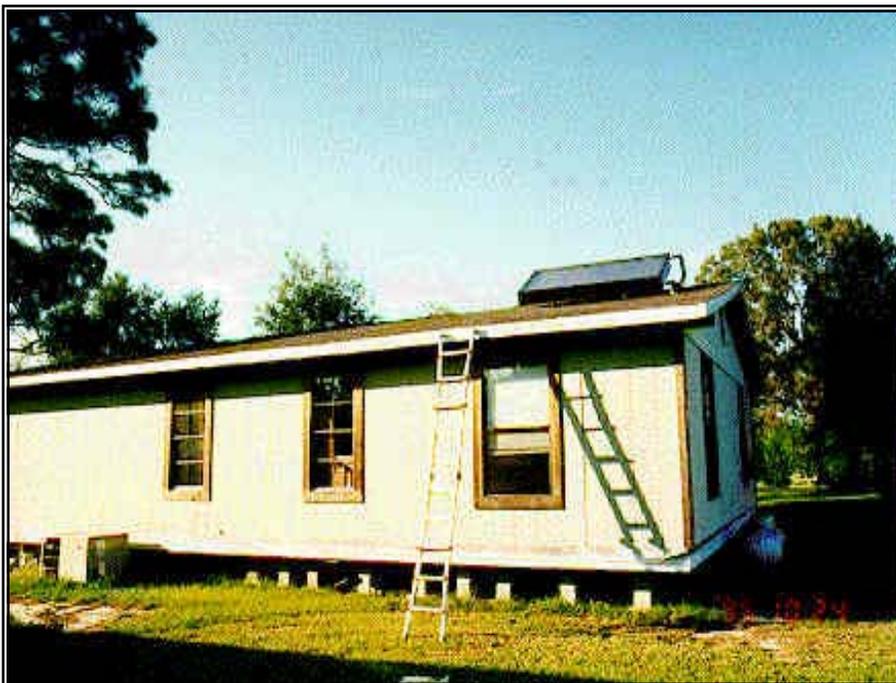
Figure 2.2-3. ICS system inadvertently installed on mobile home.

Citrus County personnel brought up a specific situation that should be addressed for future low-income solar programs. Mobile homes are excluded from the Florida WAP program since the NEAT audit procedure does not apply to mobile homes. Unfortunately, a large number of low-income clients live in mobile homes in Citrus County. SWAP systems were not installed on these homes.

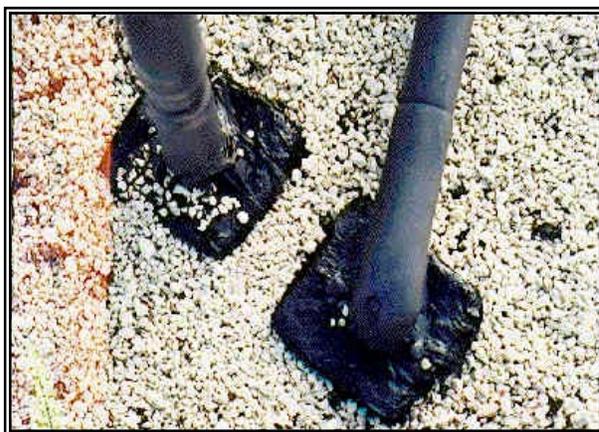
Figure 2.3-1. Pitch pan filled with bitumen.

Therefore, the majority of systems installed in the Metro-Dade area incorporated the pitch pan methods for roof sealing of penetrations. The installers did a very adequate installation of these pitch pans. Holes were drilled in the roof, the copper piping was wrapped with sealant tape and passed through the pitch pan, which was affixed to the roof. In turn, the pitch pans were filled with bitumen sealing material. A well-sealed pitch pan should not result in any problems, although pitch pans do require maintenance and inspections over the life of the system. Over time, the pitch material could dry and crack. If severe enough, these cracks could, in some instances, provide avenues for minute amounts of water to filter through.

FSEC recommended the use of copper flashing and coolie caps, but since this was not allowed in Metro-Dade, the use of pitch pans was a second, although not highly recommended, option. Periodic inspection of the pitch material is recommended.

FSEC closely monitored many of these systems. As suspected, several problems did occur with the use of pitch pans. These were quickly brought to the attention of the installers and corrected. During periodic inspections, FSEC staff inspect the pitch pans and added bitumen as required.

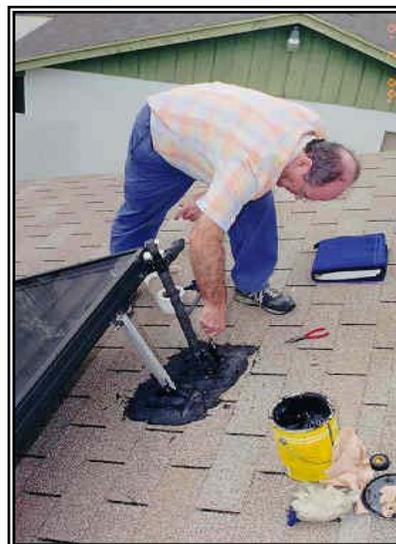
Figure 2.3-2. FSEC's Tom Tiedemann adding bitumen to pitch pan during routine FSEC inspection.

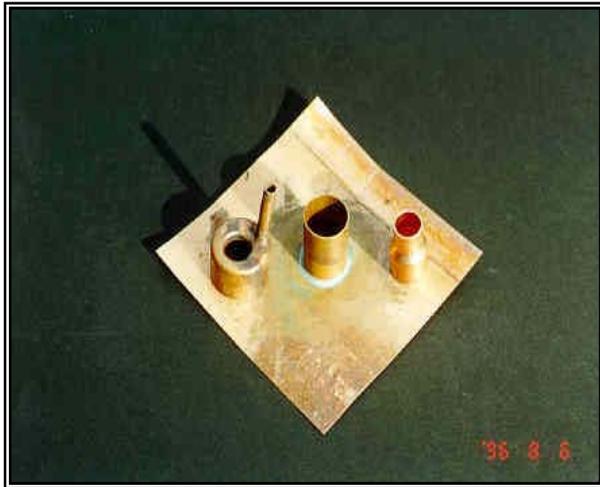
Figure 2.3-3. Standard solar industry flashing.

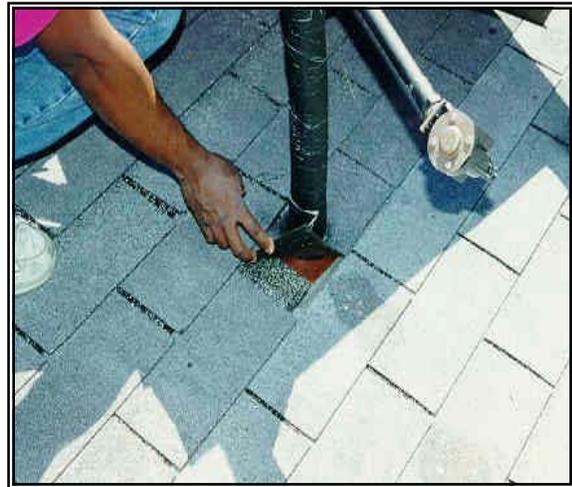
Figure 2.3-4. Ideal roof flashing using copper flashing shown in Figure 2.3-3.

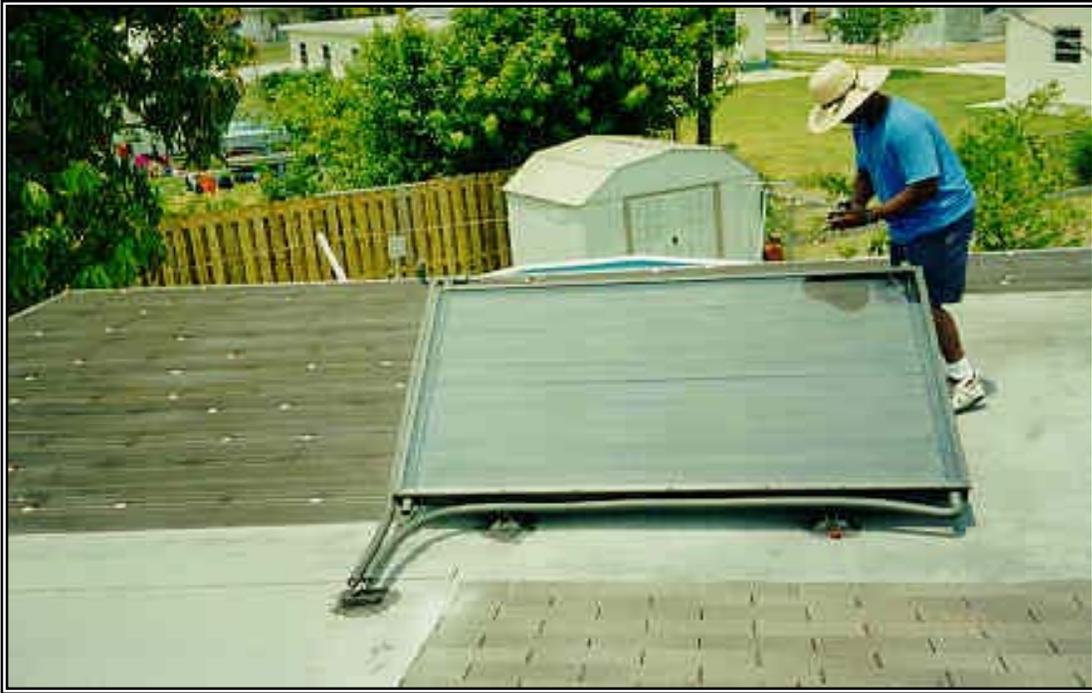
Figure 2.3-6. Twenty-five-square-foot collector installed on Miami site.

Until the collector manufacturers were able to provide mid-size collectors, the 32 ft² collectors were initially used on large occupancy residences. These were replaced, in time, by 25 ft² units. This is an ideal sized collector for retrofitting to 40- and 50-gallon water heaters in residences where there are four or more occupants. This intermediate size has several advantages. The cost is somewhat less than the larger 32 ft² unit and not much more than the 20 ft² collector. In addition, the use of this intermediate size collector tends to reduce the possibility of overheating with oversized collectors.
