Contract Report

Evaluation of the PV Systems at Martin Power Plant

FSEC-CR-1011-98

Tests Performed June 3, 1998
Report Submitted July 14, 1998
Revised July 23, 1998

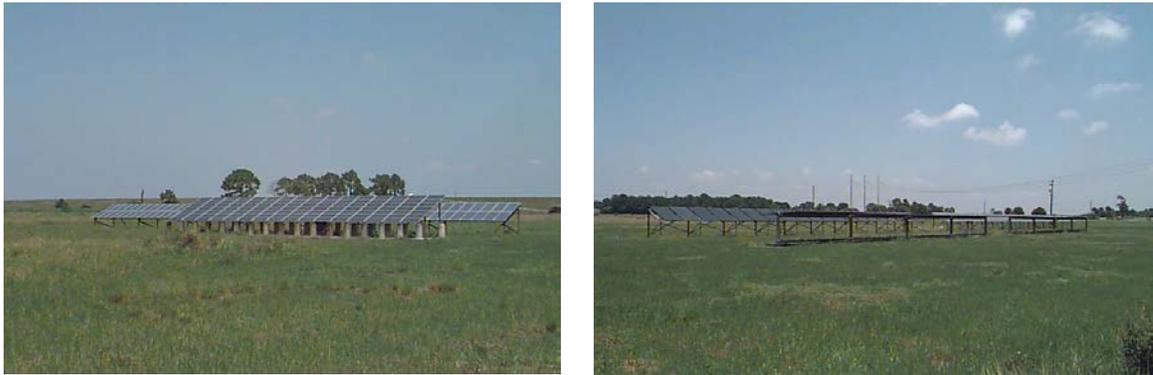
Figures 1 and 2. Martin Power Plant PV Systems

The weather conditions during test were hazy with a few clouds. This test was performed at the request of FPL to determine the operational status of the PV systems and to provide recommendations for upgrading or repairing these systems. Of the six systems, three were fully operational and were providing power to the grid. Figures 1 and 2 below show the Martin Power Plant PV systems.

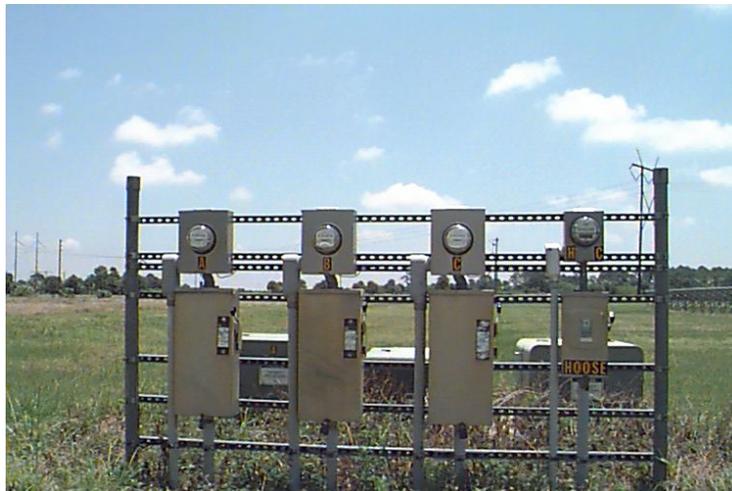
Figure 4. Grid Interconnect and Metering Equipment

The control room, shown north of the arrays, houses the power conditioning equipment, dc summing junction boxes, disconnect switches, monitoring equipment and data acquisition system (DAS). The output of the PV power plant is connected to a three-phase grid situated east of the control room (Figure 4).

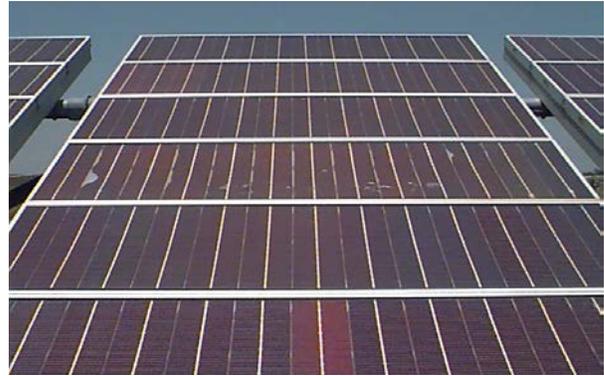
Figure 5. Sovonics Array

The array consists of 180 Sovonics P201 modules, mounted on a galvanized angle iron rack at a fixed tilt of 26 degrees (Figure 5). The array is configured in twelve strings of fifteen modules in series, which are divided evenly between the positive and negative source circuits. The original array rating at standard test conditions (STC) of 1000 W/m^2 and 25°C was 4,140 Watts. The nameplate rating of the individual Sovonics modules at STC is 21 Watts peak, $V_{oc}=22$ volts, $I_{sc}=1.6$ amps, $V_{pp}=16.3$ volts, and $I_{pp}=1.3$ amps. The array physical configuration and module serial numbers are given in Appendix B.

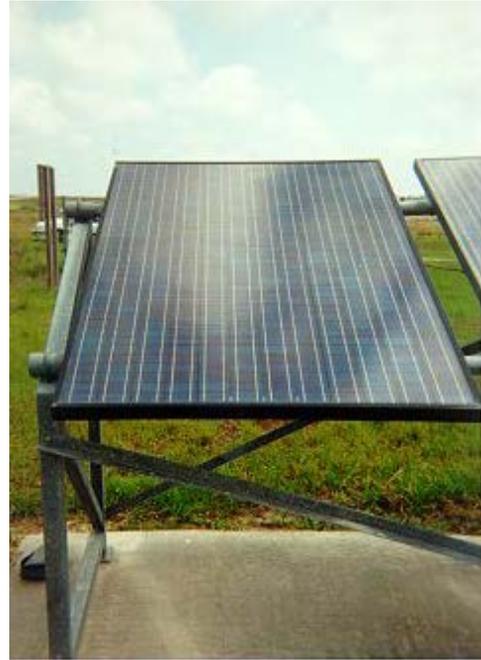
Figure 9. Mobil Array

This array consists of 20 Mobil RA180-36 modules, mounted on a galvanized pipe and angle rack at a fixed tilt of 26 degrees (Figure 9). The array is configured in four strings of five modules in series. The original power rating for this module could not be determined but typically these modules have been rated at 180 Watts peak. Assuming the 180-Watt rating, the initial rating for the array was about 3600 Watts. The array physical configuration and module serial numbers are given in Appendix B.

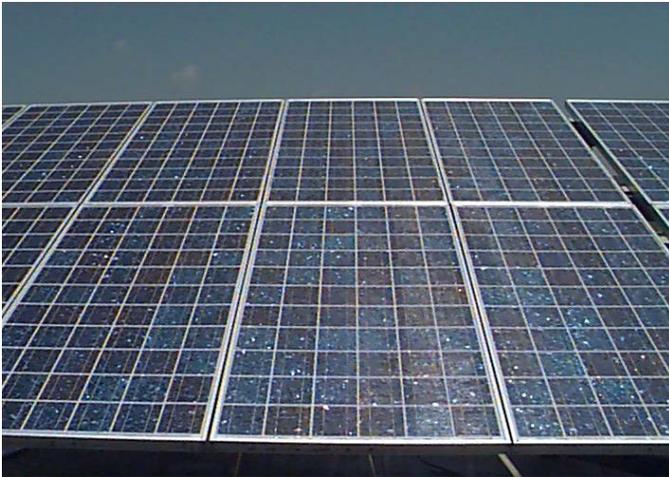
Figure 13. Kyocera Array

The array consists of 42 Kyocera LA661K94 multi-crystalline modules manufactured in 1990 (Figure 13). The 66-cell modules are mounted on a galvanized “I” beam rack at a fixed tilt of 23 degrees. The array is configured in six strings of seven modules in series, with the strings connected three in parallel to form the two bipolar sub-arrays, +/- 232 Vdc.

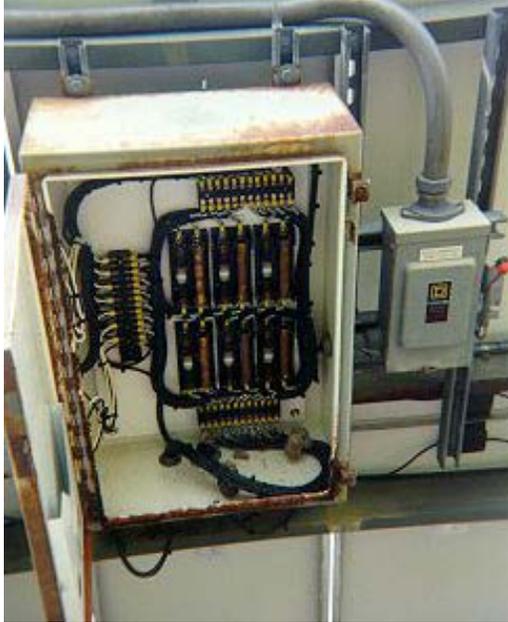
Figure 14. System 3 Source Circuit Junction Box

The source circuit junction box, mounted under the array, contains the blocking diodes, fuses, surge protection and disconnect switches (Figure 14). The output of the array is connected to the combiner box in the control room (Figure 15). The combiner box contains the fuses and monitoring equipment for Systems 3 and 4.

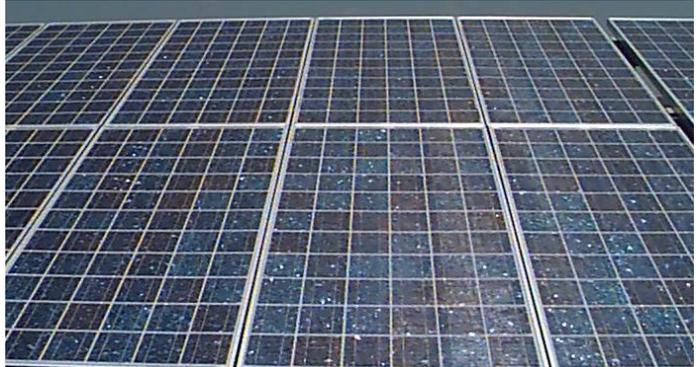
Figure 17. Kyocera Array

The array consists of 42 Kyocera LA661K94 multi-crystalline modules manufactured in 1990 (Figure 17). The 66-cell modules are mounted on a galvanized “I” beam rack at a fixed tilt of 23 degrees. The array is configured in six strings of seven modules in series, with the strings connected three in parallel to form the two bipolar sub-arrays, +/-232 Vdc. The original array rating at STC is approximately 3,900 watts. The nameplate rating of the individual Kyocera modules at STC is 93.6 Watts peak, V_{oc} =31.0 volts, and I_{sc} =3.02 amps. The module physical configuration and serial numbers are given in Appendix B.

- 3) The module frames are not grounded using a grounding conductor, but instead rely on the physical contact between the module frames and the “I” beams. The “I” beam frame was connected to earth in one location with a ground rod, but the bare conductor has been cut.

- Replace the corroded array summing junction boxes.
- Install proper bonding and grounding for the modules and array support structure.

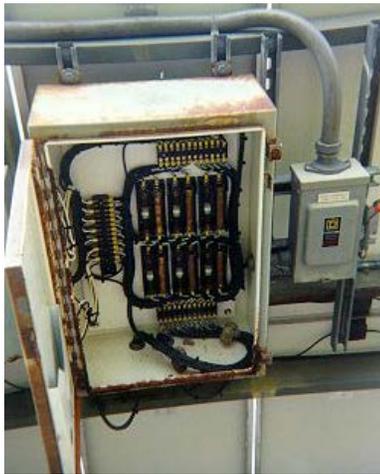
Figure 18. System 4 Source Circuit Junction Box

The source circuit junction box, mounted under the array, contains the blocking diodes, fuses, surge protection equipment and disconnect switches (Figure 18). The output of the array is connected to the combiner box in the control room (Figure 19). This box contains the fuses and monitoring equipment for Systems 3 and 4.

- 4) The source circuit junction boxes on the array are severely corroded on the outside, but the inside plates and the components mounted on the inside plate are still usable and operating.

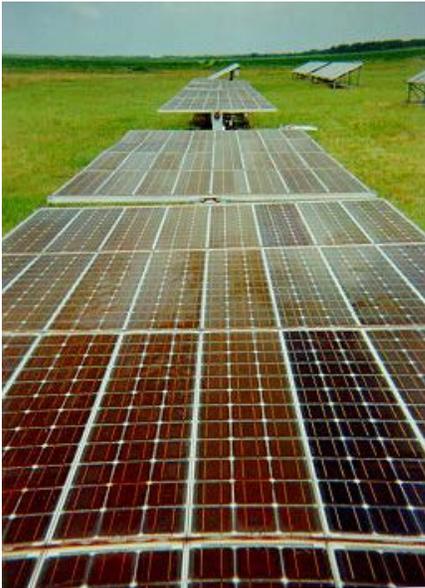
Figure 21. ARCO Array

The array consists of 256 ARCO M52-S, Part # 004013985 single crystal modules manufactured in 1983 (Figure 21). The 36-cell modules are installed on a single-axis tracker, which is currently positioned horizontally (Figure 22). The axis of rotation is north to south, which allows for yearly array tilt changes but does not allow for daily tracking. The array physical configuration and module serial numbers are given in Appendix B.

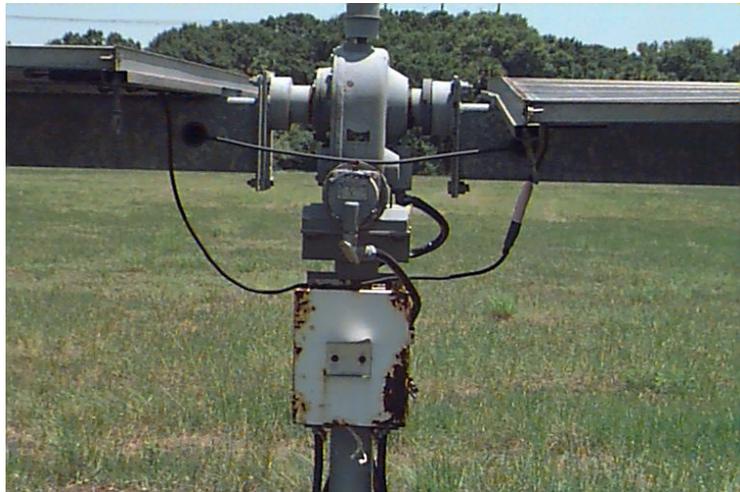
Figure 22. Tracker

This system is not connected to an inverter. The system was moved from another location and was never completely reinstalled. A DECC, model # 61289-54, three-phase inverter was placed in the control room, but the wiring was not finished.

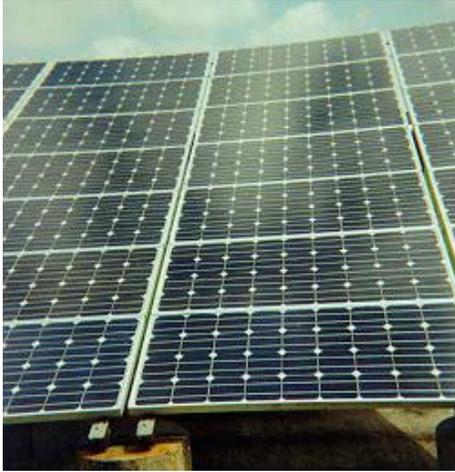
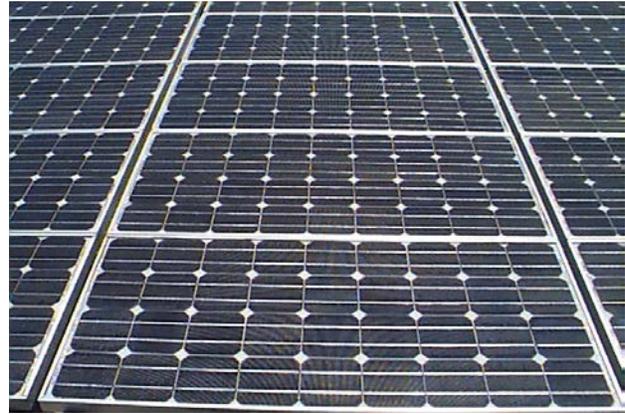
Figures 23 and 24. Hoxan Array

The array consists of 112 Hoxan H-4810 modules (Figures 23 and 24). The 36-cell modules are mounted on a Unistrut rack at a fixed tilt of 25 degrees. The modules are configured in eight strings of fourteen modules in series, with the strings connected four in parallel to produce two bipolar sub-arrays, +/- 135 vdc. The array physical configuration and module serial numbers are given in Appendix B.

- 2) The Unistrut module rack is severely rusted and in some places has lost structural integrity.
- 3) The source circuit junction box showed moderate signs of corrosion on the outside, but the inside plates and the components mounted on the inside plate are still usable and operating.

- Replace the severely corroded array support structure with a corrosion resistant structure.
- Orient the array facing south at an angle of 24 degrees from horizontal on the new mounting structure.
- Replace or repair the Abacus inverter.
- Install an ac disconnection switch at or near the inverter, or mount a sign clearly stating how to isolate the inverter.
- Test and evaluate the modules showing signs of corrosion or water damage and replace malfunctioning modules.

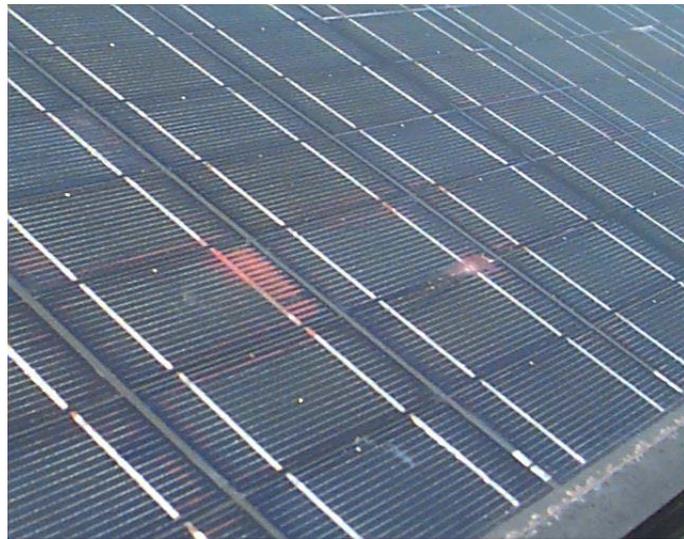
Figure 28. Mobil Array Module 4 Corrosion

- 4) Two modules were identified with problems. Module 4 had corrosion of the front contacts (Figure 28) and Module 6, a slight delamination (Figure 29).

- Test Module 6 (slight delamination was observed) and Module 4 (front contacts are corroded) during the quarterly maintenance inspections for output levels, and replace if necessary.

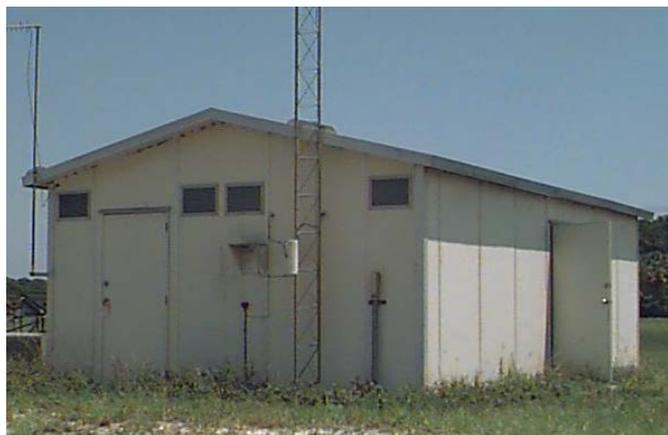
Figure 31. Control Room

The control room was in good condition (Figure 31). The ventilation fans were not operational at the time of the test, but the equipment appeared to be undamaged. The northwest side of the control room contained a DAS.
