Evaluation of Grid-Connected Photovoltaic Systems at The Nature Conservancy – Disney Wilderness Preserve

FSEC-CR-1661-99

**Prepared by
Florida Solar Energy Center
November 1999**

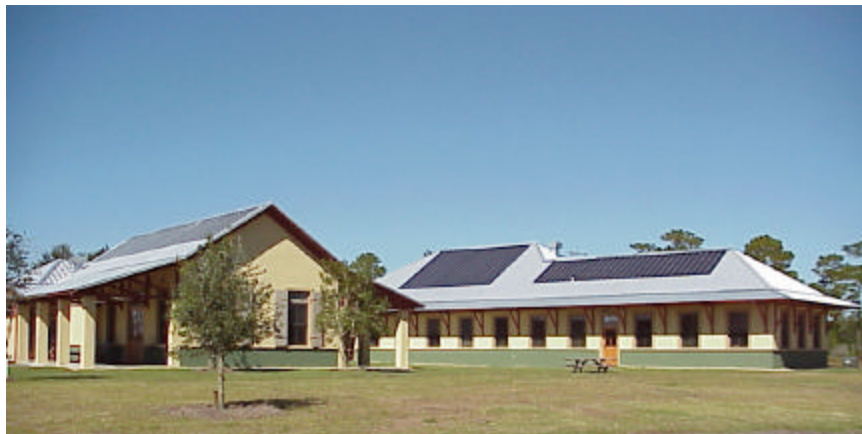
Owned and managed by The Nature Conservancy, the Disney Wilderness Preserve is an 11,500-acre nature preserve at the headwaters of the Florida Everglades system. To promote renewable energy technologies, two building-integrated grid-connected photovoltaic (PV, solar electric) systems were installed on the conservation and learning center, which opened to the public in October 1999 (Figure 1).

Figure 1. BIPV Systems at The Nature Conservancy - Disney Wilderness Preserve.

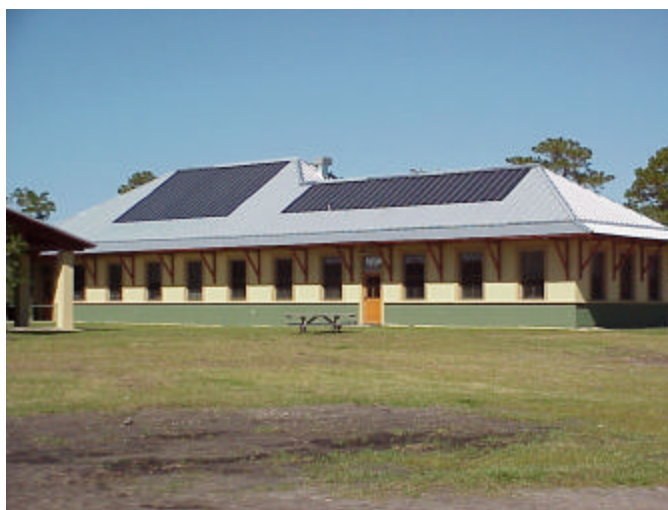
System #1 is the larger of the two systems and is located on the northernmost building at the site. This system consists of two models of the standing-seam PV roofing panels from United Solar, models ASR-60 and ASR-120. Both panels are UL listed for rooftop applications. The ASR-120 panels are twice the length, and have twice the voltage output as the ASR-60 panels, and both have the same current output. The array is facing due south and is tilted 34 degrees from horizontal (8/12 pitch). The array surface area is 79.5 m² (855 ft²). Figure 2 shows the array layout on the rooftop for System #1, with the ASR-120 panels to the left, and the ASR-60 panels to the right.

Figure 2. System #1 photovoltaic array.

The PV array for System #1 consists of twenty-three (23) total source circuits, each having the same current-voltage characteristic. Three (3) of these source circuits have three (3) ASR60 panels connected electrically in series, and twenty (20) of the source circuits have one (1) ASR60 panel and one (1) ASR120 panel connected in series. There are twenty-nine (29) ASR60 panels and twenty (20) ASR120 panels in the array, a total of forty-nine (49) individual panels. Table 1 gives the STC-rated IV parameters for the panels, source circuits and the entire System #1 array.

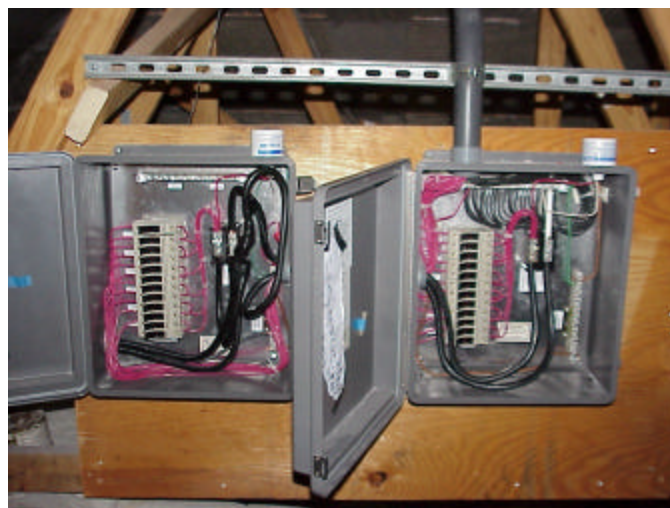
The combiner boxes are manufactured by Pulse Energy Systems, Nevada City, CA and are UL listed. In the combiner boxes, the positive leg of each source circuit passes through an 8-amp series fuse, and is combined electrically in parallel with the other source circuits at a terminal block. The combiner boxes also include silicon oxide varistors (SOVs) connected between the positive and negative legs of the array source circuits to ground. Figure 3 shows the combiner boxes for Systems #1. The combiner box on the left combines eleven (11) of the array source circuits, and the box on the right combines twelve (12) of the source circuits. The wiring from the two terminal blocks in the combiner boxes is connected in parallel, and a single pair of #2/0 AWG THW conductors makes the approximate ten (10) meter (~30 feet) run to the inverter.

Figure 3. Source circuit combiner boxes for System #1.

- Array source circuits are not labeled in the combiner boxes, making identification of specific source circuits on the rooftop difficult. Shading panels in the array concurrent with source circuit electrical measurement would be required to identify a panel's location in the array.

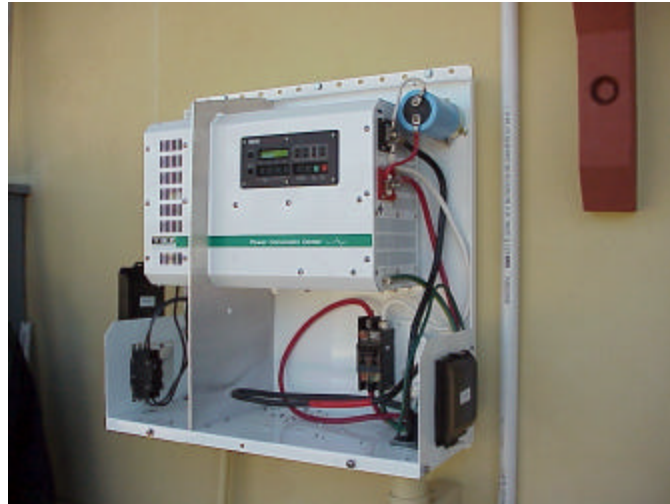
The inverter for System #1 is model SW5548 UPV manufactured by Trace Engineering and is designed for utility-interconnection. The inverter is enclosed in an outdoor cabinet and mounted under the eave on the north wall of the building, and adjacent to the main disconnect panel for the facility (Figure 4). The inverter cabinet includes external AC and DC circuit breakers, and a ground fault protection circuit. The sine wave inverter is nominally rated at 5.5 kVA, 240-volts single-phase output. The PV array DC input range is 34-75 volts for operation, and 44-66 volts for peak power tracking. There are no user adjustable settings, only a few monitoring functions are available from the front panel display. The AC output from the inverter is connected to a double-pole 40-amp circuit breaker in the adjacent main disconnect panel for the facility, using #8 AWG THWN conductors.

Figure 4. System #1 inverter.

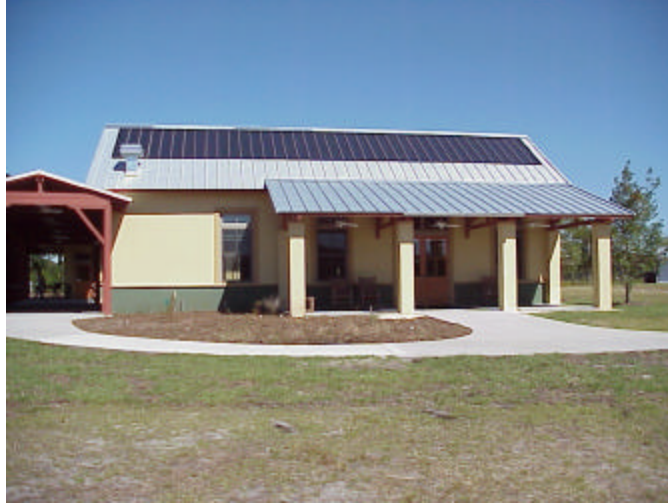
Slightly larger than one-half the size (surface area) as the array for System #1, System #2 uses only the model ASR60 PV roofing panel and is located on the southernmost building at the site. There are 39 total ASR60 panels in the array, consisting of 13 source circuits with three (3) ASR60 modules connected electrically in series. This array is facing 20 degrees west of due south and is tilted 34 degrees from horizontal (8/12 pitch). The array surface area is 45.9 m² (494 ft²). Table 2 gives the STC-rated IV parameters for the panels, source circuits and the entire System #2 array. Figure 5 shows the array layout on the building rooftop for System #2.

Figure 5. System #2 photovoltaic array.

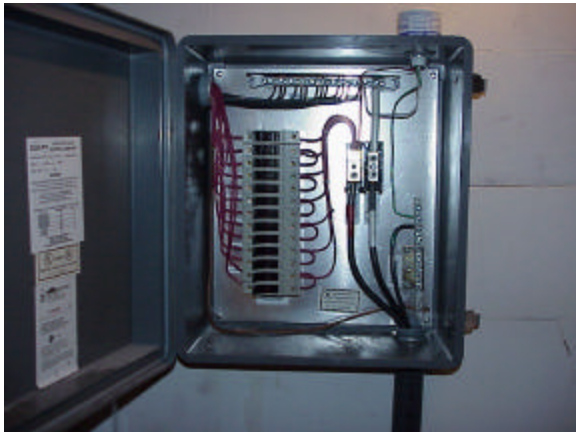
The inter-module and source circuit wiring terminations are the same as for System #1, except for the thirteen (13) source circuits are combined in a single combiner box, located in the attic (Figure 6). The length of wiring from the terminal block in the combiner box to the inverter is approximately 1 m (~3 ft) - as the inverter is also located in the attic for System #2 - and uses #4 AWG THW conductors. System #2 uses the same Trace Engineering model SW5548 line-tie inverter as System #1, however this unit is only operated at a lower power level (Figure 7). The AC output from the inverter is connected to a double-pole 30-amp branch circuit breaker in the distribution panel for the southernmost building using #10 AWG THWN conductors in ½-inch EMT.

Figure 6. System #2 source circuit combiner box.

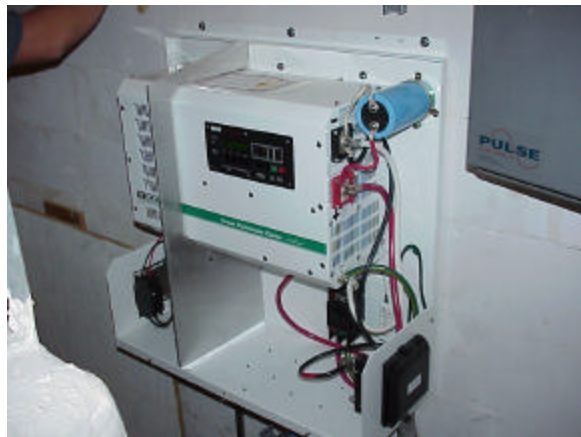
Figure 7. System #2 inverter.

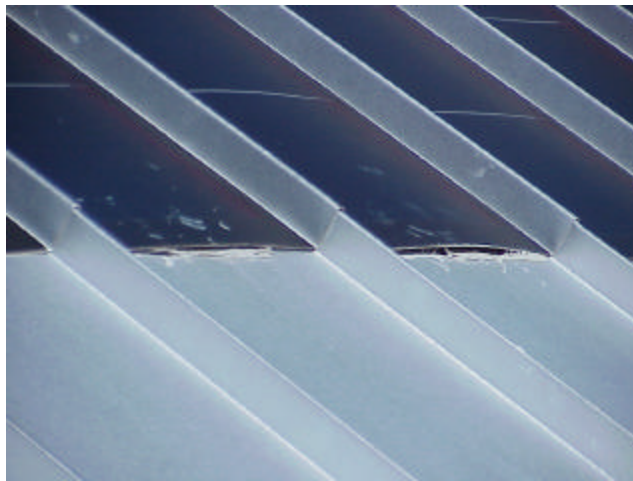
- A seaming problem exists between the PV and conventional metal roofing on the System #2 array. Attempts to seal the roofing at this point with caulking appear to have failed and the PV-integrated roof panels were bowed up slightly (Figure 8). Depending on the amount of overlap at the seams, this could potentially lead to a weather-sealing problem during wind-blown rain from the south.

Figure 8. Seam between PV and conventional metal roofing.

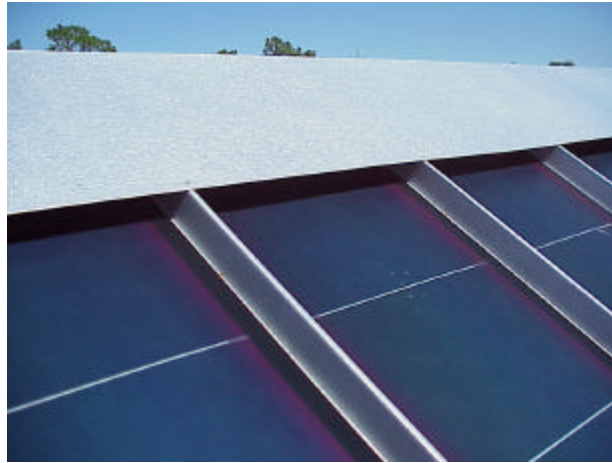
- Due to the installation of the ridge caps overhanging the top part of the standing-seam metal roofing panels, up to a 2-inch shading band was observed along the tops of the PV arrays (Figure 9). This situation will be at it's worst around the summer solstice, when the sun is higher in the sky and to the north of the array. In addition, due to the projection of the standing seams above the PV material, shading occurs along the edge of the PV material whenever the sun position more than 40 or so degrees off from normal to the panel seam.

Figure 9. Shading bands along the top and sides of PV roofing panel.

- Two types of shading concerns exist for the array installations – shading from the ridge cap at the top and shading from the standing seams between the roofing panels. Results of special tests to assess the effects of shading on panel performance are included in an addendum in the Appendix.

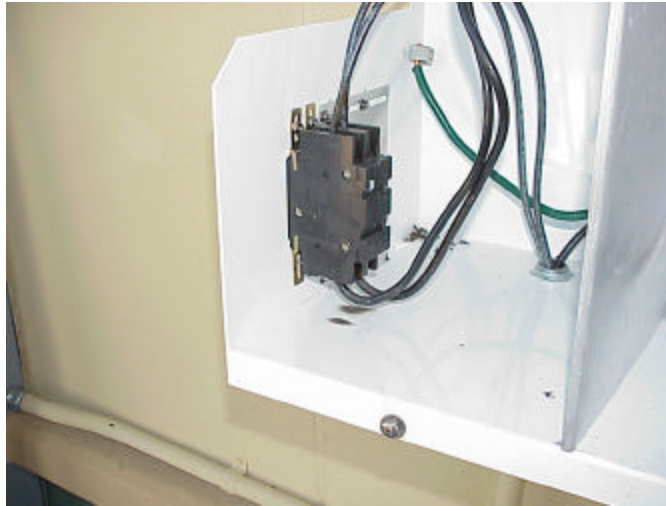
- When the case was first removed on the System #1 inverter, burn marks were noticed on the cabinet beneath and to the side of the 35-amp main AC circuit breaker (Figure 10). This was reported to have been a lightning event that occurred before the system was operational, however no obvious damage to the breaker or the inverter were found, and the system was functioning normally. Special attention should be paid to this device for heating or other problems that might occur.

Figure 10. Burn marks below AC breaker on System #1 inverter.

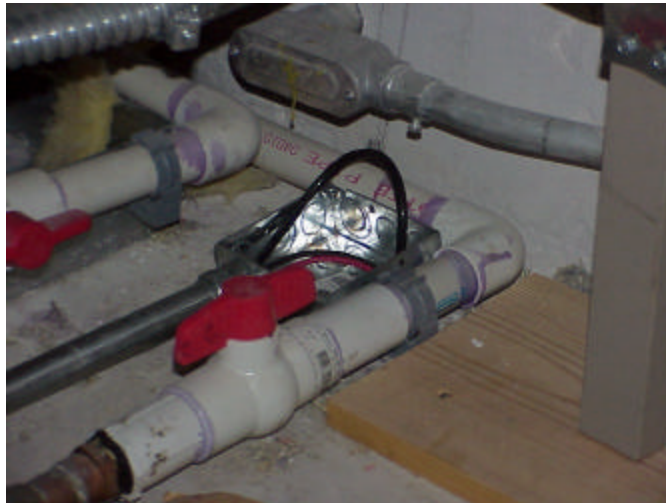
- The inverter and combiner box for System #2 are located in the attic of the southernmost building, and are extremely difficult to access through a small opening at the top of a packed closet. This is not a desirable situation, and any problems with this system would go undetected. Furthermore, a hazardous condition exists where the conduit leading from the inverter to the building distribution panel runs along side condensate pipes for the air-conditioning units, and has an uncovered junction box immediately above the distribution panel (Figure 11).

Figure 11. Wiring from inverter to distribution panel, System #2.

- With a few exceptions the system installations meet National Electrical Code requirements such as wire sizing, overcurrent protection, disconnect requirements and grounding. The exceptions include labeling and identification requirements for PV system equipment, source circuits and back-feed breakers at the service panels. The open junction box for the System #2 inverter AC output circuit wiring should be covered.
