# Measured Cooling Performance and Potential for Buried Duct Condensation in a 1991 Central Florida Retrofit Home

D. Chasar and C. Withers  
*BA-PIRC*

February 2013

On behalf of the U.S. Department of Energy's Building America Program

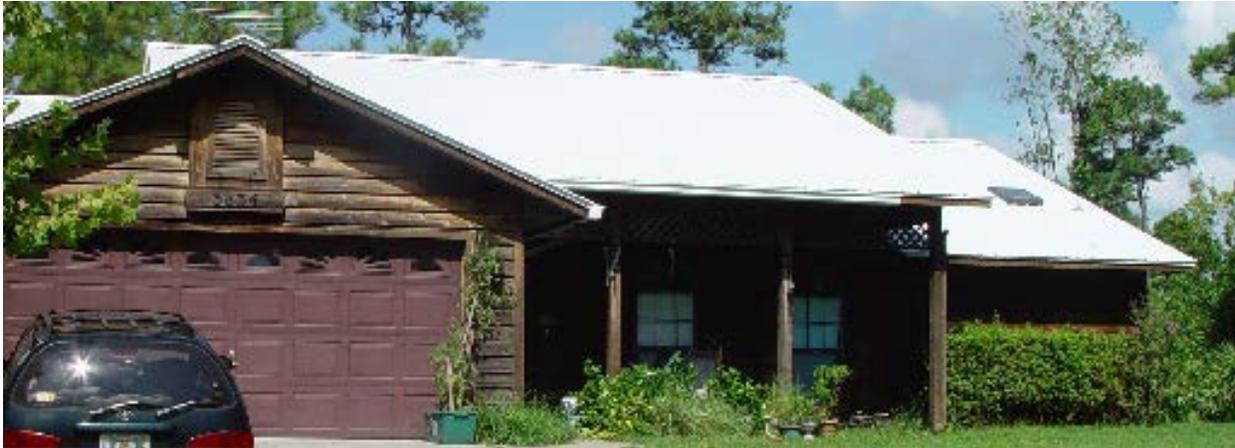
The 2,200-ft<sup>2</sup>, four-bedroom wood frame home discussed in this report was built in 1991 and is located in Cocoa, Florida (Figure 1). It is occupied by a family of six. It has a 12-year-old flat plate solar water heater and a 6-year-old white metal roof but has otherwise had no energy-related improvements. During roof replacement, attic venting was eliminated. Measured cooling savings from the replacement of dark shingles with a white metal roof amounted to 19% and are documented in an FSEC report (Chasar, Moyer, and Martin 2006).

**Figure 1. Wood frame retrofit home located in Cocoa, Florida**

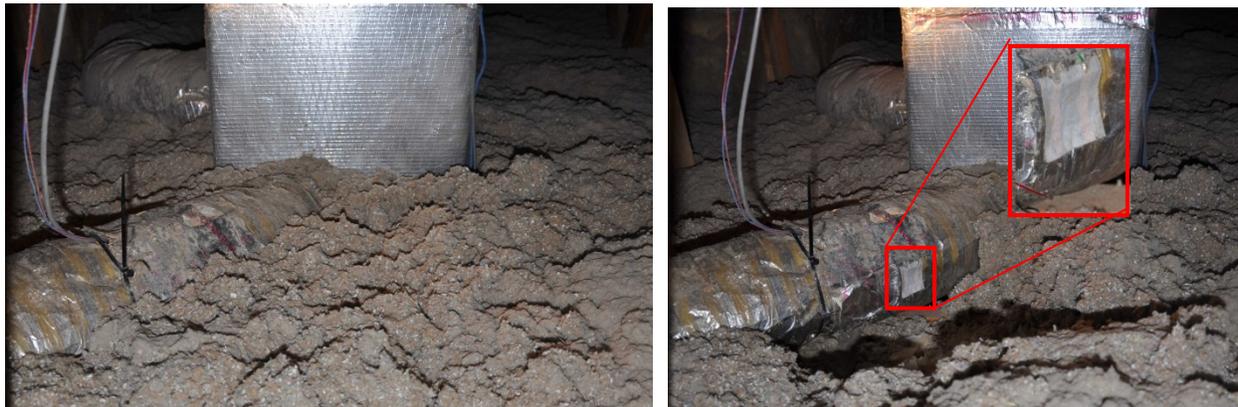
Various other measurements were used to examine additional impacts from the retrofit measures, including attic and interior temperatures as well as RH and supply air temperature. The ducts were fitted on the outer surface with thermocouples and condensate-sensing, resistive strips before being buried within the R-19 cellulose that was blown over the existing fiberglass batts. The photos in Figure 2 show the placement of instrumentation on the duct and the extent of duct coverage by the cellulose insulation. These readings, along with attic air conditions, were evaluated for potential and frequency of condensation. The ducts were also visually inspected for any noticeable physical effects.

**Figure 2. Photos of buried duct (left) and exposed moisture sensing strip (highlighted, right)**

A simple and relatively inexpensive monitoring method was desired that would be able to differentiate a wet duct surface from dry and determine the amount of time the duct was wet. The estimated duct surface moisture was a relative evaluation simply classified as dry, surface humidity >90%, surface condensation, and surface saturated. This phenomenon was investigated by evaluating attic air conditions as well as duct surface and supply air temperatures. In addition, duct surface moisture levels were estimated by measuring the voltage drop across two metallic strips imbedded onto a thin porous fabric substrate that was adhered to the duct surface. Voltage varied with the change in resistance on the strip as a function of the moisture level with the maximum occurring when the strip was fully wetted from condensation. This same principle is commonly used in moisture meters (James 1988). Resistive strips were attached to the exterior surface of a 5-in.-diameter R-6 flex duct in two locations (side and bottom). The side location would be at the 3 or 9 o'clock position if looking down the duct in direction of air flow. The bottom would be at the 6 o'clock position and represents the most likely location for condensation because it would have a colder surface temperature than the sides or top of duct covered by less insulation. The side location allows the bottom to be compared to a lower potential condensation area. The flex duct chosen for this investigation was the one nearest the cooling coil, meaning that the moisture-sensing strips were within 5 ft of the cooling coil. This represented the worst-case condensation potential with the coldest supply air passing through the duct.

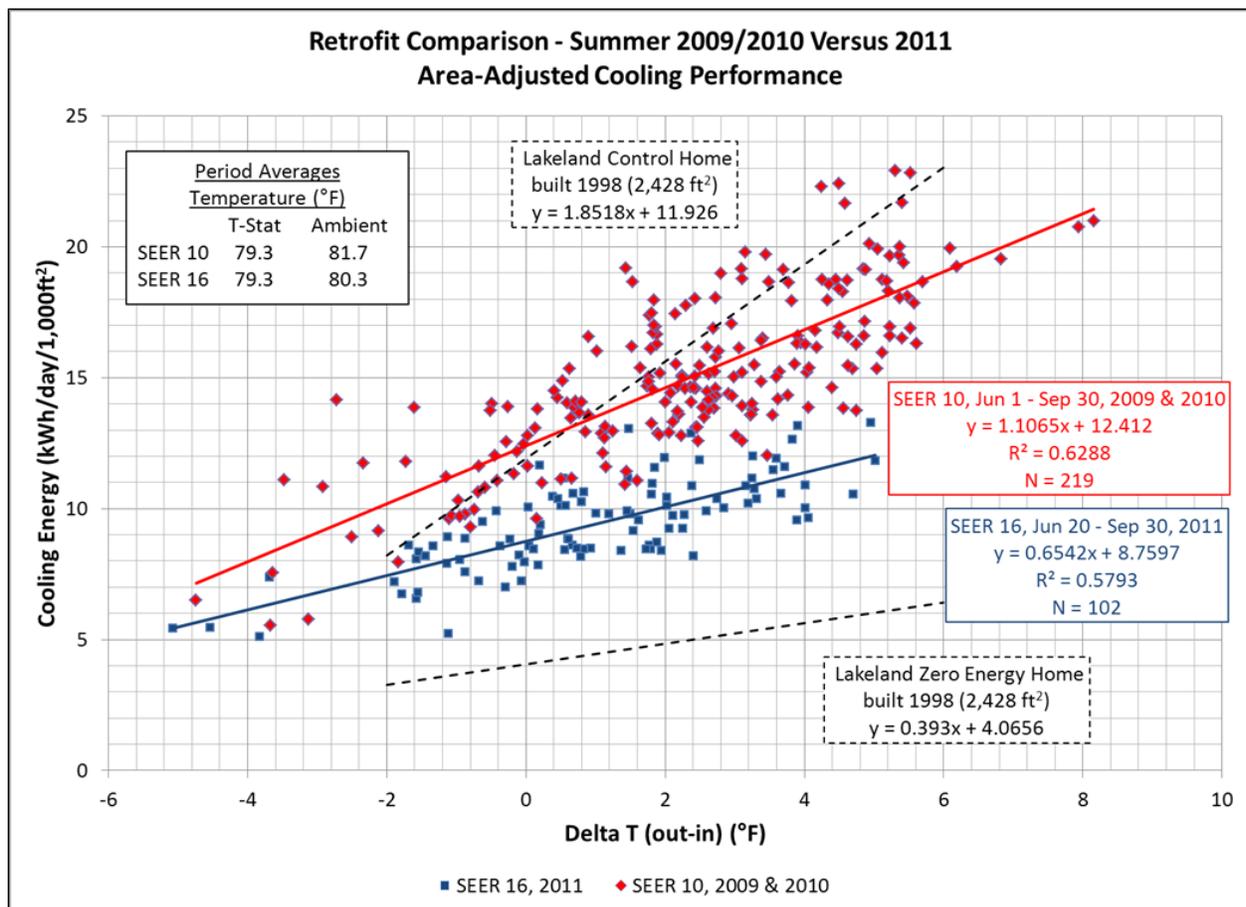
Figure 3. Pre- and post-retrofit cooling performance comparison

The pre-retrofit regression results in Figure 3 (red data) are composed of a data set from the two summers before improvements (2009 and 2010) and include a total of 219 data points. Each point represents the total cooling energy use (air handler unit [AHU] + condenser unit) for 1 day (y-axis) with respect to the outdoor minus indoor average temperature difference for the same day (x-axis). The resulting regression line has a similar y-intercept (12.4 versus 11.9) to that of the Lakeland Control Home; however, it has a noticeably lower slope (1.1 versus 1.9). This may reflect similar equipment efficiencies (both were SEER 10), but enhanced levels of building envelope performance. A similar effect was found with data taken from this residence in 2004 and 2005 that documented the impact of replacing dark shingles with a white metal roof (Chasar, Moyer, and Martin 2006).

Data from 2011, after retrofit implementation (blue data), includes 102 data points. It shows the relative performance improvements from both envelope and equipment retrofits (SEER 16, additional R-19 attic insulation and slightly tighter ducts). Twenty-six days were removed from the data sets over the three summers because of data logger downtime and known occupant influences such as vacation periods and major cooking or party events. Otherwise, all collected data were included in the analysis. An average savings of 30% was derived by applying the measured daily delta Ts for the 2011 summer period from June through September to each best-fit equation. The magnitude of this savings in the study home would amount to 1,072 kWh (or 8.9 kWh/day) for this 4-month summer period.

To normalize results for weather and occupant thermostat settings, best-fit linear regressions were used to characterize cooling energy use versus temperature difference ( $T_{\text{outdoor}}$  minus  $T_{\text{indoor}}$ ). These methods are well established to estimate combined HVAC equipment and building efficiencies (Kissock, Haberl, and Claridge 2003). Uncertainties in the method have been documented by Cummings, Parker, and Sutherland (2010). Figure 3 shows the pre- and post-retrofit results. It includes reference to two other Central Florida homes built in 1998 where cooling performance was similarly measured from 1998 to 2002. Located in Lakeland, Florida, these reference homes were monitored by FSEC to show the impact of extensive envelope and equipment improvements between homes with otherwise identical building style, layout, and orientation (Parker et al. 1998). The Lakeland Control Home provides an upper boundary for cooling energy use in a typical, code-minimum, mid-90s home with a SEER 10 heat pump. Cooling energy use in the Lakeland Zero Energy Home (ZEH) provides a lower boundary for comparison purposes. Data from this home (the first to use the ZEH label) continue to compare favorably with more recent ZEHs. The home even outperforms many Building America prototype homes with cooling efficiencies that are higher than its SEER 14 system (Chasar et al. 2006).

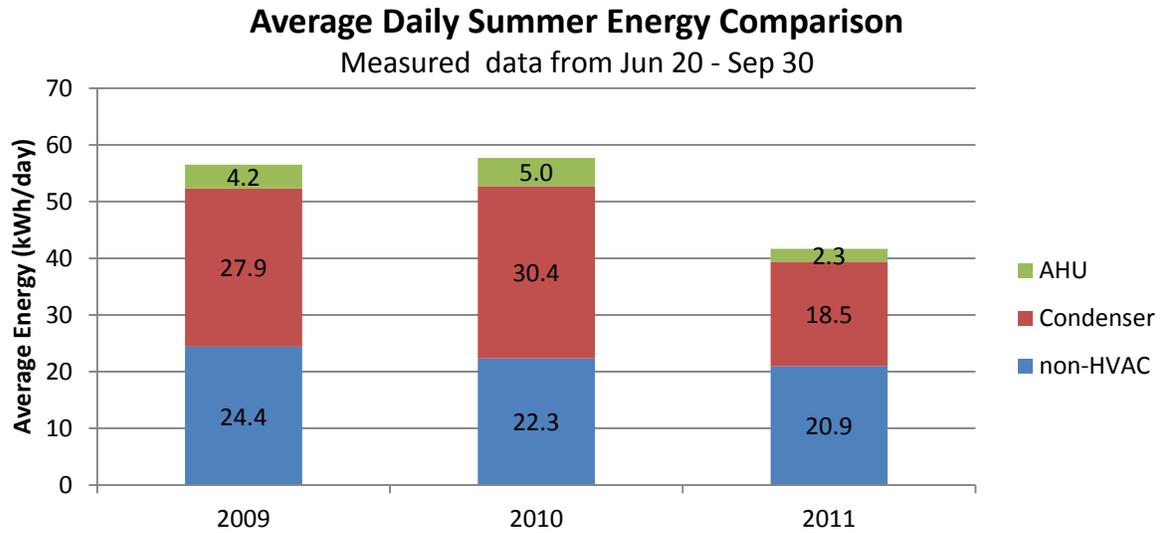
**Figure 4. Unadjusted average daily cooling performance comparison**

Table 3 directly compares average daily energy use and temperatures from the two pre-retrofit years (2009 and 2010) with post-retrofit data (2011). These values were unadjusted for weather differences between years but were taken from equivalent periods from June 20 to September 30. The results show a 27% total building energy reduction and 39% less cooling energy use after retrofit measures were in place. Average daily outdoor temperatures were 1°F to 2°F higher during the pre-retrofit years than during the post-retrofit period. Indoor temperatures were maintained at a stable 79.1°F to 79.5°F over the full study period with a relatively constant thermostat setting. Table 3 and Figure 4 also show how the variable-speed AHU effectively used about one-half the energy of the single-speed unit it replaced. Condenser unit energy was reduced by about one-third.

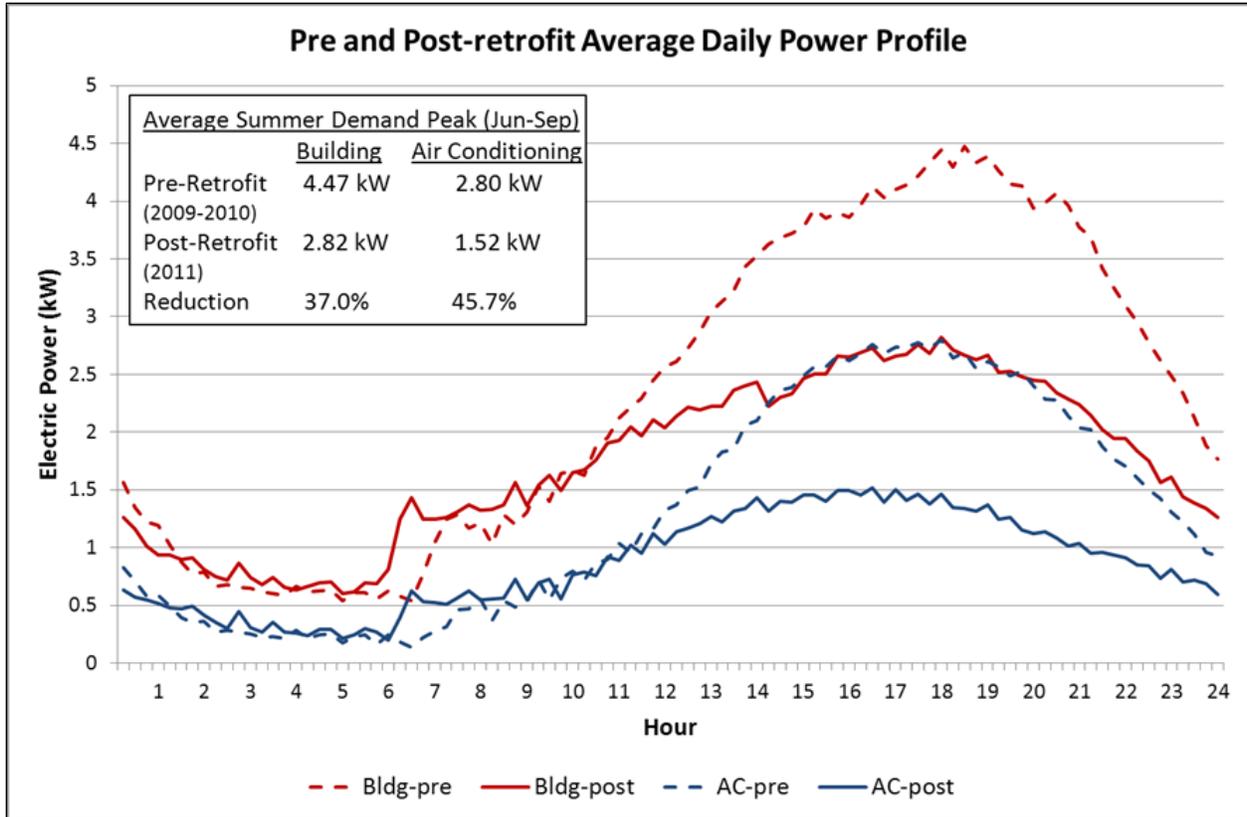
Electric demand was also analyzed over the same summer periods. An average daily demand profile was created (Figure 5) by averaging 15-min power draws and plotting the pre- and post-retrofit values. The figure shows what an average 24-h day would look like before and after energy improvements took place. Average 15-min peak demand was reduced by 37% on a whole-building basis; submetered A/C peak demand (combined AHU and condenser unit energy) was reduced by 46%. The peak summer demand window for utilities is typically from hours 14 to 16 (2 p.m. to 4 p.m.), and reductions during this period were slightly reduced at 34% for whole-building demand and 45% for A/C peak demand.

Figure 5. Pre- and post-retrofit average daily electric demand

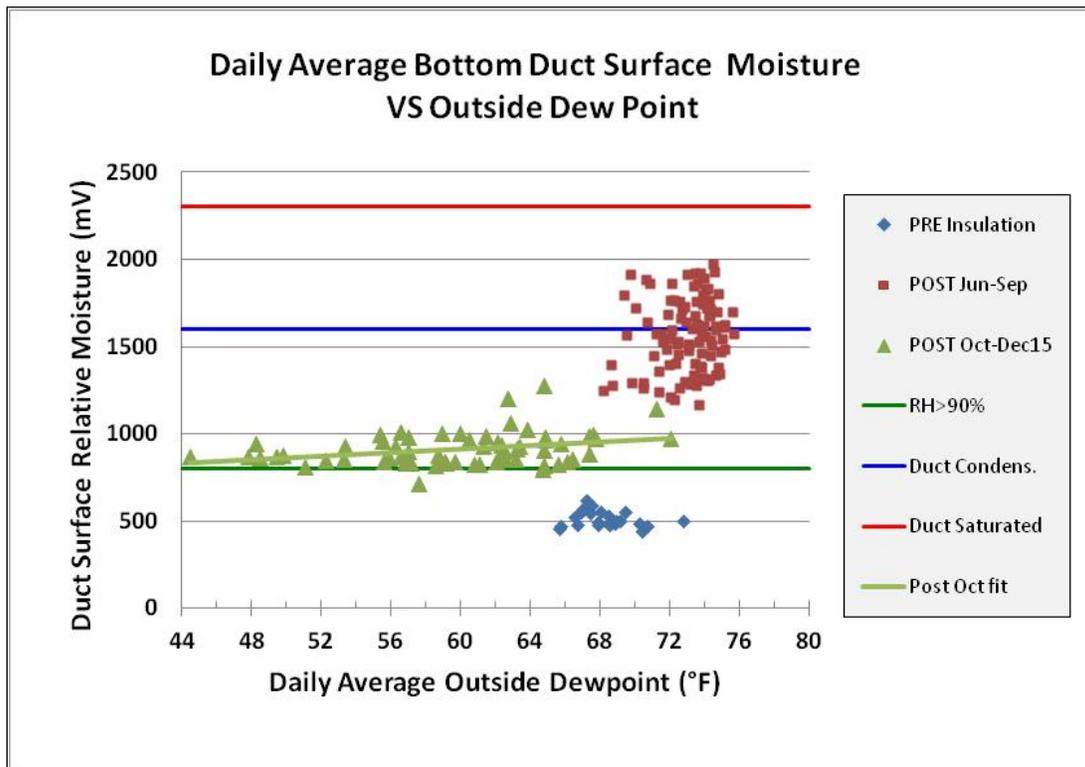
Figure 6 illustrates relative duct moisture levels using the Table 4 thresholds during pre- and post-retrofit periods. Three periods chosen from the data set (one pre-retrofit and two post-retrofit) show the impact on moisture readings under various circumstances. Data points in Figure 6 were plotted by taking the daily average duct surface moisture (mV) against daily average outdoor dew point (°F). Duct moisture data logging began in late May 2011 just 3 weeks before the blown insulation was added, as reflected in the relatively small number of blue data points clustered near the 500-mV level. Although this data set is small and was taken at moderate dew point temperatures, it illustrates the relatively low potential for condensation before burying the ducts in insulation.

**Figure 6. Relative duct moisture levels during one pre-retrofit and two post-retrofit periods**

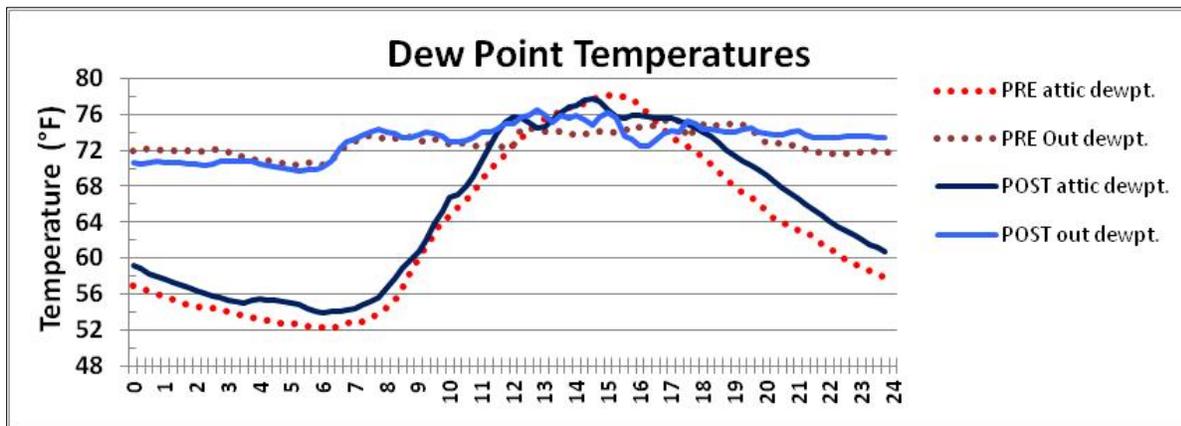
Data were selected for 2 days that had similar outdoor dew points representative of common summer conditions. Data for the selected days are shown in Figures 7 through 9, one before and the other after adding blown insulation to illustrate the impact of burying the ducts. Figure 7 shows the similarity of outdoor and attic dew points between periods. Pre- and post-retrofit outdoor dew points were quite similar in each case, remaining at or above 70°F during the entire period. Attic dew point temperatures were also quite similar but varied over the period, with each data set experiencing a peak between 3 p.m. and 4 p.m. before declining steadily until approximately 7 a.m. the next morning. This is a common characteristic in summertime attics where moisture desorbs from wood building materials during solar heating, adding moisture into the attic air and resulting in elevated dew points that can exceed the ambient dew point. As the attic begins cooling down overnight, the dry attic wood begins to adsorb moisture from the air, and the attic air dew point drops (Cleary 1985; Fairey, Swami, and Beal 1988).

Figure 7. Outdoor and attic dew point temperatures

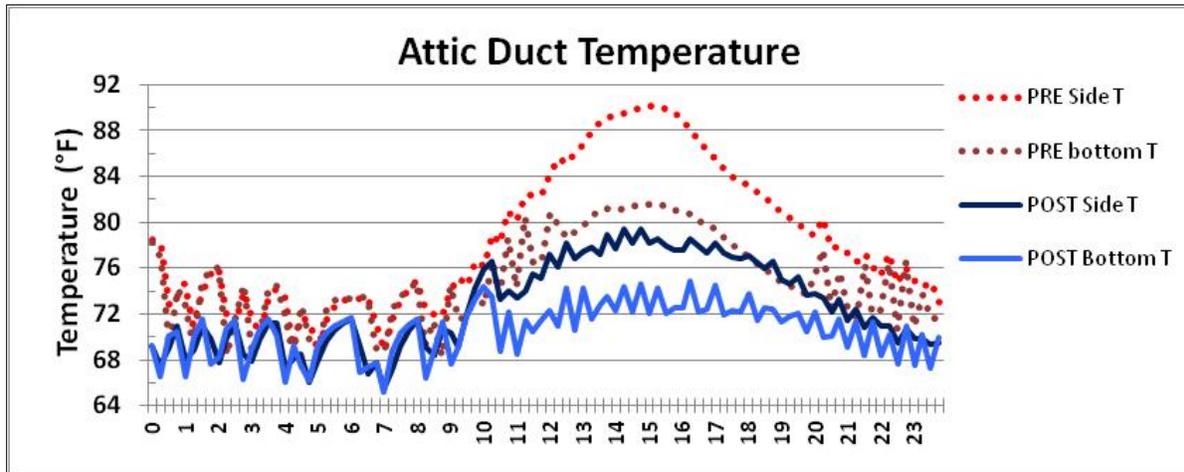
Figure 8 compares duct surface temperatures over a daily period. This graph clearly shows how duct surface temperature is reduced after being buried in insulation. Dotted lines represent the pre-retrofit condition, which shows higher surface temperatures than the post condition, as would be expected. The bottom surface of the duct showed an 8°F drop in temperature during peak temperatures, and the side surface location showed a 12°F decrease.

**Figure 8. Pre- and post-retrofit attic duct dry bulb temperatures during similar outdoor conditions**

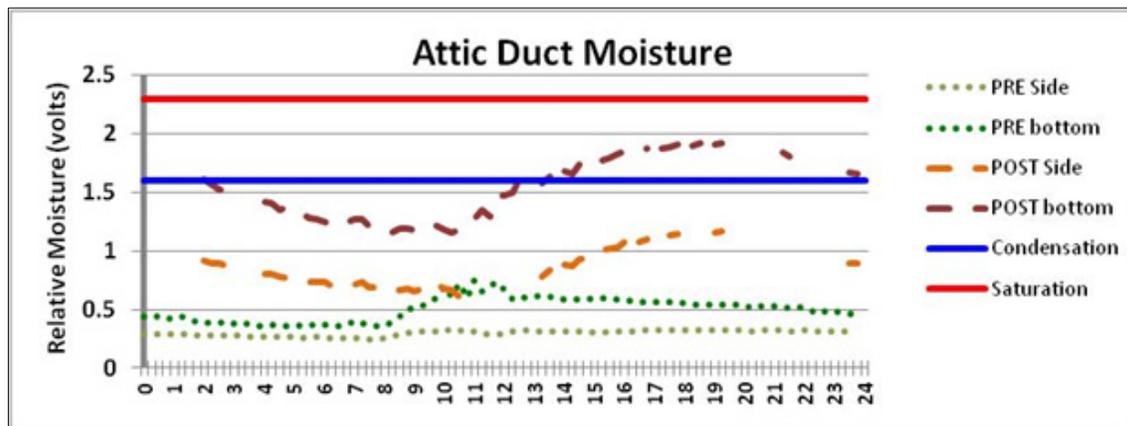
Figure 9 shows duct surface moisture levels. Two solid horizontal lines are shown as a reference to the degree of wetness. The solid red line at the top indicates a saturated surface dripping with water. The solid blue line indicates a lesser degree of moisture with condensation present on the surface, but not dripping wet. A clear impact can be seen where adding insulation over the ducts results in greater surface moisture levels. The bottom area is coolest and shows the highest moisture levels. Gaps in the post-retrofit measured data (dashed lines) can be seen in the graph and are unexplained at the time this writing. These gaps occurred only during the post-retrofit period when moisture levels were elevated. Further research in the use of moisture-sensing strips will help establish the long-term reliability of moisture sensing tapes.

**Figure 9. Pre- and post-retrofit attic duct surface moisture levels during similar outdoor conditions**

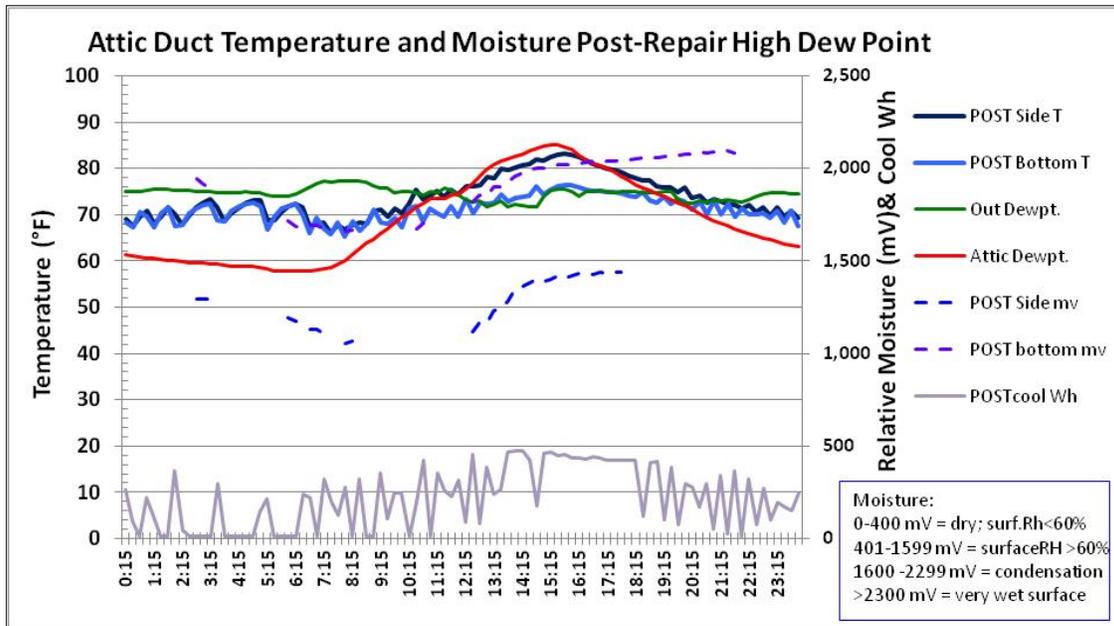
Figure 10 is a 24-h plot of post-retrofit duct, attic, and outdoor conditions when dew point temperatures and A/C runtime were at their highest. This would represent a higher potential for attic duct condensation. As seen in Figure 9, the moisture sensor on the bottom duct location showed the highest potential for condensation. The daily average reading of the bottom duct location in Figure 10 is 1,929 mV. This is high enough to indicate some condensation, but not high enough to be considered saturated. A visual inspection of the ducts conducted in late fall showed no obvious signs of physical damage from accumulated moisture. Therefore, even though the moisture sensors indicate significant periods of elevated moisture during hot and humid weather, it was not enough to create any visually observable impact such as material damage or mold and mildew. As a caution, however, even though no moisture damage was observed, it might still be possible under different circumstances. As mentioned previously, a colder thermostat cooling set point will cause long runtime and colder duct surfaces. It is possible that such operation in this home could still result in enough moisture accumulation to cause moisture-related damage. Conditions will continue to be observed during the next hot and humid period.

**Figure 10. Post-retrofit duct conditions during worst-case dew point temperatures**
