Problems Related to Air Handler Leakage

Cummings, J., Withers, C., "Problems Related to Air Handler Leakage",
American Society of Heating, Refrigerating and Air-Conditioning Engineers, Inc.,
ASHRAE Journal, January 2008.

FSEC-GP-335-08

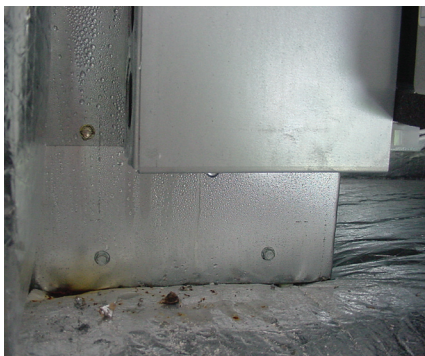
Figure 1: Condensation on metal electric panel inside air handler. Figure 2: Refrigerant line penetration into air handler without seal.

Two additional problems of AHU leakage in the garage, attic, or outdoors are related to water vapor condensation. First, in some AHUs the cabinet insulation is lined with foil, in effect placing a vapor barrier on the cold side of the insulation assembly. During hot and humid weather, moist air sucked into the cabinet meets the cold foil surface causing condensation. This results in saturated cabinet insulation that becomes ineffective. Second, return leakage in the AHU cabinet between the coil and the blower can draw hot and humid air into an airstream that is about 55°F (13°C). If the dew-point temperature of the return leak air is 75°F (24°C) (a common summer dew-point temperature in the southeastern U.S.), and if the return leakage is sufficiently large, then condensation will create a “fog” that will wet the surfaces between the coil and blower, and the supply ductwork (*Figure 1*).

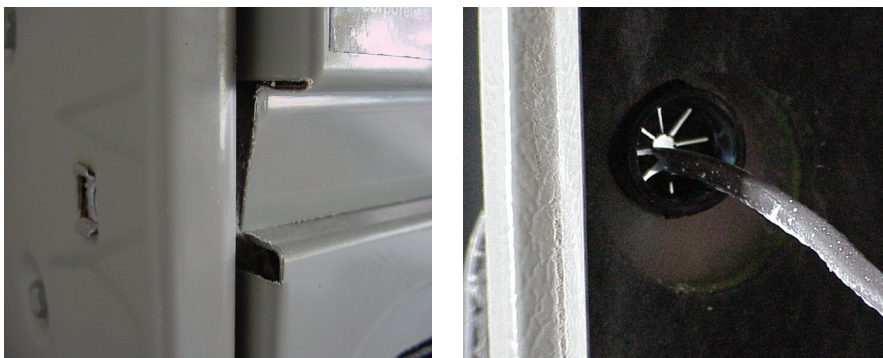
Figure 3 (Left): Example of panel leakage in electric heat AHU. Figure 4 (Right): Thermostat control wire penetration leak area.

AHU cabinet leakage is distributed differently between gas and non-gas AHU systems. For gas furnaces, it is estimated (based on visual inspection) that about 80% of AHU leakage (Q_{25}) was due to panel leakage, 15% due to cooling coil box and 5% due to wire penetration. For non-gas AHUs, failure to install O-ring gaskets represented an estimated 50% of cabinet leakage. The other 50% was related to panel leakage, especially at the filter access (Figures 3 and 4).

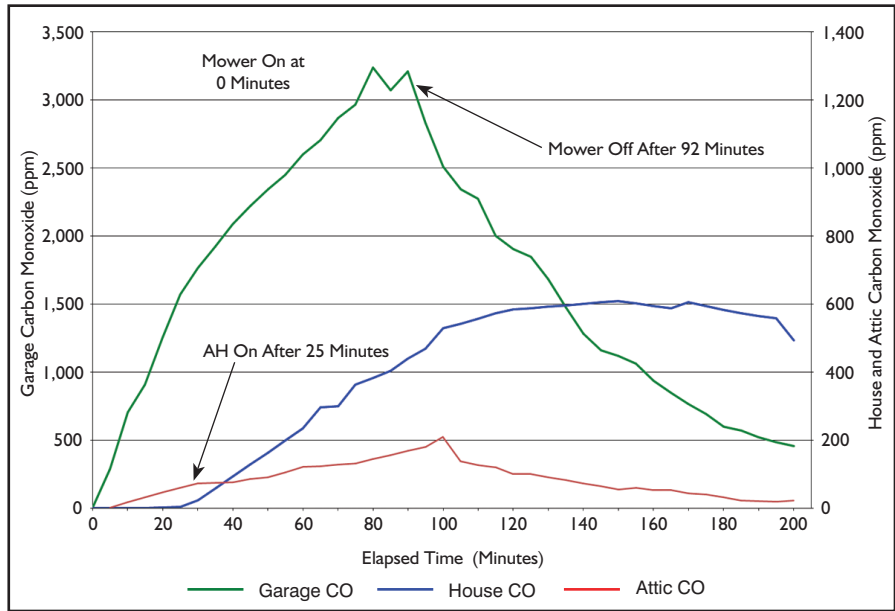
Figure 6: House 2 CO in house, garage and attic.

Testing at House 2 was performed in much the same manner as at House 1. The same lawn mower was operated in the closed garage for a total of 92 minutes. At the end of 25 minutes, the garage CO level had increased to 1,570 ppm, and with the AHU remaining off, indoor CO had risen to only 3 ppm. At 25 minutes, the AHU was turned on and left running continuously for 68 minutes. Indoor CO levels began to increase immediately upon the activation of the AHU, rising to 300 ppm after 23

minutes of AHU operation (Figure 6). Garage and indoor CO levels peaked at 3,207 ppm and 600 ppm, respectively. NIOSH has a ceiling rate of 200 ppm that should not be exceeded at any time and has established an 8-hour time weighted average (TWA) “recommended exposure limit” of 35 ppm.⁸ It is of concern that the ratio of indoor CO to garage CO was about 20 times higher in House 2 than in House 1, indicating that AHU leakage and associated duct leakage create serious contaminant transport issues.

Testing found that the return leak fraction for the House 2 system was 6.9%, or 48 cfm (22.7 L/s), based on a tracer gas methodology.⁹ So, the question arises; what level of duct system tightness would be necessary to make House 2 safe from CO poisoning risk? If we select 35 ppm as a maximum permissible level, then the leakage that could be permitted would have to be on the order of 20 times less than what currently exists in that house. The return leak fraction, which is currently 6.9%, would need to be reduced to about 0.35%. In practical terms, this is an unachievable level of airtightness. The authors conclude that AHUs should not be located in the garage.
