Measured Crawlspace Conditions in a HUD-code Home

Beal, D. and Chasar, D., "Measured Crawlspace Conditions in a HUD-code Home",
Fifteenth Symposium on Improving Building Systems in Hot and Humid Climates,
July 24-26, 2006 Orlando, FL.

FSEC-PF-418-06

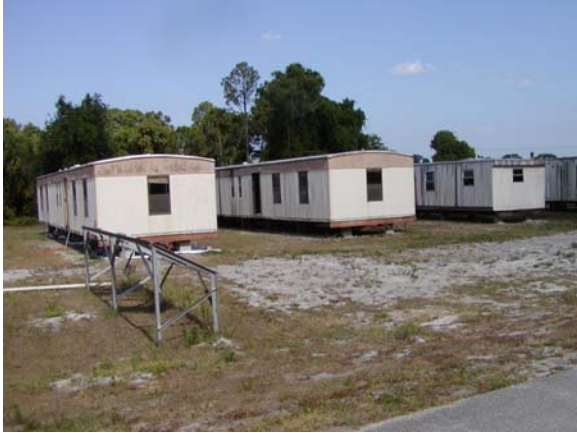
Figure 1 The Three experimental houses

The three singlewide homes are sited side-by-side at the site (Figure 1). Two of the homes are virtually identical 14' by 60' units, and the third is a 12' by 60' unit. One of the homes had to be moved into place for the three homes to be side-by-side, so when this was done a ground cover of 6-mil polyethylene was installed under the house (Figure 2). All houses were in poor condition, with badly breached rodent barrier (an air barrier installed under the home's floor insulation, isolating the home from the crawl space) and rotten spots in all three floors. For the sake of uniformity between the houses, it was decided to remove the floor's rodent barrier and insulation from all homes and remove all interior walls from the homes. When this was done the bad spots in the floor were repaired, and new vinyl flooring was installed on all three homes, creating a moisture impermeable barrier between the home's interior and crawlspace (Figure 3).

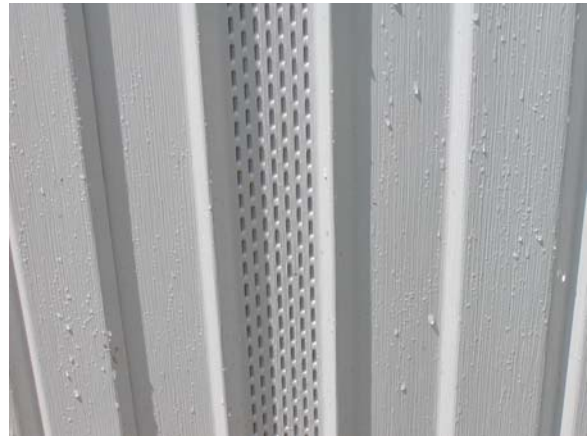
Figure 4 Perforated skirting

The results of these tests are presented below; three different crawlspace configurations chosen as representative of what is found in the field. The first test conducted was of open crawlspaces (Figure 2) with no skirting. As many local codes and park regulations prohibit un-skirted homes, the other tests used skirting. First tested was "standard" perforated skirting (Figure 4). Trends observed in the field are revealing more and more homes with the siding run all the way down to the grade level, or a solid faux rock skirting used. The result of these practices is a poorly vented crawlspace, simulated for these tests with solid skirting (Figure 5).

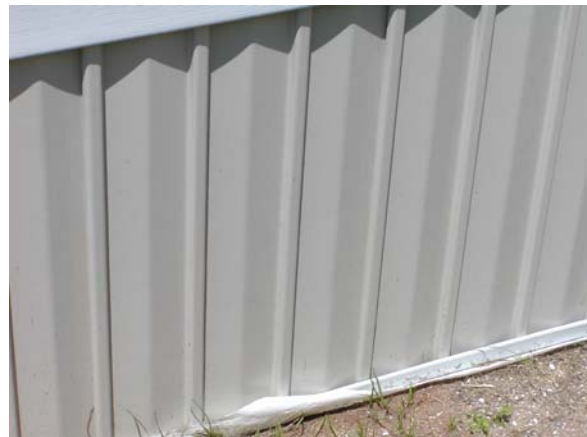
Figure 5 Solid skirting

Test three employed solid, un-perforated skirting. We were unable to measure how airtight the crawl space was or whether the ground cover completely covered the ground. Hurricane Jeanne destroyed the test configuration before air tightness measurements could be taken. However, we believe these crawlspaces were typical of poorly vented crawls one might find under a manufactured home.

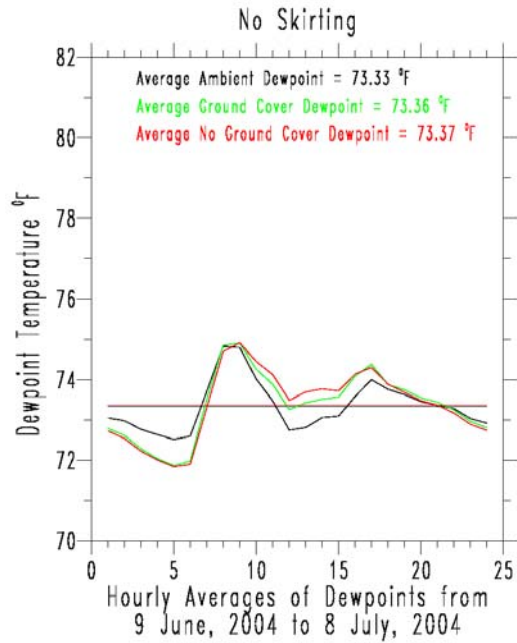
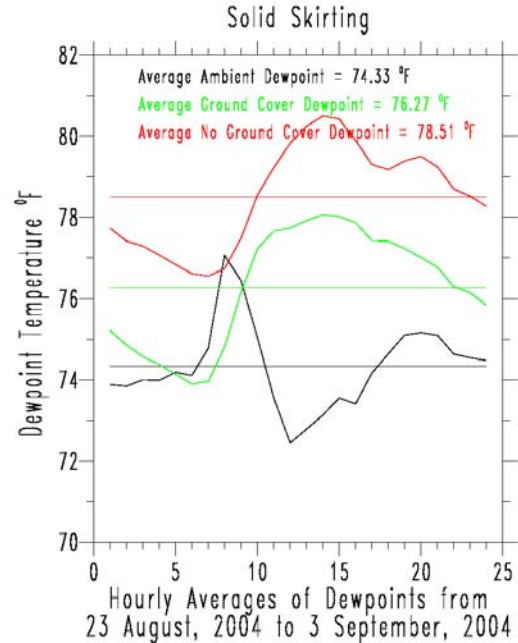
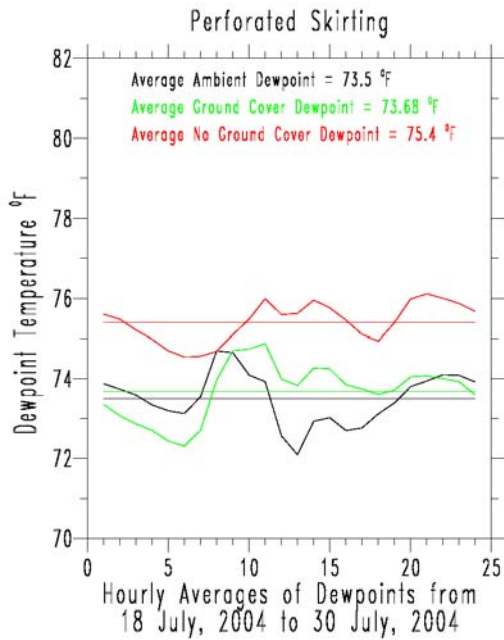
All data is an hourly average of data collected at 15-minute increments. Crawlspace data is the average of the two measurements made at each end of the crawlspaces. The plots represent all available data during the period indicated by the dates at the bottom of the plot. The titles of the plots tell what skirting configuration is described, and which crawlspace is shown by the data. The data is presented as an "average" day; all the readings from 8 AM for the test period are averaged, all the 9 AM, etc.

As can be seen from the graphs, skirting installations increase the dewpoint under manufactured homes. Solid skirting installed on a home without a ground cover increases the dewpoint under homes by as much as 8°F over the ambient dewpoint. Installation of a ground cover mitigates this dewpoint increase, but dewpoints are still increased by 2 to 3 °F.
