PV Lighting Systems for BCC - Evaluation of VRLA Batteries and PWM Controls

**PHOTOVOLTAIC LIGHTING SYSTEMS
FOR THE
BREVARD COMMUNITY COLLEGE COMET WALKWAY**

EVALUATION OF VRLA BATTERIES WITH PWM CONTROLLERS

SEVEN-MONTH PERFORMANCE SUMMARY

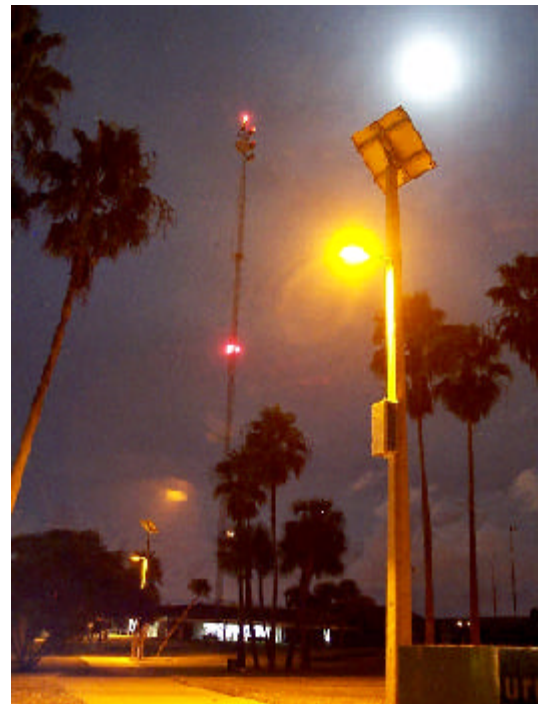
Figure 2. PV lighting system at night under full moon.

Each of the fifteen PV lighting systems are fully self-contained, independently-operating power systems, each consisting of a photovoltaic (PV) array, battery bank, lighting fixture and system control board. The components for each system are integrated on a 35 foot Type III concrete utility pole as shown in Figures 1 and 2. Table 1 lists the specifications for the major components in each system.

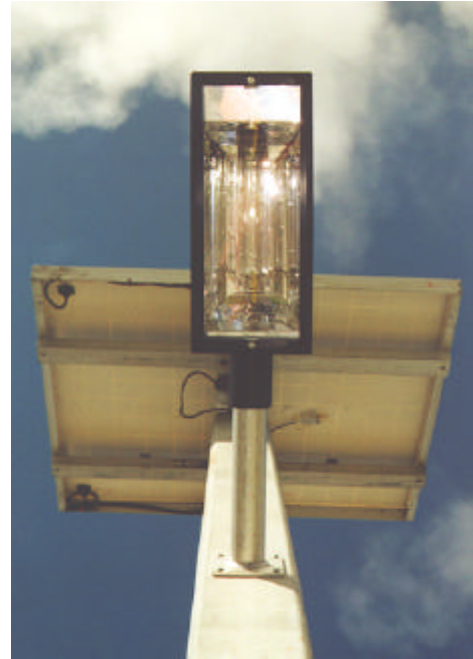
Figure 4. Low pressure sodium lighting fixture.

The lighting fixtures are manufactured by C-Ran Corp. of Largo, Florida, and use a 35 watt low pressure sodium (LPS) lamp powered by a 12-volt dc ballast with a nominal rated load current of 3 amps. The fixture includes a specially designed reflector, a Lexan lens, and has a characteristic “cut-off” lighting illumination pattern. The choice of the LPS lamp and specific distribution were intended to reduce the potential glare and other problems associated with nighttime observations at the BCC Planetarium (Figure 4).

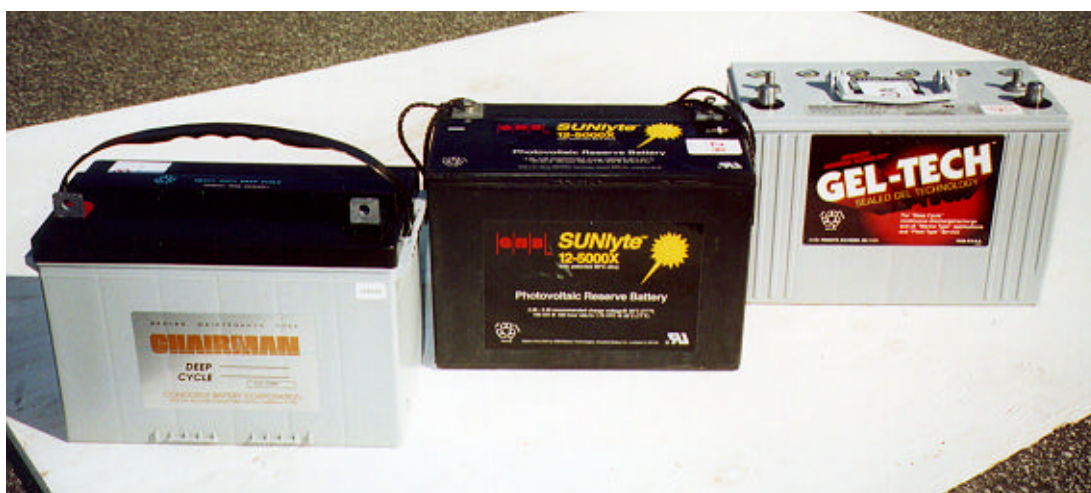
Figure 6. VRLA batteries used in systems (L-R: Concorde PVC 1295H, GNB 12-5000X and Deka DF30H).

Three types of valve-regulated lead-acid (VRLA) batteries commonly used in PV lighting applications are being evaluated in these systems, with five (5) systems using each type of battery. These batteries include the Concorde PVC 1295H (absorbed-glass-mat), GNB 12/5000X (absorbed-glass-mat) and Deka DF30H (gelled), shown left to right in Figure 6. Each system uses two of the nominal 100 amp-hour batteries connected in parallel, for a total rated capacity of 200 amp-hours at 12 volts dc for each system.

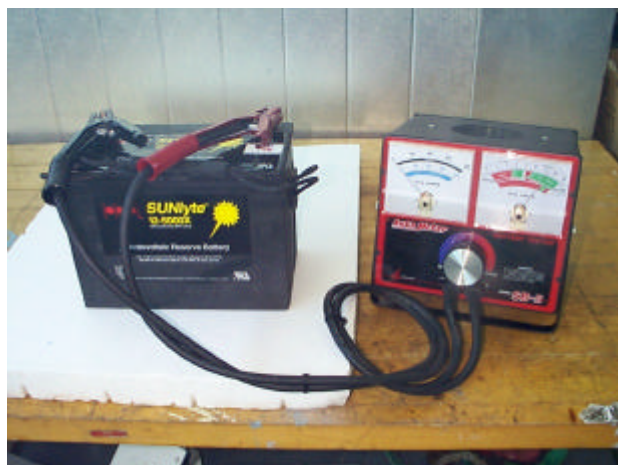
The first step was to isolate the bad cell in the battery by means of a high rate load test (Figures 24-25). The top of the battery was cut open so that individual cell voltages could be measured. During this 200-amp load test for 15 seconds, the cell voltages (from positive to negative) were 1.7, 1.95, 1.95, 1.95, 1.95 and 0.87 volts, respectively. This test identified the bad cell as the negative-most cell in the 12-volt unit.

Observation of each cell indicated some cells were dryer than others, although this was difficult to determine with the AGM batteries. Note that no significant weight loss was recorded for this battery after seven months of operation. When the battery was tipped on its side (Figure 26), cells 2-5 had excess liquid electrolyte that collected in the cavity in the top of the battery case. Specific gravity readings for these cells were 1.295, 1.295, and 1.290, respectively for cells 2-4. No excess electrolyte was available in cells 1, 5 or 6.

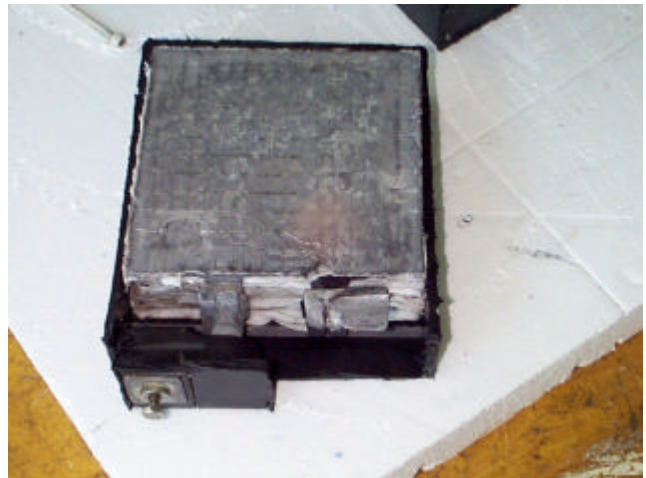
Figure 27. Negative cell extracted from GNB battery 10A.

After the load test identified the failed cell as the one at the negative terminal of the battery, this cell stack was extracted from the rest of the battery for a detailed inspection of the plates and separators for signs of short-circuiting.

The bottom part of positive plates are wrapped with glass mats, and no signs of short-circuiting were observed there. Similarly, no unusual problems were observed at the sides of the plate stack. A problem could have been overlooked at the inter-cell connections at the top of the cell, but nothing unusual was observed.

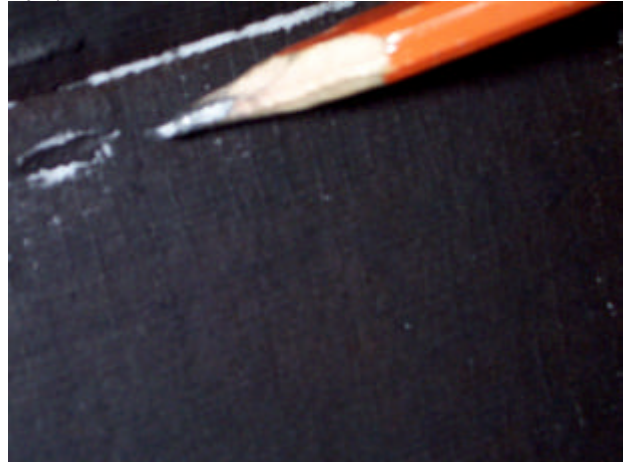
Figure 28. Indentation caused by excess material on positive plate.

Upon disassembly of the plates, two noteworthy observations were made. The first was a lump of brownish material (probably lead-dioxide) removed from the positive plate (Figure 28). This material had indented the glass mat and separator, possibly coming into contact with the adjacent negative plate. However, no apparent signs of short-circuiting were observed.

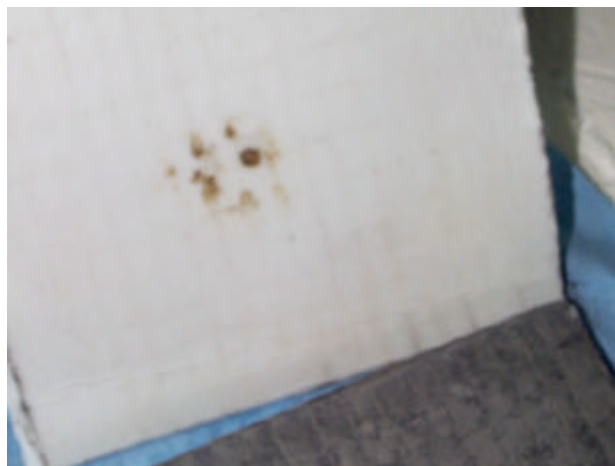
Figure 29. Stain on glass mat between positive and negative cell.

The second observation from the disassembly of the plate stack was a dark “stain” on a couple of plate groups near the middle of the cell, and appeared to continue from the positive to negative plates (Figure 29). Again, it was not certain if this was related to the cell problem, but appeared possible.

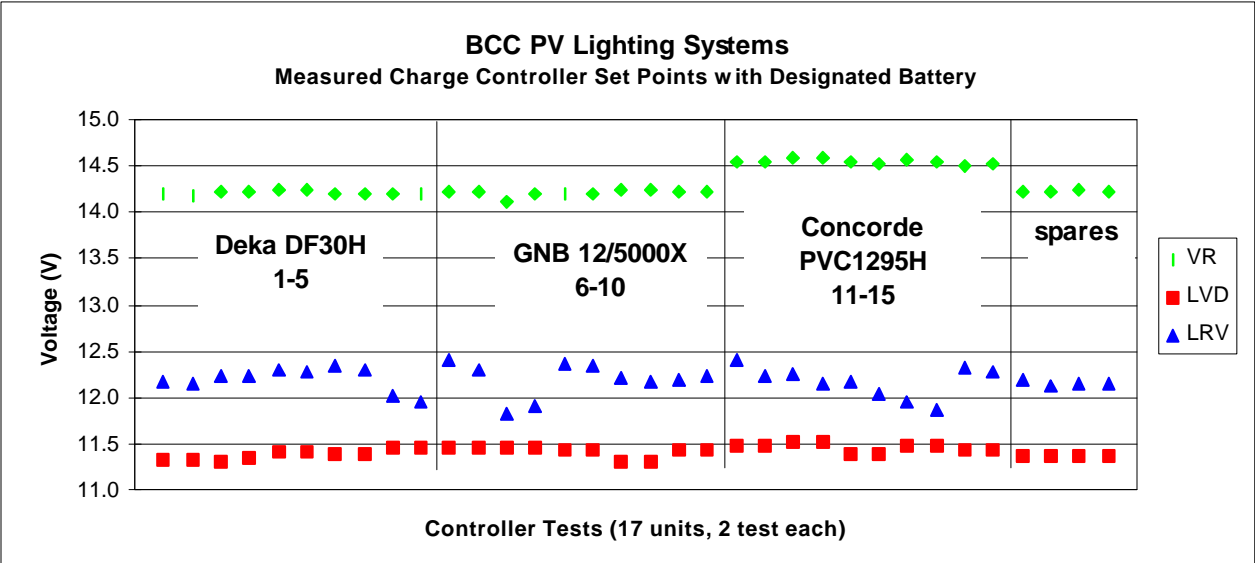
Figure 30. Measured charge controller set points.

Each charge controller was bench tested prior to installation to verify proper operation and set point values. The specified controller set points are 14.1 or 14.4 volts regulation voltage (jumper selectable), 11.3 volt load disconnect and 12.3 volt load reconnect. Figure 30 shows the initial controller set points measured in the lab at 25 +/- 2 °C.

Based on these charge controller measurements and the battery state-of-charge levels at which the specified control voltages occur, some concern is raised about the appropriateness of the load control set point values. While the low battery state-of-charge at load disconnect is a concern, another issue is the low 12.3 volt load reconnect set point.

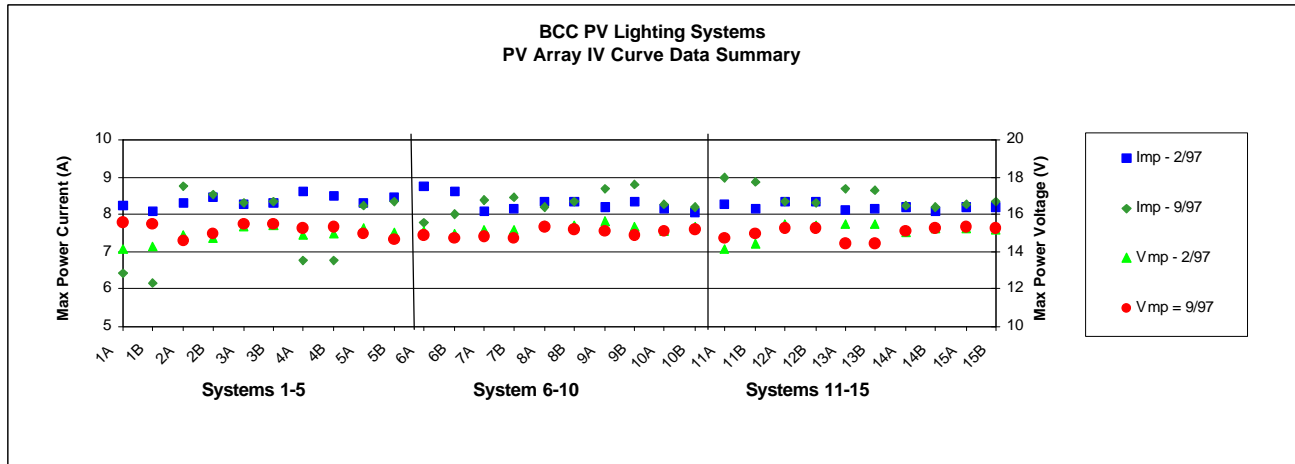
Figure 32. PV array IV curve data summary.

The problem with the array in System 1 is much more severe, resulting in approximately a one-third reduction in the maximum power current (at nominal battery voltages). Although the arrays were carefully checked and tested prior to installation, this problem was not entirely unexpected, as similar problems have occurred with this batch of modules before (c. 1983 Solarex product). At this time, the load has been correspondingly reduced on these systems to account for the lack of array output and to maintain the 1.25 to 1 PV to load energy ratio. Plans are being made to replace all arrays in the near future with newer modules to achieve better consistency among the arrays.

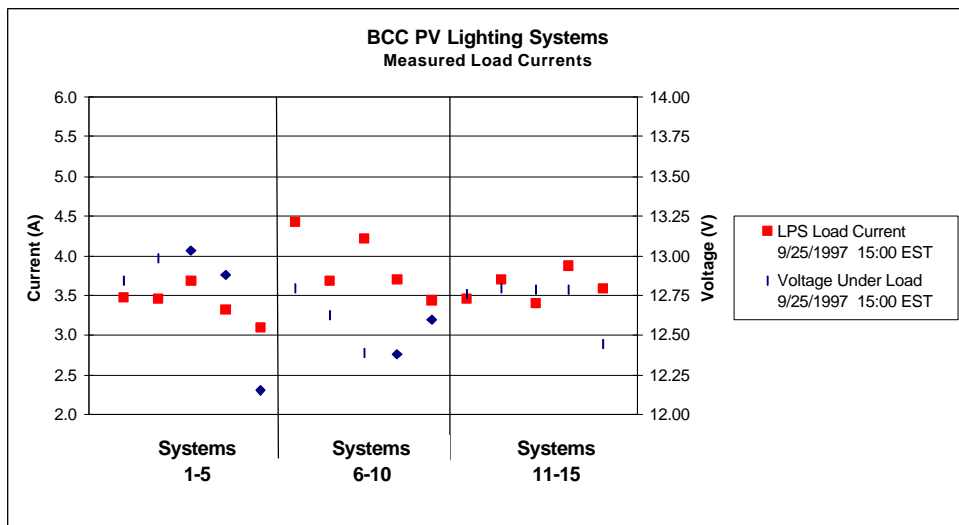
Figure 34. Seven-month load current measurements.

Figure 34 shows the load currents measured after seven months of operation, with surprising results. In all cases the load currents were higher, some more than 40% higher consuming over 4 amps. Although the system voltages were generally higher during this second measurement, this is not considered to be the cause of the higher load currents. Observing the data for Systems 5, 10 and 15 (with DAS units), the load currents (and nightly amp-hours) were proportionally higher for Systems 5, 10 and 15, respectively.

Based on this data, the load currents appear to be significantly affecting the PV to load energy ratios, and may require adjustment of the load time clocks to achieve a higher consistency in the daily load amp-hours. Additional load current measurements will be performed and contact will be made with the fixture manufacturer regarding this issue.

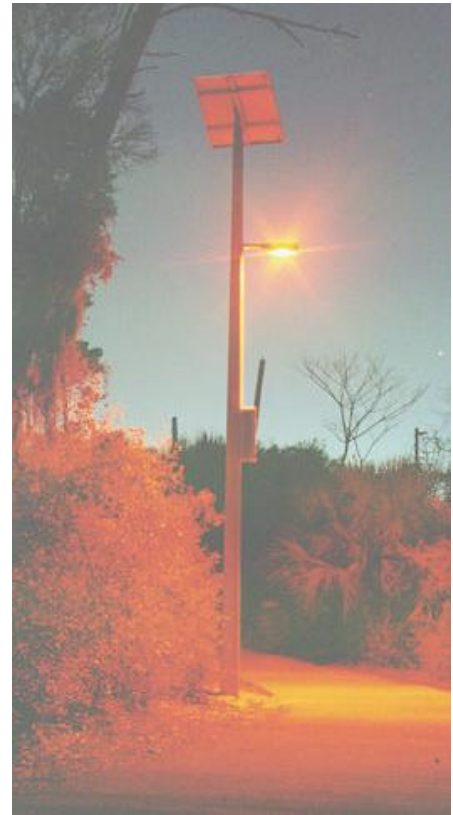
Figure 35. PV lighting system at night.

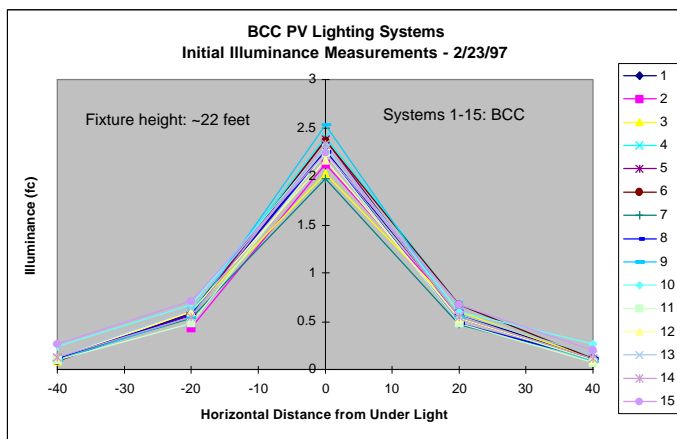
Figure 36. Initial illuminance measurements.

Figure 35 shows the results of illuminance measurements for the 15 BCC PV lighting systems on February 23, 1997. At this time the illuminance directly below the fixture averaged about 2.2 foot-candles (fc), ranging from 2 to 2.5 fc.

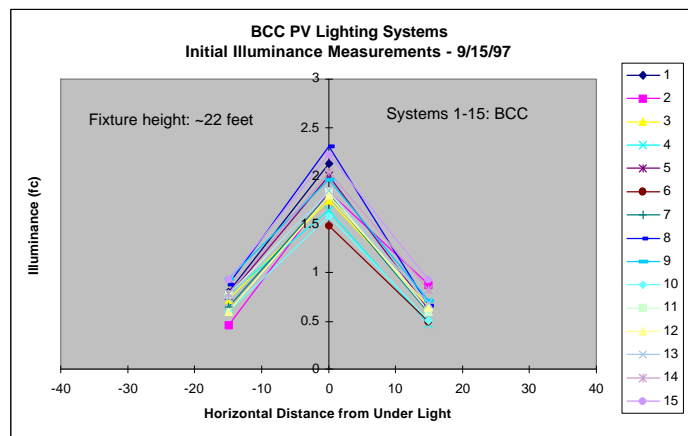
Figure 37. Seven-month illuminance measurements.

On September 15, 1997, another set of illuminance measurements were recorded as shown in Figure 37. These data were measured at slightly warmer ambient temperature (approximately 28 °C), and were generally lower than the initial measurements. System #8 provided the highest illuminance level at nearly 2.3 fc underneath the fixture, and also had a high load current (greater than 4 amps). However, no other correlation between load current and illumination levels were found. Further tests will be conducted on the lighting loads to investigate these issues.
