Opportunities for Energy Conservation and Improved Comfort From Wind Washing Retrofits in Two-Story Homes - Part I

FSEC-PF-449-10

September, 2010

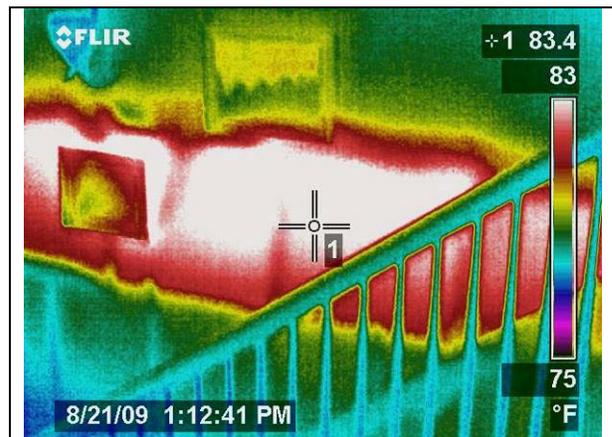
Figure 1 Infrared image shows that floor space behind wall is very warm. (Image credit C. Withers)

During hot weather, the first type of wind washing pushes hot air into the floor cavity (between the first and second stories) thereby heating ceiling, floor, and interior wall surfaces (see Figures 1 and 2). Condensation may occur on cold supply duct surfaces within the floor cavity resulting in ceiling moisture damage. In cold climates, cold air from wind washing can chill surfaces within the interior floor space and result in frozen water pipes.

During the cooling season, infrared scanning was typically done during early to mid afternoon after the sun had heated the attic and other materials substantially. During winter weather when heating occurred, scans were done as early as possible when the attic and external building materials were cooler. The effectiveness of using thermography is limited by cloudy mild weather or in homes with high mass construction, reflective roofing or radiant barriers which limit heat transfer to building materials. Figures 1 and 4 are examples of IR scans that show thermal patterns associated with wind washing air flows.

In Figure 1, the thermal signature shows where hot air (from an attic space located above a one-story portion of the house) has been able to migrate throughout the interstitial floor cavity, between the first and second floors of the house. This hot pocket of attic air has been pushed into the inter-floor cavity where it then delivers considerable heat, by means of conduction and convection) to the ceiling of the first floor, the floor of the second story, and a portion of the stairwell wall.

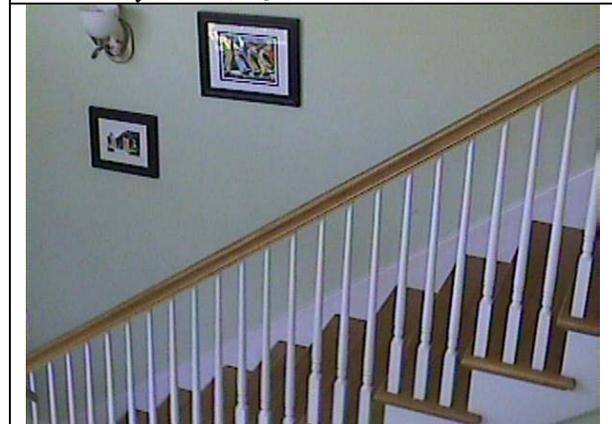
Figure 2 Photograph of IR image above. Floor space begins under the hung picture at top. (Withers)

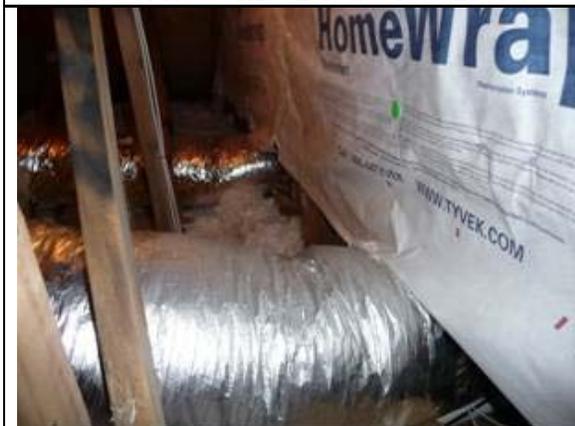
Figure 7 Open area of floor cavity below kneewall covered with house wrap on the west side of house.

In addition to these identified pathways, an additional “exit” pathway plays an important role in this wind-driven air flow. This can be thought of as a complimentary pathway, providing an opportunity for air to freely flow through the house interstitial cavities. In the absence of the complimentary hole or pathway, the potential for wind washing air flow is considerably decreased. This exit pathway can be an opening in the floor cavity on the other side of the house. House number 23 provides a good example of a house with complimentary pathways. It is located within a half mile of the Atlantic Ocean, has a vented attic, and has an open floor space orientation east to west which readily allows the sea breeze to flow through the building cavities. The floor plan can be seen in Figure 6 and an example of open floor cavity on the west side is shown in Figure 7. Evidence of heated interior surface materials at this house can be seen in Figures 1 and 8.

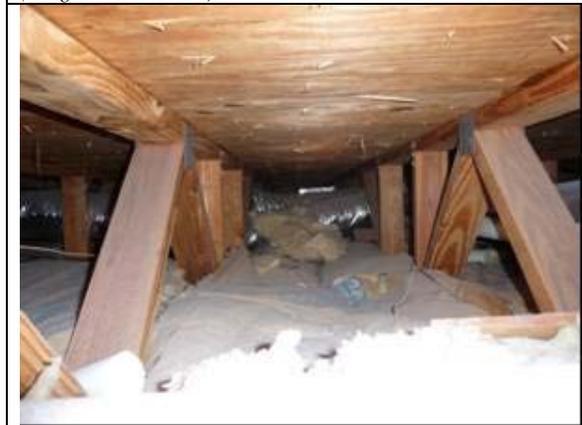
Figure 10 Photo of image above. The floor space is between conditioned space above and below. (Withers)

House number 16 was one of the houses chosen for retrofit. It had only one floor cavity open to attic space with no complimentary holes on other sides of the house. Even without complimentary pathways, air can move into floor cavities. Infrared images taken inside the floor space on a hot day show significant indications of thermal transfer between the conditioned and unconditioned space (See Figures 9 and 10). Notice the stratification of temperature inside the floor space where the hotter temperatures (seen as red) are at the top and the relatively cooler temperatures (seen as yellow-green) are in the lower half. The attic air temperature was about 90° F in front of the floor space at the time the images were taken. Normally, the inter-story floor cavity contains no insulation. However, in this case batt insulation can be seen on the bottom of the floor cavity (Figure 10). The insulation would slow heat transfer to the first floor, but do nothing to prevent aggressive heat conduction to the second floor.
