New Construction Builders Challenge: Sealed Attic and High Efficiency HVAC in Central Florida: A Year in Review

FSEC-PF-454-11

May 2011

Monitored Prototypes - Springwater Homes

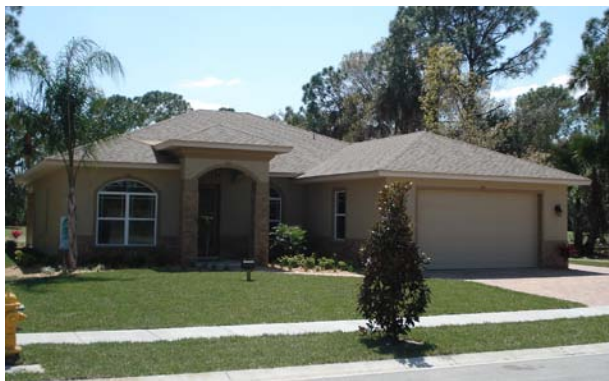
Figure 1: Builder’s Challenge home (2127 Sq. Ft.) construction with conventional hip roof and shingles in Rockledge, FL.

In 2010, the Florida Solar Energy Center (FSEC), with funding from the Building America program, was involved with a new Builders Challenge builder located in Rockledge, Florida -- Springwater Homes (see Figure 1). The home was constructed in March 2010 and features a sealed attic with R-27 open cell sprayed foam roof deck insulation (shown in Figure 2). Selection of the HVAC system, an important aspect to achieve high efficiency levels in buildings, ended with one of the highest residential equipment systems available in the U.S. – the Nutone IQ Drive (SEER 21). The house was confirmed with a HERS index of 53 using the EnergyGauge simulation program. By April 2010, FSEC researchers had installed a variety of sensors and a data logger to investigate the power consumption of the mechanical HVAC equipment and, most importantly, the humidity characteristics inside the sealed attic.

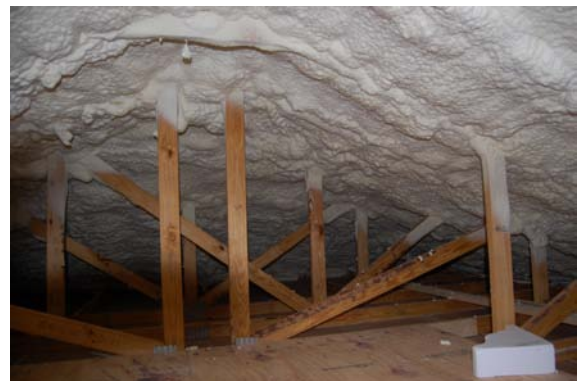
Figure 2: Roof deck insulation (R-27) featured on Builders Challenge Home in Rockledge, FL

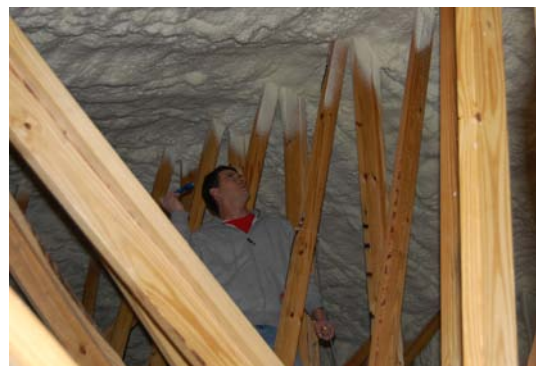
Figure 3: RH and temperatures were measured at peak and mid levels within the sealed attic.

In April 2010, FSEC completed installation of instrumentation wiring and sensors for temperature and relative humidity (RH) measurements in the conditioned space, attic and outdoors. The attic temperatures and RH sensors were positioned in the attic at mid and peak levels, as shown in Figure 3.

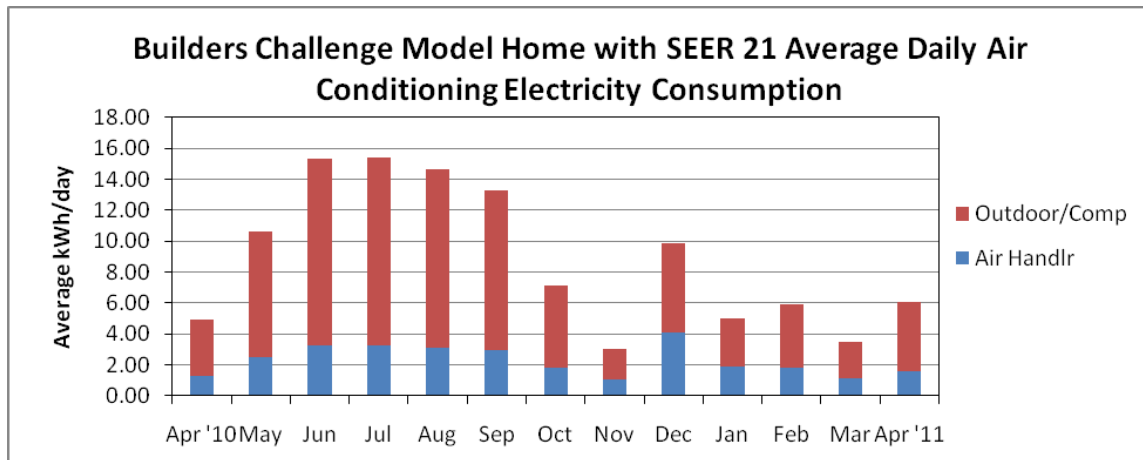
Figure 4 Average Daily electric consumption by month for the SEER 21 air conditioner on a 2,127 sq. ft. model home in Rockledge, FL.

HVAC electricity used at the Builders Challenge home site, although it does not represent a typical family use pattern, was kept at a comfortable 73°F during the monitoring period (summer included). Average daily electricity consumption for the HVAC system can be observed in Figure 4. The months of June and July measured a daily electric consumption slightly above 15 kWh/day. The indoor air handler unit during cooling months (May-Oct 2010) represents 28% of the total air conditioner power consumption on average.

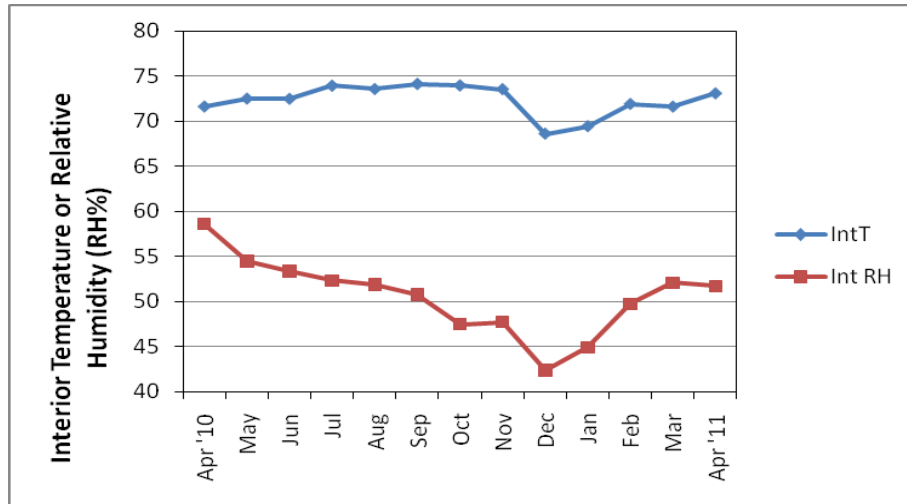
Figure 5: Average monthly interior temperatures and progressive downward trend of relative humidity.

average. The trend of relative humidity throughout the following months is shown in Figure 5 along with the interior temperatures. The relative humidity trend indicates that the HVAC equipment slowly brings interior conditions of the new constructed house slowly towards the target of 50%. High humidity content is typically found in new construction due to moisture in building materials. Furthermore, the Manual on Moisture Analysis in Buildings states that a newly constructed house can release an estimated 5,730 lb of water from concrete foundation and construction lumber. Thus, moisture from construction materials can be a serious source of humidity in the first year and second year.

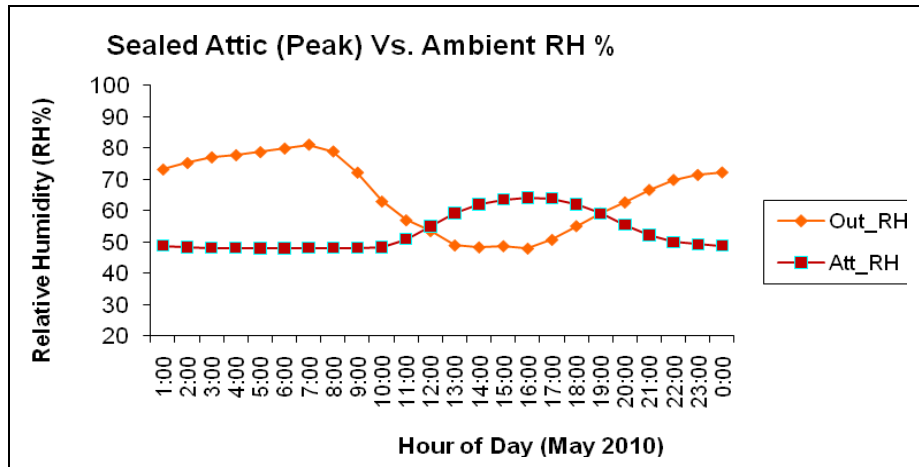
Figure 6: Sealed attic (peak) and outdoor relative humidity averaged daily by hour for May 2010.

In Florida, as recommended by code, it may be standard practice to apply a vapor barrier underlayment on a shingle roof constructed with sealed attic. Averaged hourly data collected during May 2010 clearly indicates high relative humidity measurements appearing at 4:00 PM at the peak of the attic. This measurement is being taken at 6 inches below the sprayed roof deck insulation. Relative humidity levels reached as high as 83% in May 2010 and 78.3% during April 2011 as indicated from 15-minute data interval. The relative humidity levels almost seem inversely proportional with respect to the outdoors, as shown in Figure 6.

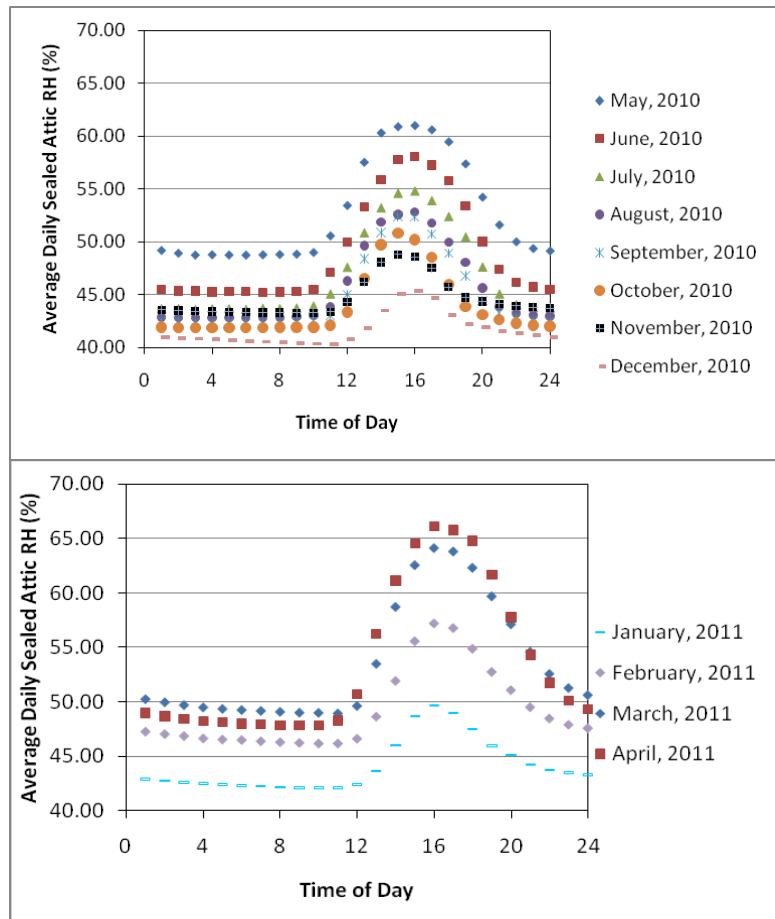
Figure 7: Monthly trend of relative humidity levels in sealed attics for 2010 and 2011.

Initially, during May 2010, humidity levels in the attic appeared high, but consecutive months showed a steady downward trend in magnitude, as seen on the top plot in Figure 7, for the first eight months ending on December 2010. However the latest data analysis clearly shows a reverse trend with increasing relative humidity levels beginning in January of 2011 (Figure 7, bottom plot). Relative humidity levels in the attic during April 2011 appear to exceed those high levels measured almost a year before during May 2010. These monthly averaged measurements of relative humidity conditions have prompted further investigation of the humidity in this particular sealed attic configuration. Relative humidity and attic temperature measurements were used to calculate the amount of moisture content in the air, also known as humidity ratio (W).

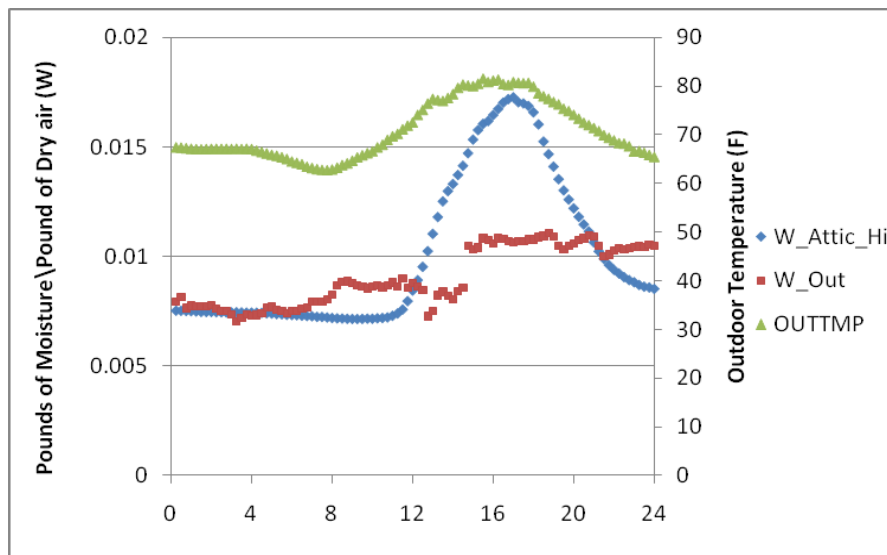
Figure 8: Humidity content plot for sealed attic and outside air on April 1, 2011.

The humidity ratio (W), as defined in the ASHRAE handbook of fundamentals, is the ratio of the mass water vapor to the mass of dry air. The humidity ratio is expressed as pounds of moisture per pound of dry air in the British (IP) system. Analysis of sealed attic humidity content may be easier to analyze by looking at the calculated W values of the sealed attic air and adjacent air spaces. In this manner, the source of moisture can be easier to identify on a 24-hour day period, for example. Figure 8 shows the calculated moisture content (W) found in the attic plotted along with the W ratios found for outdoor air on April 1, 2011. Air temperature measured at the sealed attic peak level is also shown in degrees Fahrenheit (F). The temperature data is helpful to identify trends of moisture. As indicated previously, this model home does not have the typical moisture generation of an occupied residence (i.e., showers, cooking, occupants). The plot on Figure 8 may indicate that a year after the home was built, wood truss components exposed in the sealed attic are prone to sorption and desorption trends throughout the day.

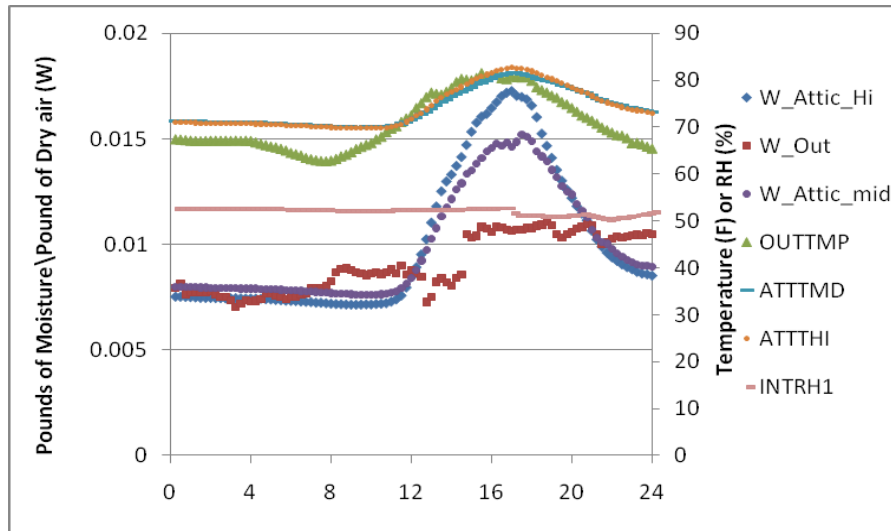
Figure 9: Enhanced plot showing humidity content at two levels in attic and temperatures along with interior home conditions

Furthermore, the same plot was enhanced to examine humidity content in the sealed attic at mid-level (Figure 9). Data points representing indoor relative humidity conditions are also shown to represent interior conditions. Although the air conditioner did not operate until late afternoon this day, relative humidity in the conditioned space did not vary much from 50% throughout the day. The interior temperature that day (April 1, 2011) was kept by the air conditioner at or below 73.1°F, and relative humidity reached 52.7% at its highest. A small reduction in moisture content can be seen due to the operation of the variable speed HVAC unit between 4:45 PM and 6:00 PM.
