High Performance Existing Homes Partnerships and Research

Janet McIlvaine

Retrofit Case Study: Sarasota Home

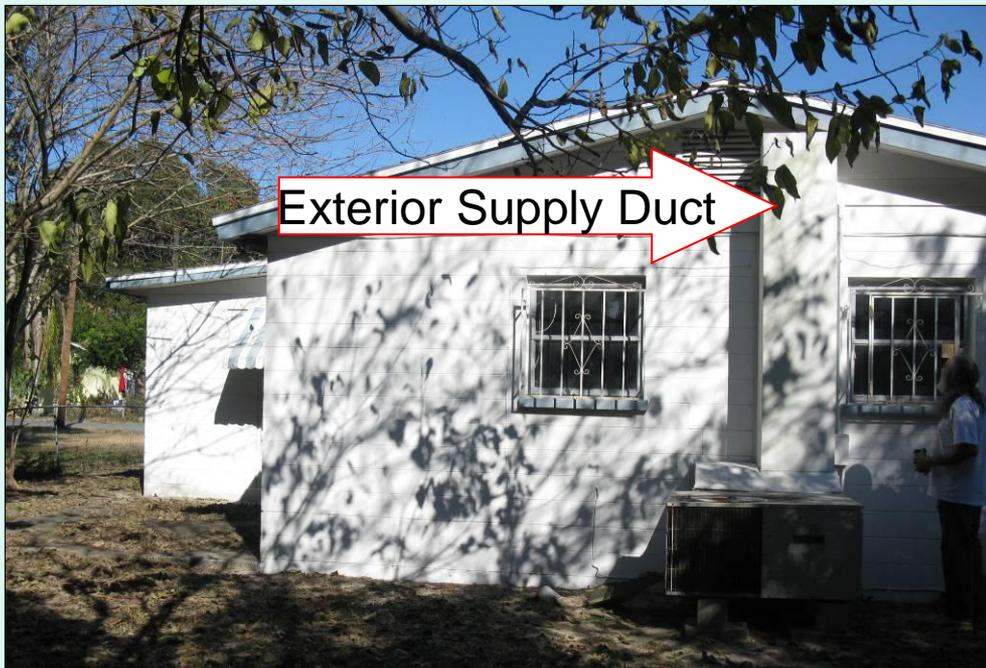
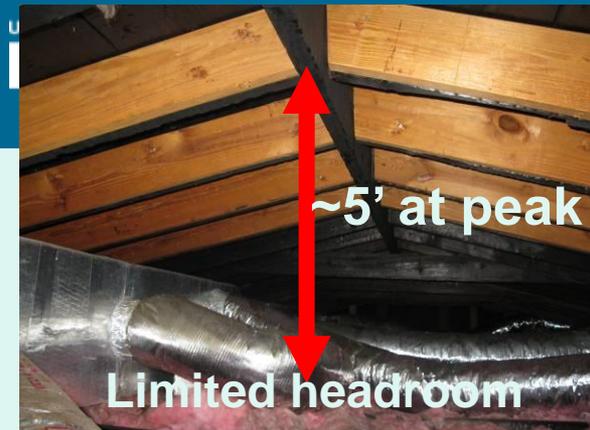
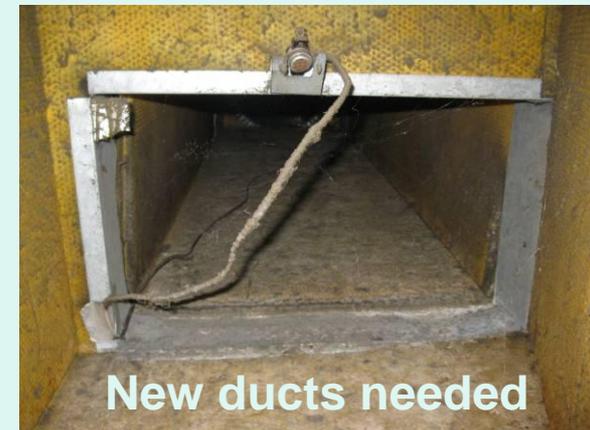
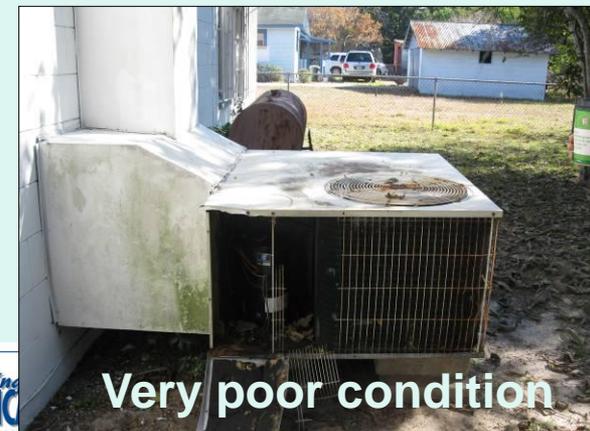
- 1250 ft², 1960 3 bed/2 bath
- Central Florida
- Slab on grade, block construction
- Test-In HERS Index 178
- Target HERS Index 89
- **Projected 50% Improvement**
 - Attic insulation, window and HVAC replacement, appliances, & lighting

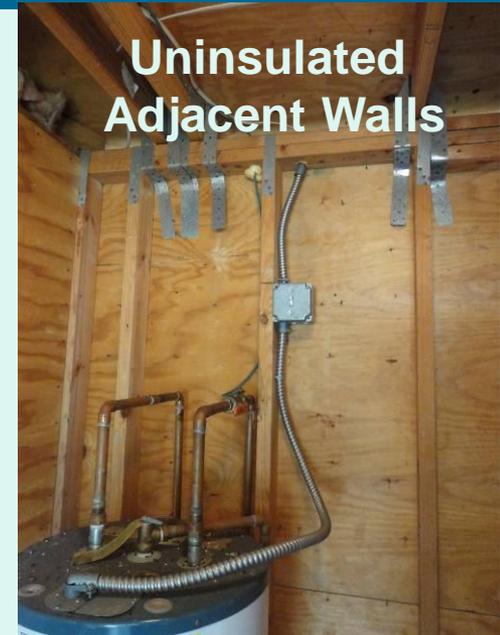
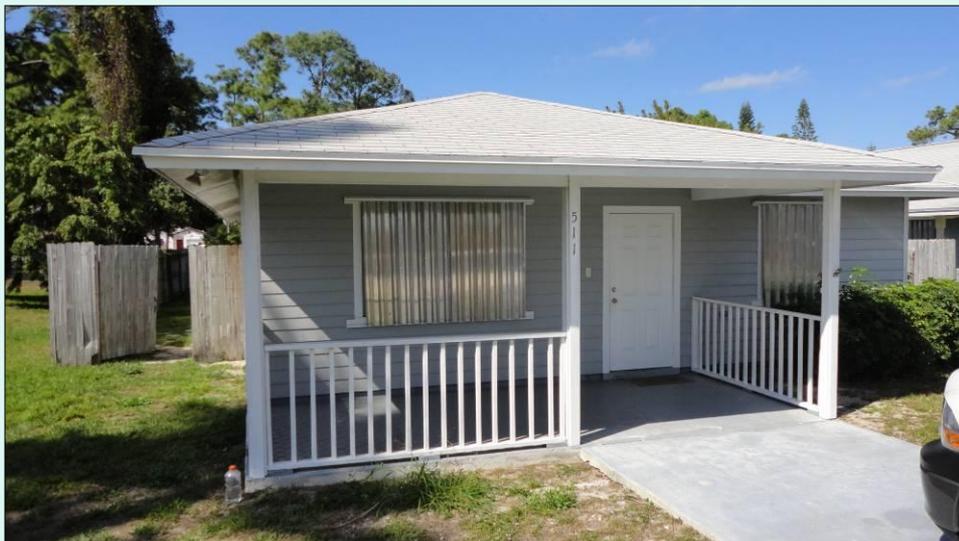
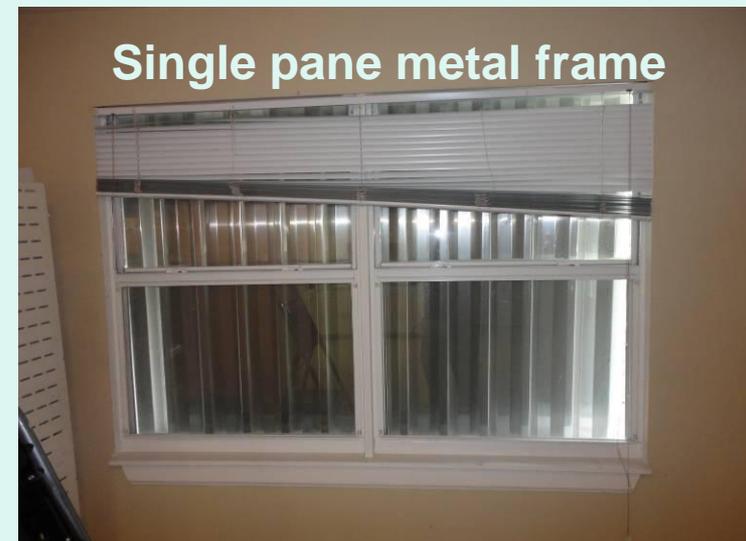
- 1373 ft², 2003 3 bed/2 bath
- South Florida
- Slab on grade, frame construction
- Test-In HERS Index 97
- Target HERS Index 63
- **Projected 35% Improvement**
 - HVAC, HP water heater, window film, appliances, lighting

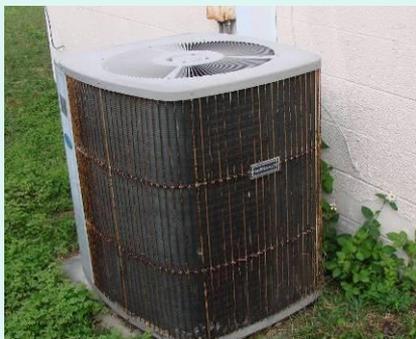
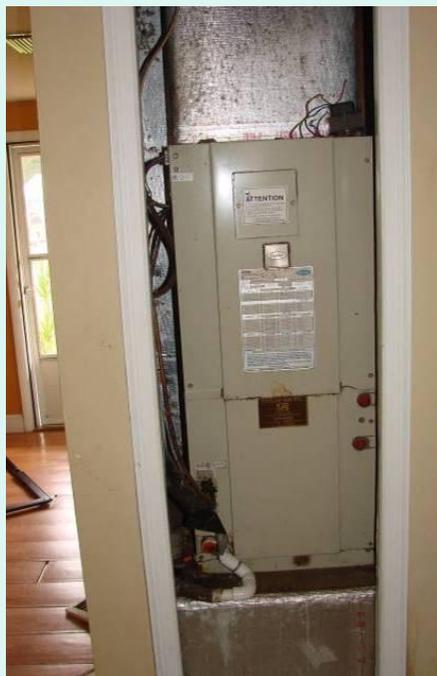
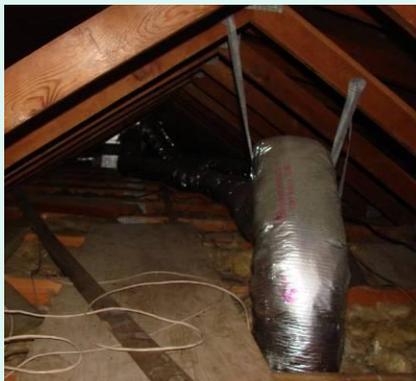
Pre-retrofit

SEER 8.7, HSPF 6.75 Heat Pump with
better than typical duct leakage
($q_{n,out} = 0.05$)

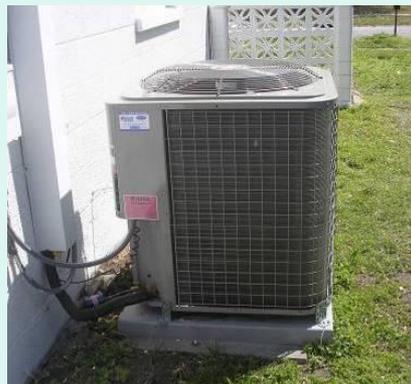
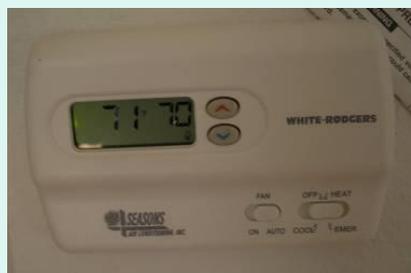
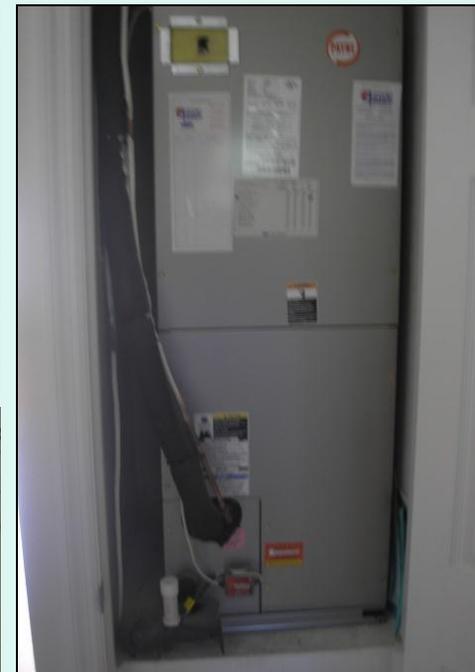
Post-retrofit

SEER 15, HSPF 8.8 Heat Pump with
sealed ducts
($q_{n,out} = 0.02$)
