## Final Report

### **Investigating Solutions to Wind Washing Issues in 2-Story Florida Homes; Phase 1**

FSEC-CR-1842-09

December 31, 2009

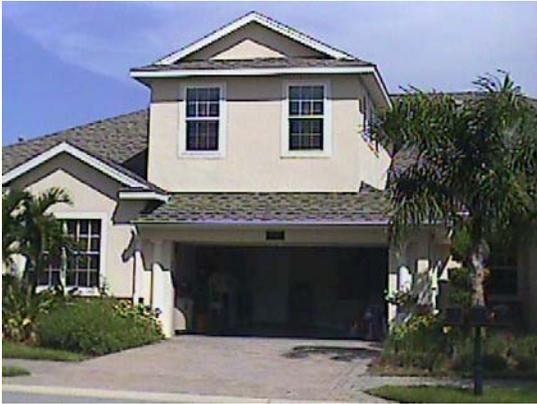
**Figure E-1** Home (H7G) faces west.

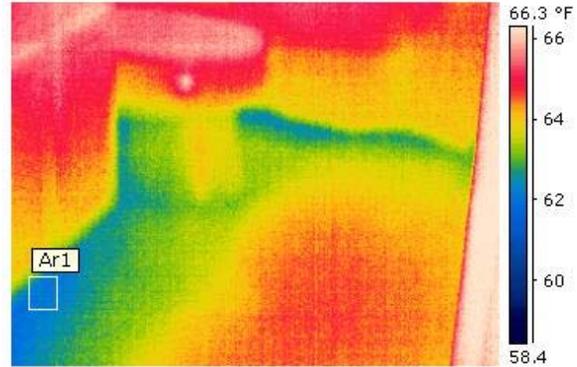
**Figure E-2** Infrared image of 2<sup>nd</sup> story bathroom floor before repair. Area in box (Ar1) is 62.7°F on a cold day.

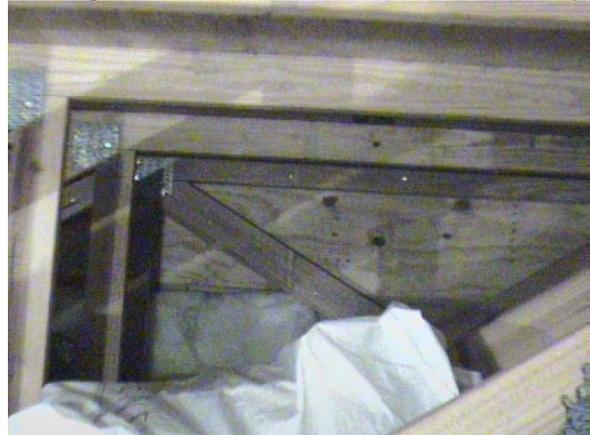
**Figure E-4** Photo of image at left. Small hipped, vented attic area is on the other side of this cold area.

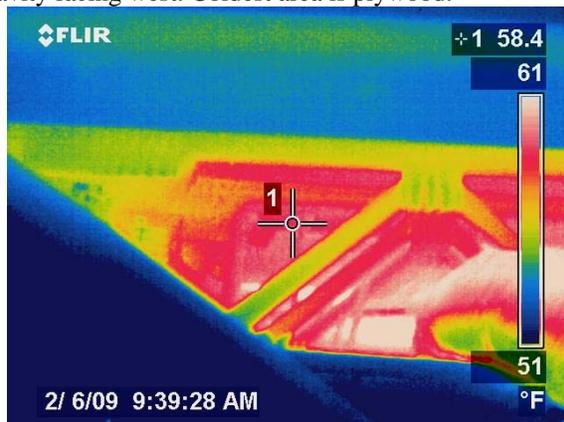
**Figure E-5** IR image inside bonus room floor space facing east (H7G). The truss marks the boundary between 2<sup>nd</sup> story floor space (which is much warmer) and bonus room floor space (which is much colder).

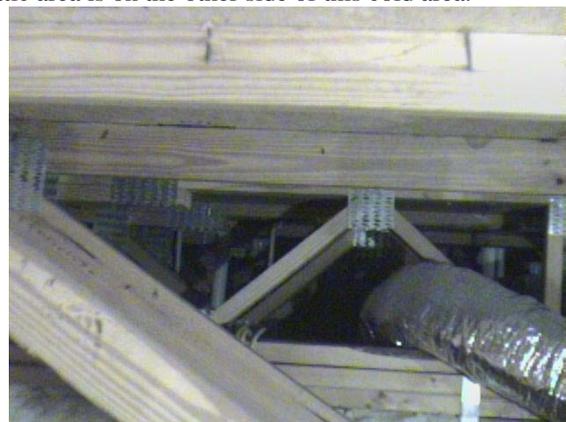
**Figure E-6** Photo of image at left. View is facing east into 14" high 2<sup>nd</sup> story floor space in the main part of the house.

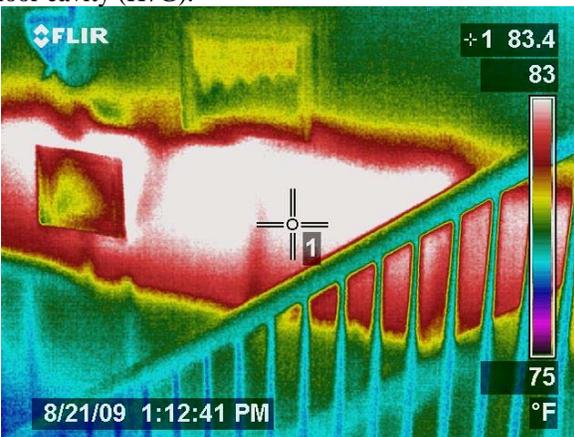
**Figure E-9** Infrared image of floor space behind wall in house H23. Wall surface is about 83.4F at floor space due to open floor space to attic on east and west sides of house.

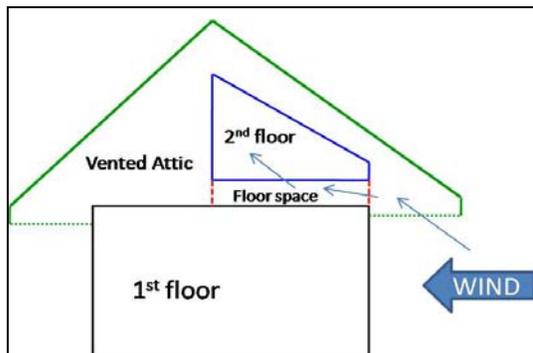
**Figure 1** Wind-driven attic air is pushed into the space between floors.

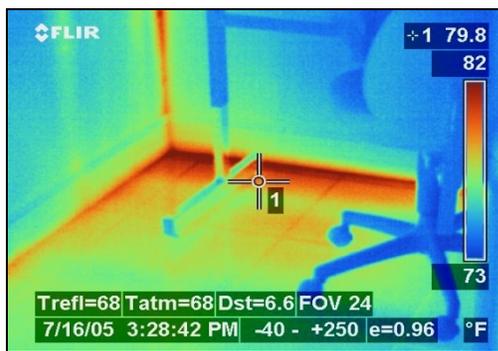
**Figure 2** Elevated floor temperature results from hot attic air flowing through the floor cavity.

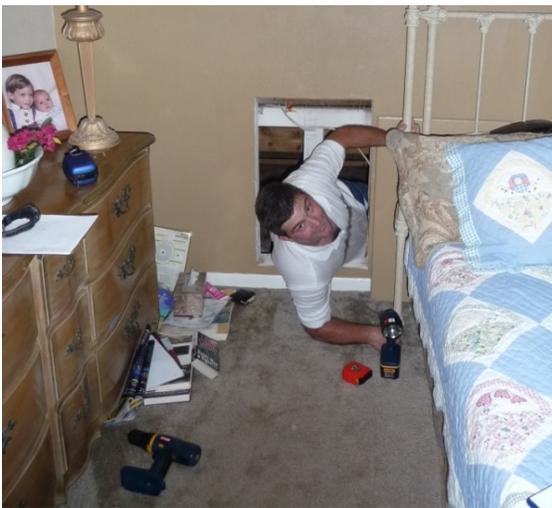
**Figure 3** House H13. Visual inspection in the attic space is necessary to identify the presence and magnitude of wind washing.

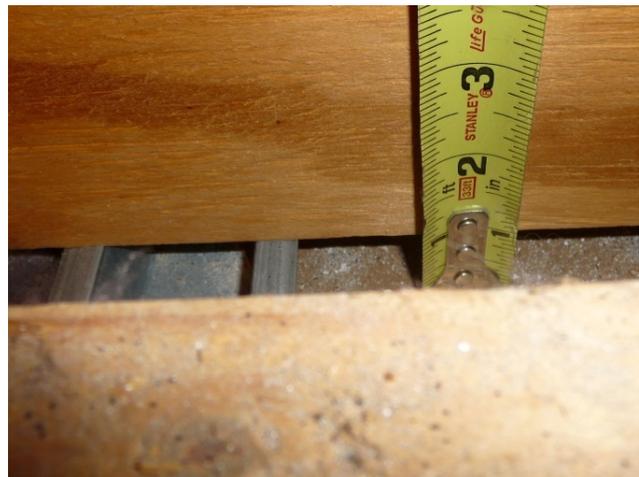
**Figure 4** Photo from inside attic at House H13. A 1” gap exists between plywood that covers the kneewall and the 1<sup>st</sup> floor ceiling below. This gap allows air to flow from the attic space to the 2<sup>nd</sup> story floor cavity.

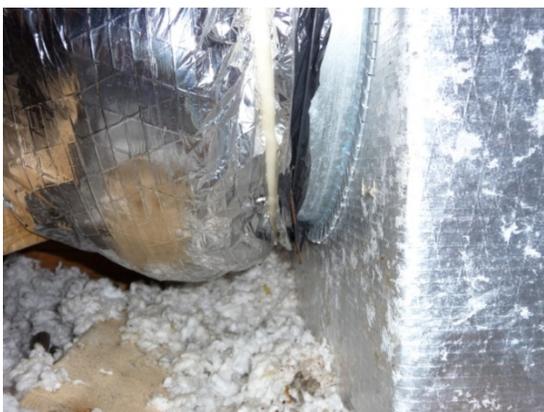
**Figure 5** In House H2, a loose fitting flex duct creates part of a large return leak.

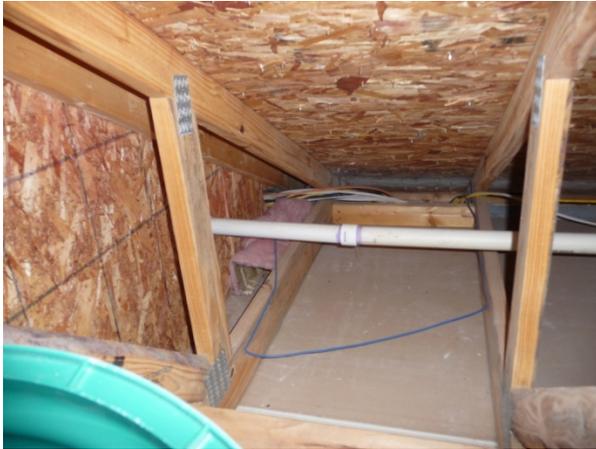
**Figure 12** No wind washing potential was found in House H18 because the kneewall insulation and floor cavity are covered by plywood.

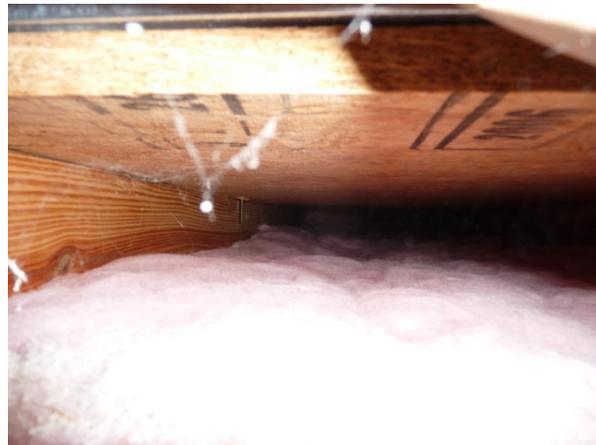
**Figure 16** A view inside the floor cavity of House H22 shows that batt insulation is lying on top of 1<sup>st</sup> floor ceiling, providing a thermal barrier to heat flow through the ceiling, but not through the floor of the 2<sup>nd</sup> story. These batts were used only where garage portions were below 2<sup>nd</sup> story conditioned space.

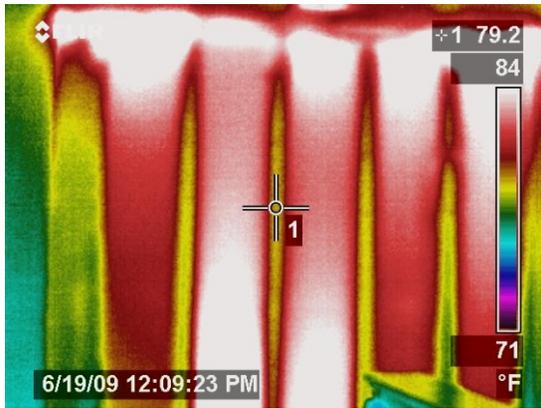
**Figure 17** IR image of Wall adjacent to unconditioned space.

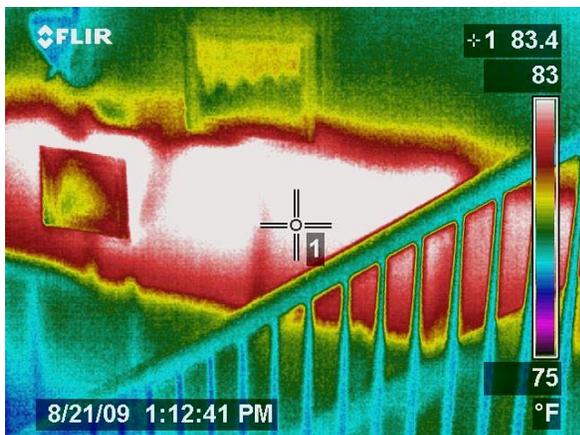
**Figure 19** Infrared image of floor space behind wall.

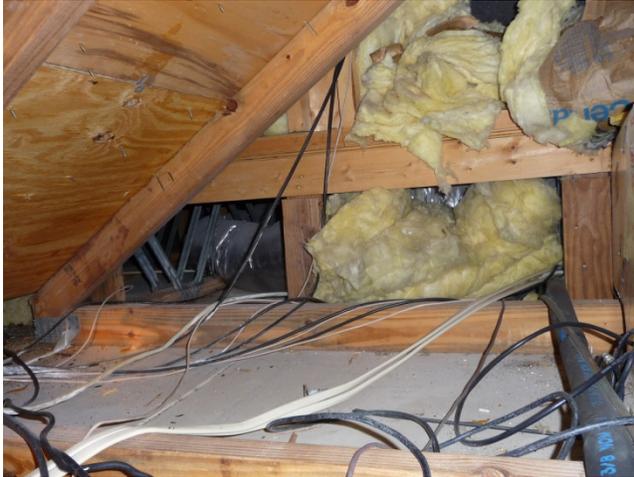
The kneewall (between the garage attic and the second floor of the house) on either side of the bonus room is poorly blocked with kraft faced batt and allows for uncontrolled airflow into the

interstitial floor space. Numerous wires, refrigerant lines and ducts penetrate into the floor cavity and very little effort was made during construction to effectively seal the kneewall. Figures 27 - 30 illustrate the open areas in the kneewall and the floor cavity of the bonus room floor, which is open to the attic air.

**Figure 27** Garage attic open to interstitial floor space.

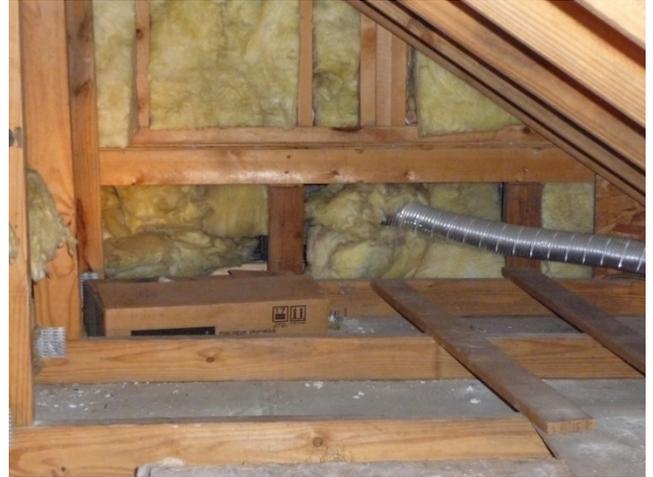
**Figure 28** Kneewall partially blocked adjacent to floor space

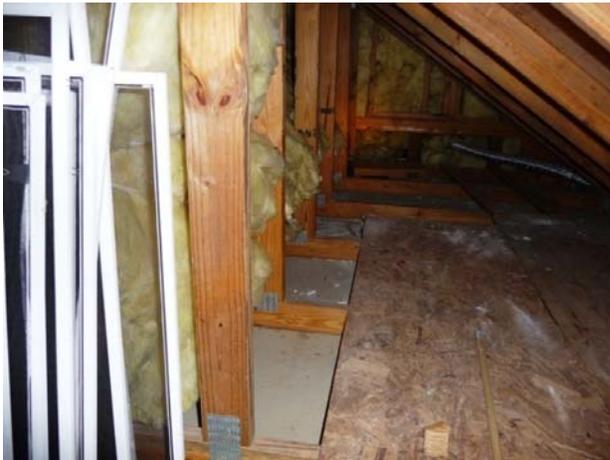
**Figure 29** View of kneewall, floor space (far), and bonus room wall. Unsealed floor cavity is to the left.

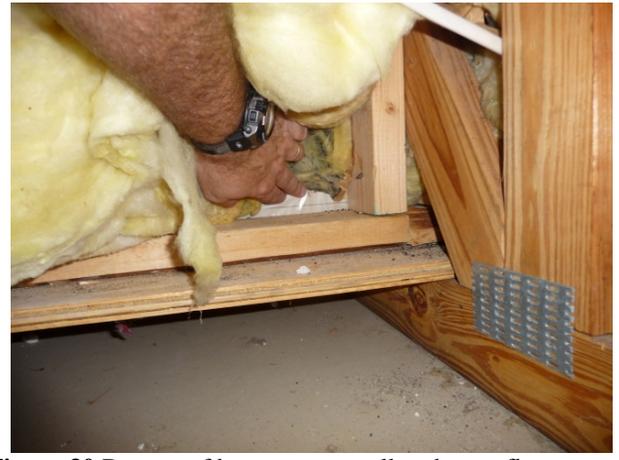
**Figure 30** Bottom of bonus room wall and open floor space as seen from garage attic. Wall assembly (as described above) is also evident in this picture.

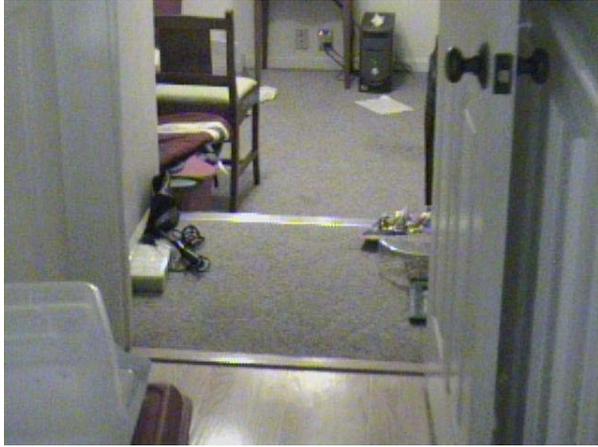
**Figure 31** Floor of the bonus room

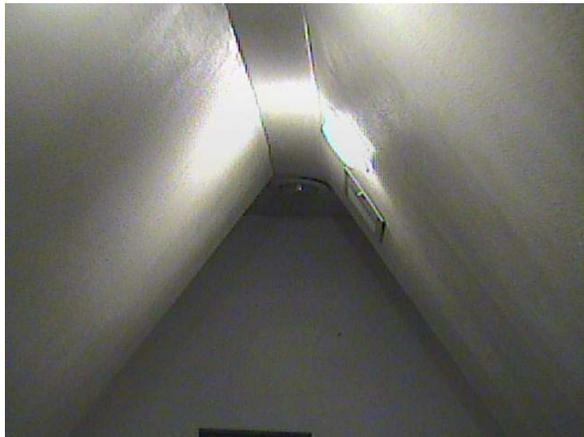
**Figure 33** Ceiling of bonus room with leaky recessed light.

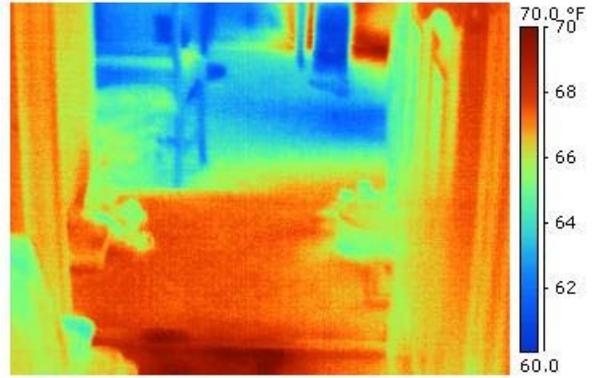
**Figure 32** Warm (red) heat signature due to unconditioned air beneath the bonus room floor. The blue emanating from the right is due to the low supply grills.

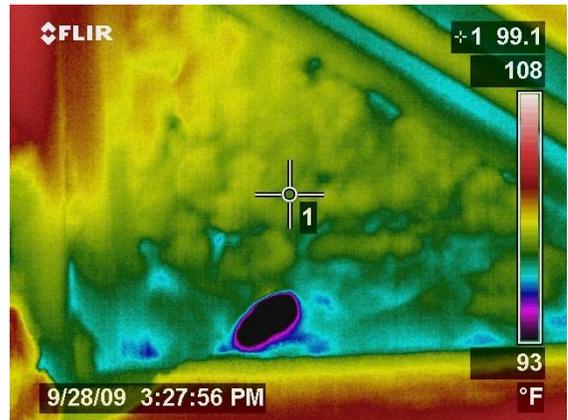
**Figure 40** A relative cool spot is a bathroom exhaust duct that vents to the attic.

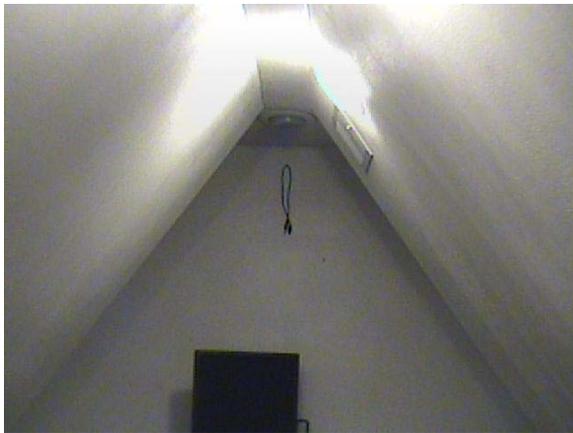
**Figure 41** Ceiling and east wall of bonus room.

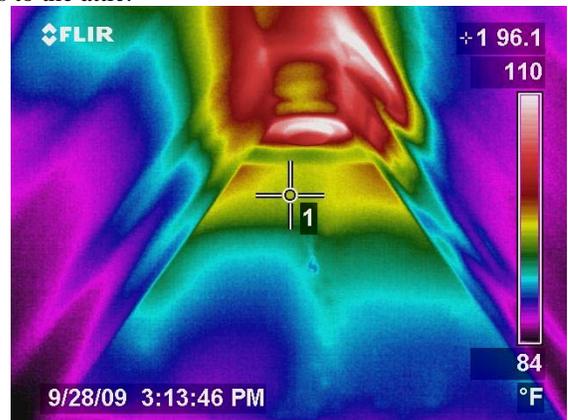
**Figure 42** heat transfer through the bonus room walls is high in upper sections which are close to attic roof deck.

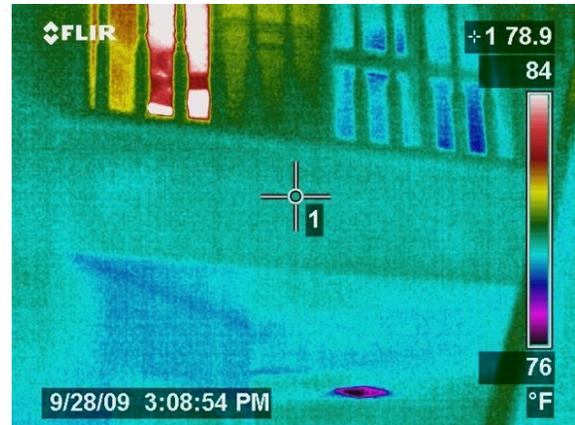
**Figure 44** After repair, evidence of wind washing heat penetration into house interstitial cavities is now gone.

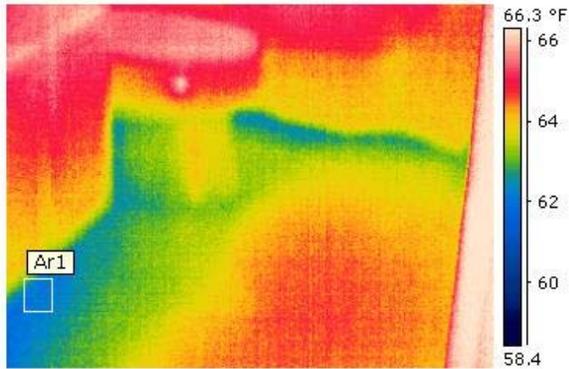
**Figure 47** 2<sup>nd</sup> story bathroom floor before repair. Area in box is 62.7°F on a cold day.

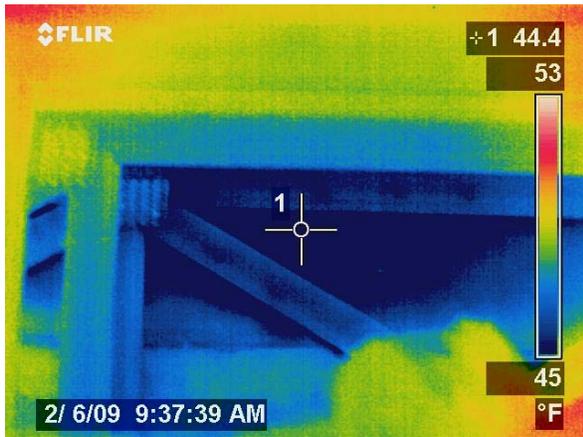
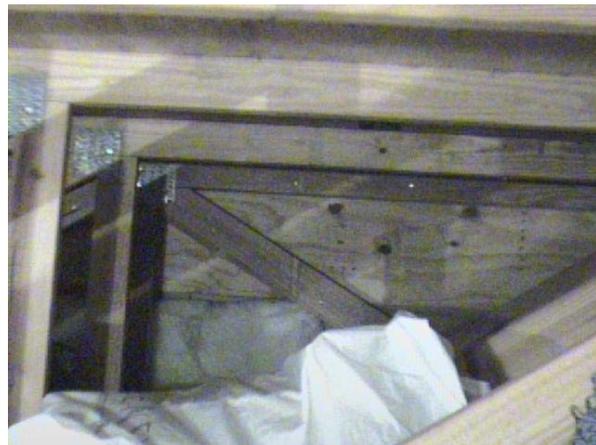
**Figure 50** IR scan inside bonus room floor cavity facing west. Coldest area is plywood. Small hipped, vented attic area is on the other side of this cold area.

**Figure 51** Photo of image at left.

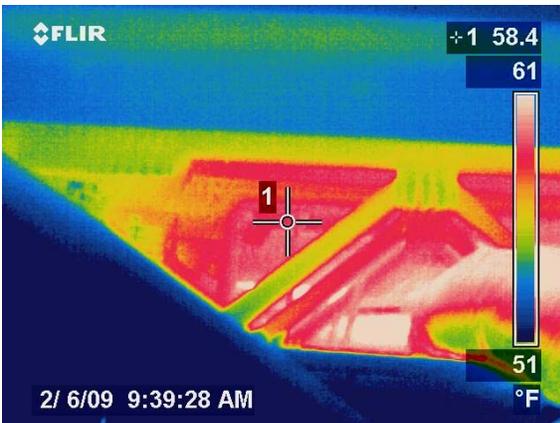
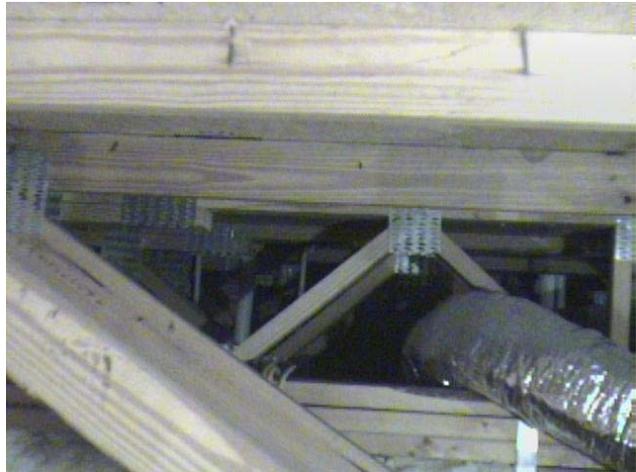
**Figure 52** IR image inside bonus room floor space facing east. The truss marks the boundary between 2<sup>nd</sup> story floor space (which is much warmer) and bonus room floor space (which is much colder).

**Figure 53** Photo of image at left.

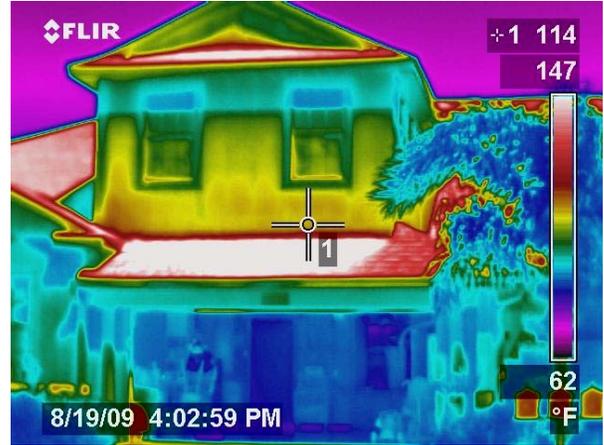
**Figure 55** H7 Infrared image of west facing front taken August 19 about 4 PM.

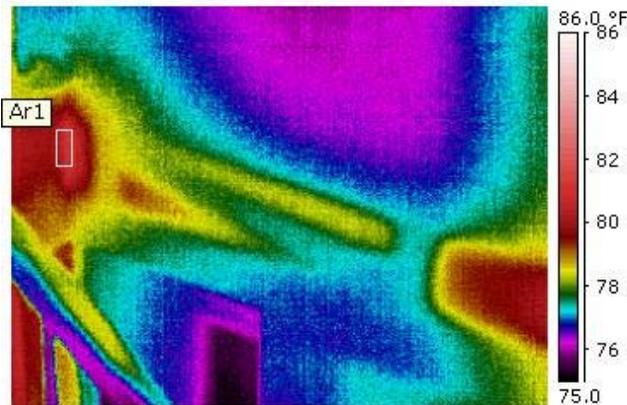
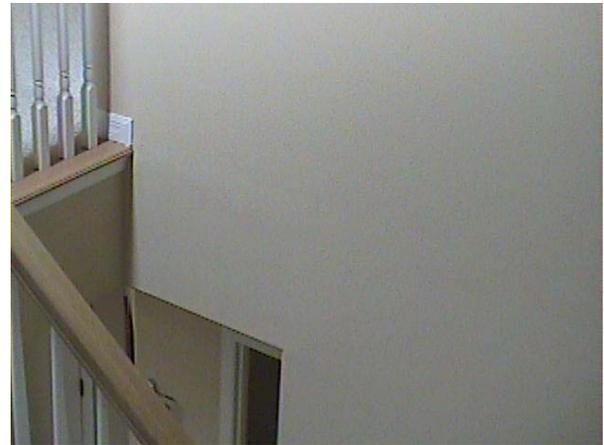
**Figure 56** IR image of floor space area at stairwell shows areas of elevated surface temperature before retrofit. Area in box is about 81.4F.

**Figure 57** Photo of image to left. Indoor set point is about 77.3 F on average.

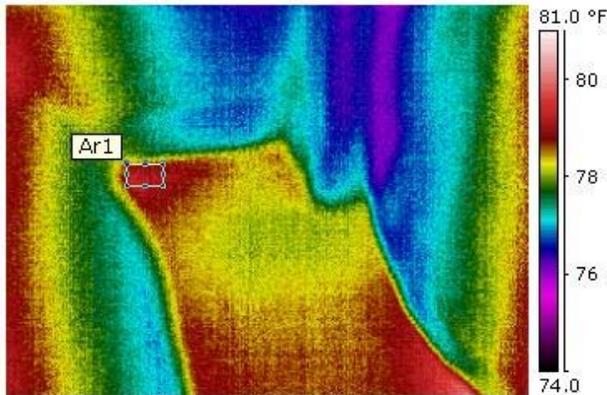
**Figure 58** Tile floor surface temperature before repair in the area box is in a location shielded from the supply vent and is about 79.5F when indoor air temperature is about 77F.

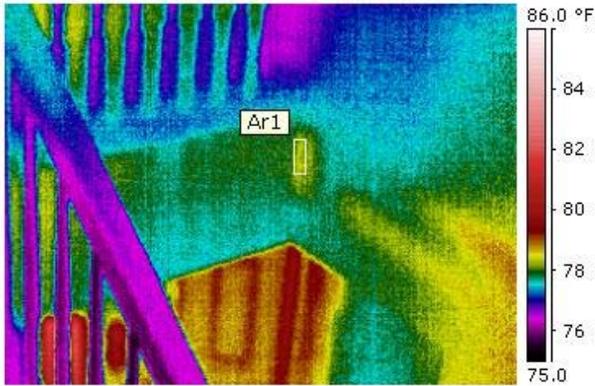
**Figure 60** Post Retrofit IR image of stairwell floor space area on a hot day in October. Area in box is 78.5°F, approximately 2.9 deg °F cooler than pre retrofit.

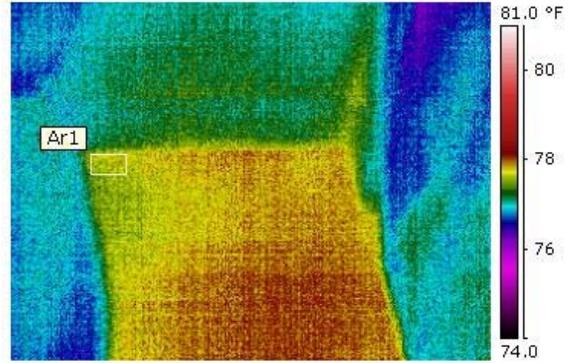
**Figure 61** Post retrofit IR image of bathroom floor. Area in box is 78.0°F, approximately 1.5 deg °F cooler than pre-retrofit.

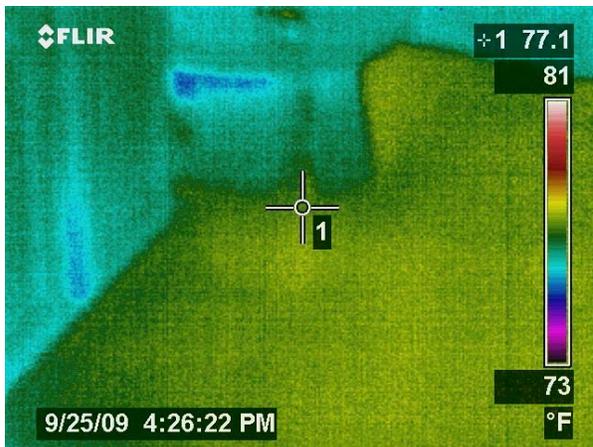
**Figure 62** IR image of 2<sup>nd</sup> story bathroom floor after repair. Floor surface is about 1.2°F cooler than pre-repair.

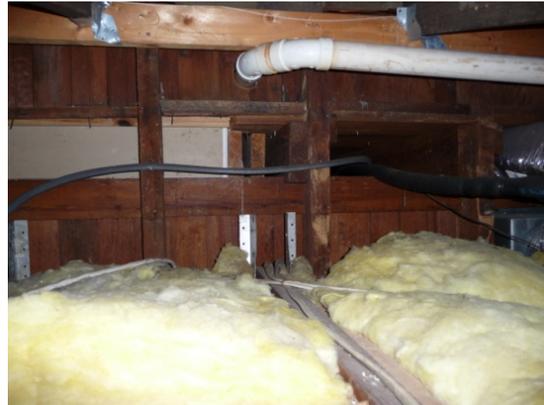
The outside air leakage pathway from outdoors to the interstitial floor cavity starts with two small opposing gable vents in the attic above the kitchen. They provide (limited) cross ventilation to the attic space above the kitchen. Each vent is a 6" diameter round opening with a grill covering with estimated 0.65 open fraction (each with 0.13 ft<sup>2</sup> net free area). In addition to leakage to the outside, the first floor AC system had a leaky return plenum which was able to draw considerable air from the interstitial floor cavity (between the two floors) and indirectly from the kitchen attic space. In all, the opening between the floor cavity and the adjacent attic space over the kitchen is estimated to be 18 ft<sup>2</sup> gross and about 12.0 ft<sup>2</sup> net free area. (Note that the attic vent opening area was only 1% of the gross open floor cavity opening.) Because of difficult access, we were only able to seal about 9 ft<sup>2</sup> or about 75% of the floor cavity opening.

**Figure 74** Floor cavity directly connected to attic area.

Foam insulation product was applied to the open floor cavity and exterior walls of the attic. Open cell foam was also used to seal any open space that connected the floor cavity to the unvented attic. The gable vents were sealed to create a semi conditioned attic space and further reducing the potential for wind washing. This repair required 4.0 man-hours to cover 209 ft<sup>2</sup> of surface area.

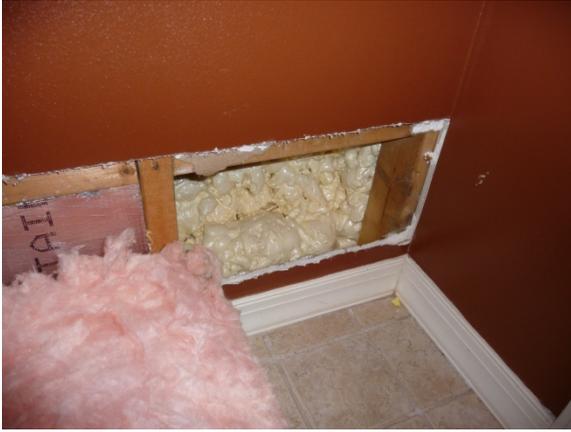
Prior to initial inspection the homeowner had complained of condensation, mold, and warping on two pocket doors in the 2<sup>nd</sup> level bathroom on the north side (Figure 84 shows a warped door). Our inspections also identified these moisture issues. The pocket doors are located in the east and west facing interior walls running perpendicular to the north facing exterior wall. It is also important to note that the homeowners prefer lower than average set points especially during summer evening hours. Based on our inspection, it appears that outdoor air enters through soffit venting, passes into the interstitial floor cavity, and then flows into the interior wall cavities containing these pocket doors. The cold indoor temperatures (AC setpoint) enable the high moisture content air to condense on the surfaces of the pocket doors. As shown in Figure 83, the homeowner had put effort into stopping this form of uncontrolled air flow prior to our inspection and testing.

**Figure 83** Attempt by homeowner to seal perceived air pathway in bathroom.

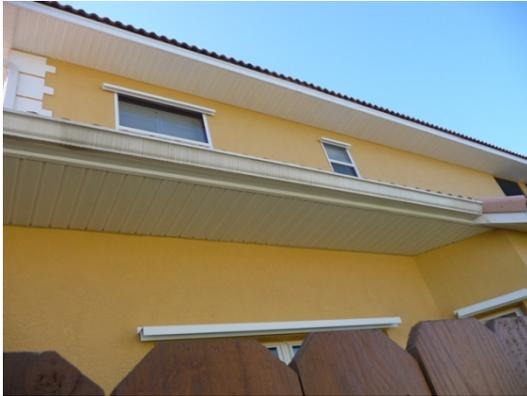
The open area of floor space adjacent to the North attic section is about 35 ft<sup>2</sup> (41ft x 0.85 ft). The next hole in the series to outdoors is through the space between the roof deck and the top of exterior wall. This hole has an effective size of 11.0 ft<sup>2</sup> (31.5% of open floor area). The last hole in the series is through the soffit vents which have a net free area of 2.3 ft<sup>2</sup>. Again, the controlling aperture is at the soffit vent.

**Figure 85** North attic is next to open floor space

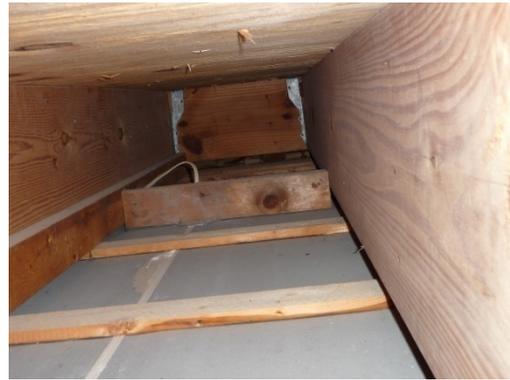
**Figure 88** View from inside west soffit, evidence of complimentary air pathway at back of photo.

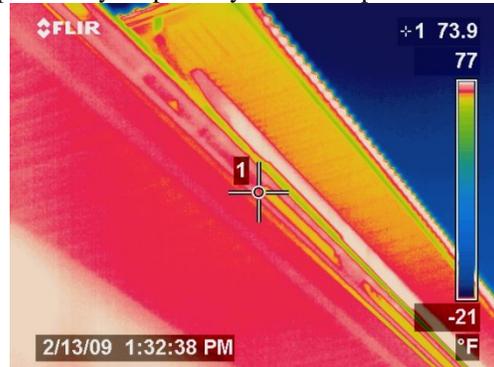
**Figure 90** IR North soffit.

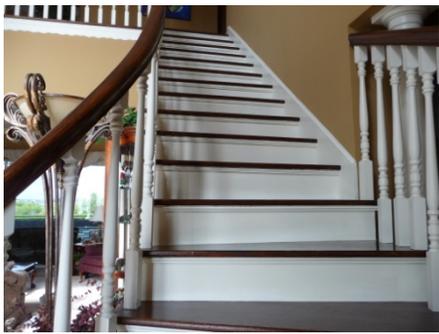
**Figure 91** Right staircase

The homeowner also brought to our attention warping and cracking of the grand staircase in the front foyer of the home. Upon inspection it became clear that the rear of this staircase could be well connected to the interstitial floor cavities which are well vented to the west-facing soffits. We hypothesize that prevailing winds (coming from the nearby ocean) drive moist outdoor air into the interstitial floor cavities where it interfaces with the backside of the stair case promoting warping and separation of the wooden risers and treads as wood absorbs moisture. Figures 91 – 96 illustrate moisture issues, including cracking of the wooden risers. (Note that these moisture-induced cracks had been largely eliminated within two months of the wind washing repairs.) Moisture data was collected with a Delmhorst Moisture meter before repair and was found to vary from 13.1% moisture content at the top of stairs down to 9.5% moisture content towards the bottom of the stairs. The average moisture content of wood in staircase before retrofit was

10.9% . By comparison, wood furniture inside the home had a moisture content around 7.5%-8% , within expectations for wood located in a humidity controlled environment. The average wood moisture dropped down to about 9.0% after retrofit.

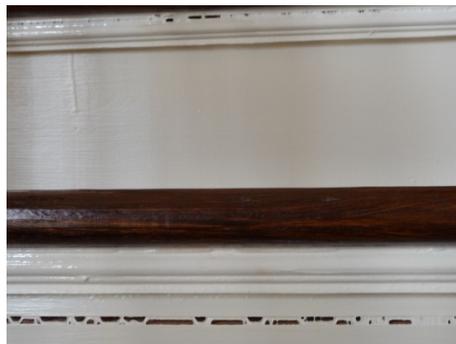
**Figure 92** Riser separation before repair.

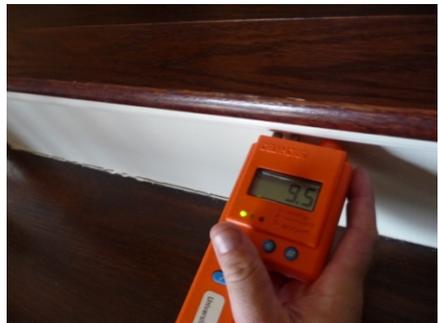
**Figure 93** Moisture content readings were about 13% at top of stairs with trend that fell to about 9.5% at bottom of stairs.

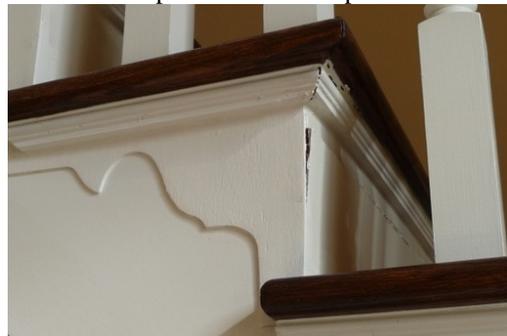
**Figure 94** Cracking and separation before repair.

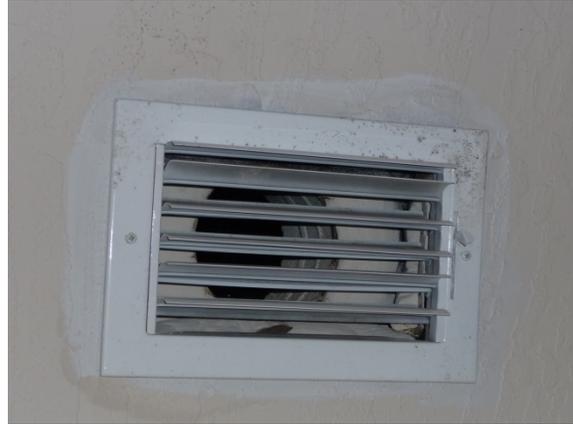
In addition to the staircase issue, the owner also reported that supply registers on the first floor had experienced moisture condensation and dripping in areas that were directly under the interstitial floor cavity (Figure 96). The owner also noted that ceiling drywall had been damaged in the kitchen and adjacent hallway from condensation on ductwork inside the floor cavity. This is clear evidence of wind washing penetration into the depths of the building structure. These ceiling surfaces had been repaired and some duct modifications made by a contractor about a year prior to our testing and monitoring.

**Figure 96** Evidence of condensation damage, mold and recent repairs by homeowner.

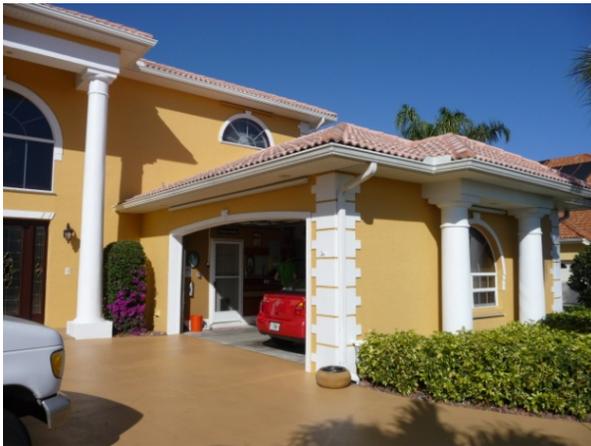
**Figure 99** Garage attic adjacent to floor cavity.

Foam insulation product was applied to the kneewall in the garage attic. Where the existing ducts penetrate from the garage attic into the interstitial floor cavity, the foam insulation was isolated from outer jacket of the ducts by an insulating vapor barrier/thermal barrier product to prevent these moisture condensation problems from reappearing.

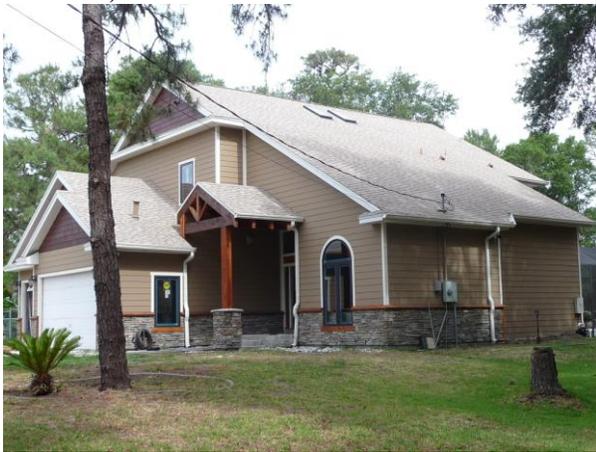
**Figure 104** Attic over garage faces south.

Additionally, the floor cavity between the first and second stories of the main part of the house was largely wide open to the garage attic space. This attic space vents to both the unfinished garage ceiling and the soffit surrounding the garage.

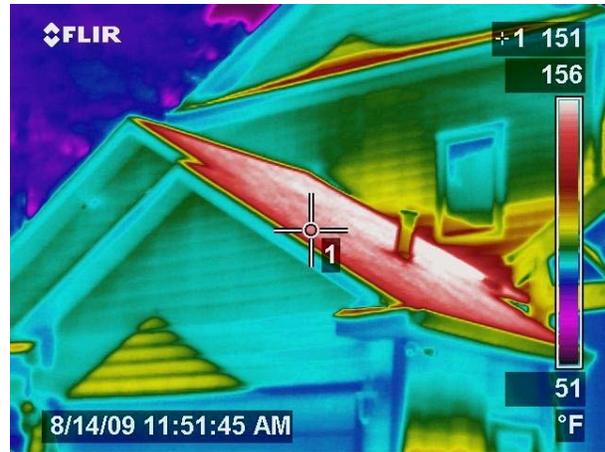
**Figure 105** IR image of attic over garage. East-facing roof is about 151deg. F just before noon.

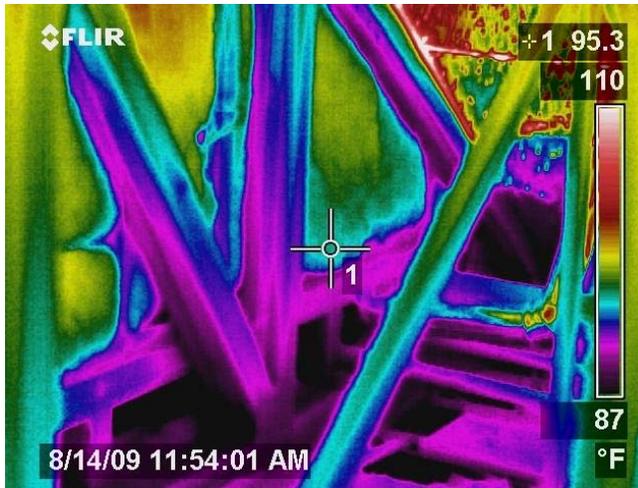
**Figure 106** IR view inside the attic shows cool temperatures in the floor space and cooled surfaces low in attic.

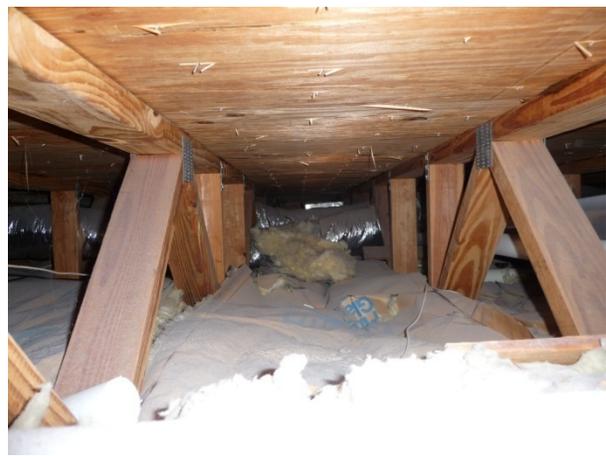
The opening between the second story floor cavity and the garage attic is about 25 ft<sup>2</sup>. This opening is facing south into the garage attic. The open area of space from the soffits into the attic is very small since batts are located on top of the garage attic floor close to the roof deck. We estimate that the total soffit-to-attic opening is only about 1 ft<sup>2</sup>. The soffit vent net free area is estimated to be about 1.6 ft<sup>2</sup>. Therefore, the opportunity for wind driven air entry into the interstitial floor cavity is small. There are no complimentary holes or pathways on the other side of the house to allow air to flow freely through the interstitial floor cavity. Note, however, that passive, stack-effect air flow between the attic and the floor cavity may be occurring, as is suggested in the IR image of Figure 108, where there is considerable stratification of temperatures from top to bottom of the floor cavity.

**Figure 109** View inside floor space.

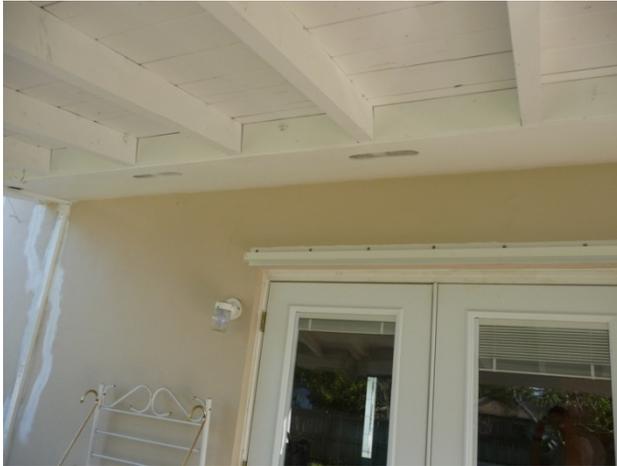
On the south side of the house, the exposed open area of floor cavity is estimated to be about 4.1 ft<sup>2</sup>. The total net free area of the nine south soffit vents that open into the floor cavities is about 1.4 ft<sup>2</sup>. Therefore, the attic venting is the most restrictive opening. Figures 116 – 123 show soffit vents and interstitial floor cavities.

**Figure 116** Cantilevered section of floor space on south side showing 2 of nine vent openings.

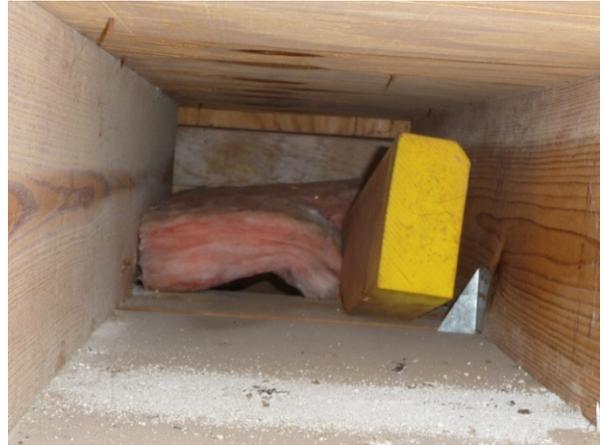
**Figure 116** Kraft faced batts located inside cantilevered portion of floor deck in most bays. Most only partially block opening from vent space to floor area. View from inside looking out to patio south side.)

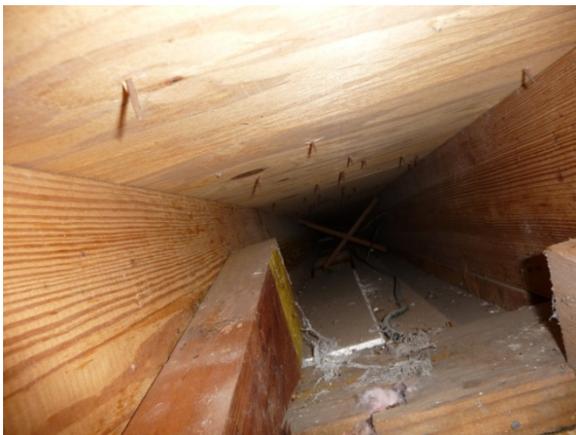
**Figure 117** View from soffit vent looking inside towards floor space in area having no batt. This is a different floor space bay than previous picture.

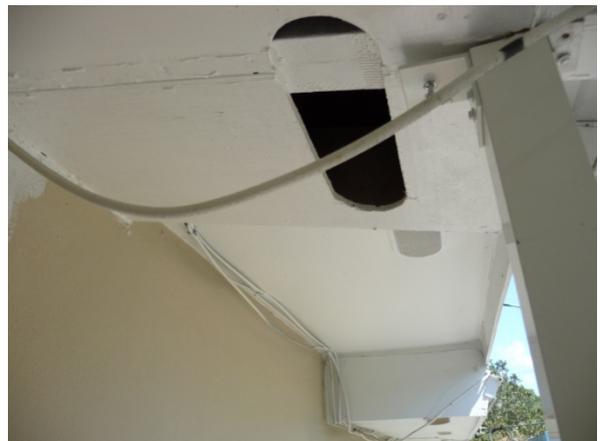
**Figure 118** Soffit vents down the south side of the house.

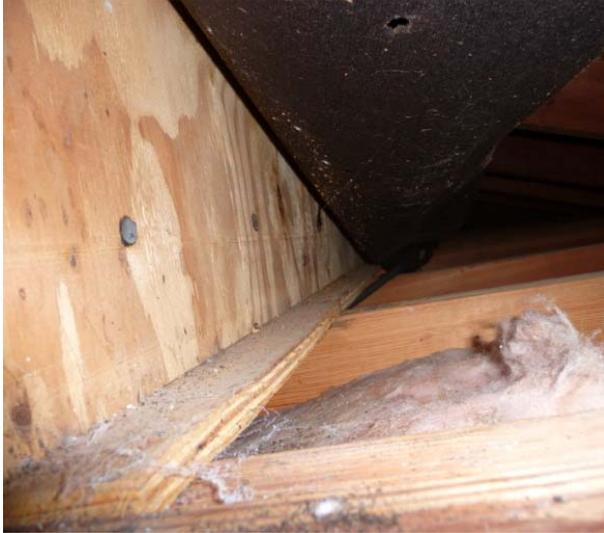
On the north side of the house, the exposed open area of floor cavity on the north side is about 5.5 ft<sup>2</sup> and the open area of the floor cavity from north attic to north soffit is about 11.6 ft<sup>2</sup>. The total air pathway from north attic through soffit and ridge vents is about 2.3 ft<sup>2</sup>. Therefore, the attic venting is the most restrictive opening.

**Figure 119** North attic section looking west from garage attic. North soffit vents are to the right. Felt paper being held up to view small kneewall area not insulated and floor space at bottom.

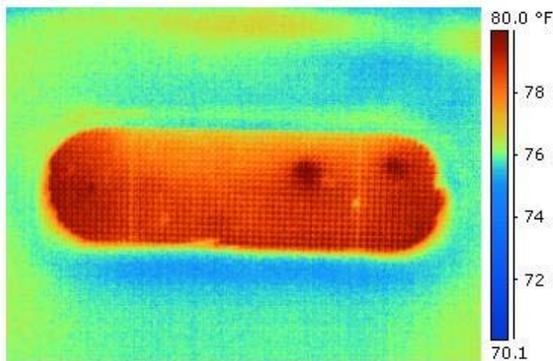
**Figure 121** With 10 mph wind from the north, the north soffit vent shows interior surface temperatures about 78-80 °F. Outside air temperature =80.1 °F and interior air temperature=71.0 °F.

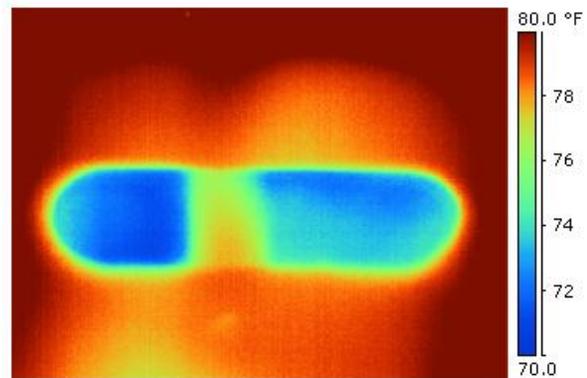
**Figure 122** With 10 mph wind from the north, the south soffit vent shows average of 71.9 °F on interior surfaces in left bay and about 73.2 °F on right bay indicating cool house air being pushed through the house by means of the floor cavity and the force of the wind.

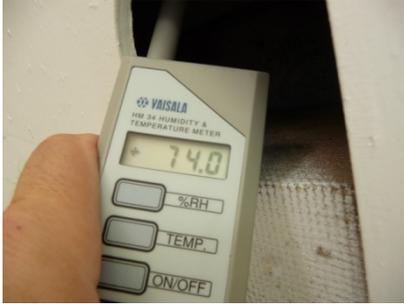
Chuck Withers noticed that very cool dry air was felt at the south soffits prior to sealing off floor space. HOBO loggers placed in both soffits also recorded dew point temperatures that were much lower than outside much of the time. The figure below shows dew point temperatures in six locations (including indoors, outdoors, eaves, attic, and floor cavities) over a two-day summer period. The figure also shows the power use of the AC system. Interesting patterns can be observed. The homeowner typically sets the thermostat up during the day, and then lowers it

It appears from this, that duct leakage is creating a mechanical driving force that displaces air through the floor cavities into the eaves and attic spaces. Additionally, it is known that the wind pushes air from the floor cavities into the eaves. On three different occasions, a research analyst has felt and measured with Vaisala HM34 (Figures 128 - 129) pulses of cool dry air that were being pushed into the south eave space. These pulses coincided with significant wind from the north at times when the air handler was off.

**Figure 127** Evidence of cool, dry air emanating from the vented eaves on the south side of the house. (T)

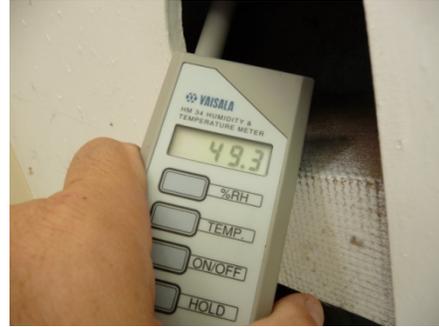
**Figure 128** Measurement of RH (%) showing low humidity air discharging from the soffit vent on the south side of the house.

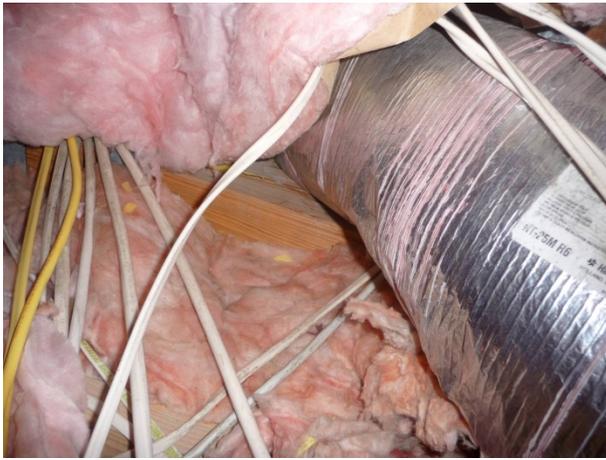
Condensation on ducts can be accentuated when insulation materials come into contact with the exterior of the duct or duct insulation. This problem was observed in House H8Hd. The homeowner had become aware of the wind washing problem prior to our testing, monitoring, and repairs, and had taken steps to partially block openings into the floor cavity. Specifically, the homeowner had placed insulation batts with kraft paper backing into the floor cavity gap. In places where these batts came into contact with supply flex ducts (that were going from the attic space into the floor cavity), we found moisture condensation occurring (see photos in Figures 130 - 131). Because of our knowledge of this problem and because of what we observed at house H8Hd, we took steps to avoid moisture condensation problems.

**Figure 129** Batt placed against supply duct by homeowner at H8Hd.

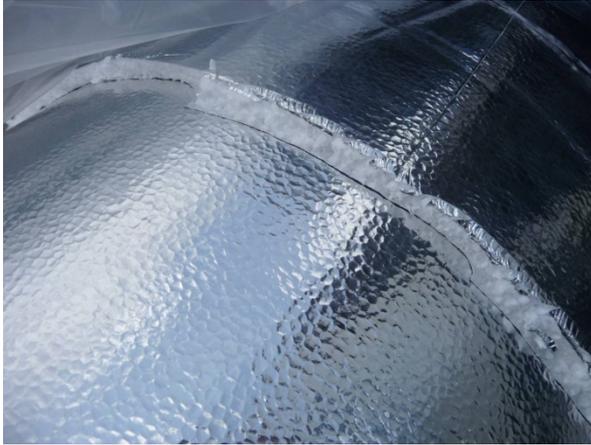
**Figure 131** 3/8 inch beadboard insulation with foil face on one side and plastic film on the other.

To avoid condensation on the exterior of supply ducts where they would potentially contact the open-cell foam, we instructed the foam insulation contractor to apply (wrap) a layer of (3/8" thick) foil-faced insulation material around the flex duct prior to the application of the foam insulation (Figures 132 - 133). The insulation wrap has foil on one side of a closed-cell polyethylene foam center and a plastic membrane on the other. Thus, the spray foam insulation

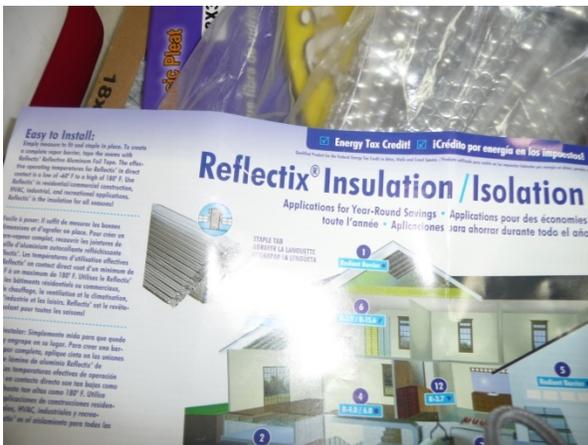
A second brand of insulation product was also used to wrap supply ducts in one house (Figure 134). This product has foil facing on both sides of a polyethylene air bubble. This product is about half the thickness of the flexible foam board product. The manufacture claims thermal resistance of R1.1 downward (R4.9 upward) and water vapor permeance of 0.000 perms.

**Figure 133** Second product used to wrap supply ducts has foil facing on both sides of a plastic air bubble pack.

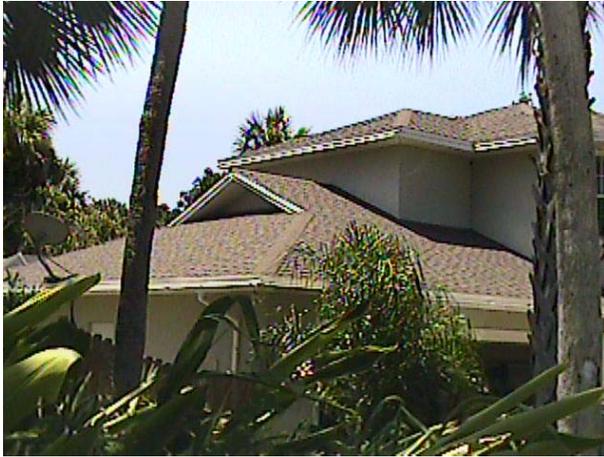
**Figure 134** East and north side of house with attic over garage adjacent to open floor cavities.

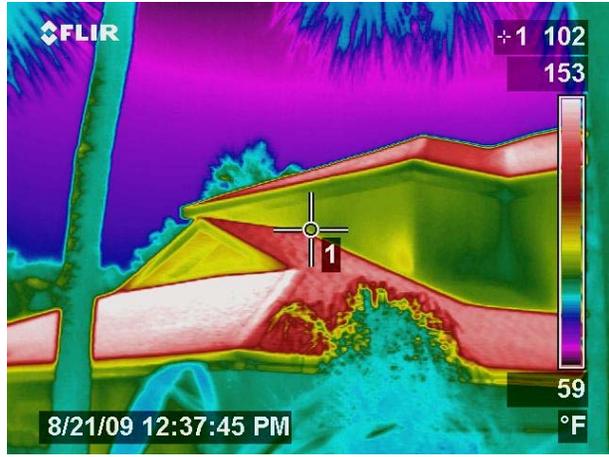
**Figure 135** Infrared image of the house during midday after mostly sunny conditions all morning.

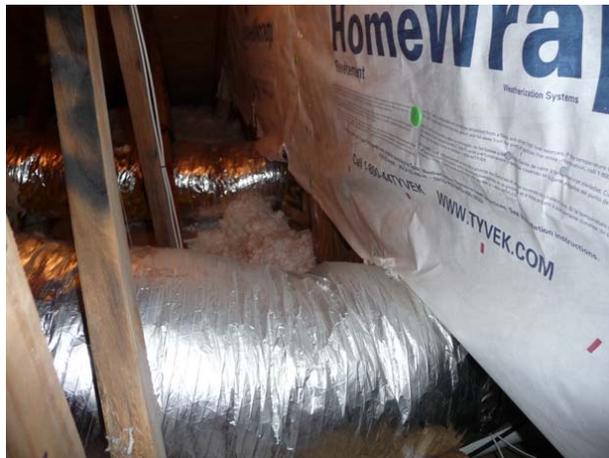
**Figure 137** Open floor cavity area in the west attic. (west side is to the left)

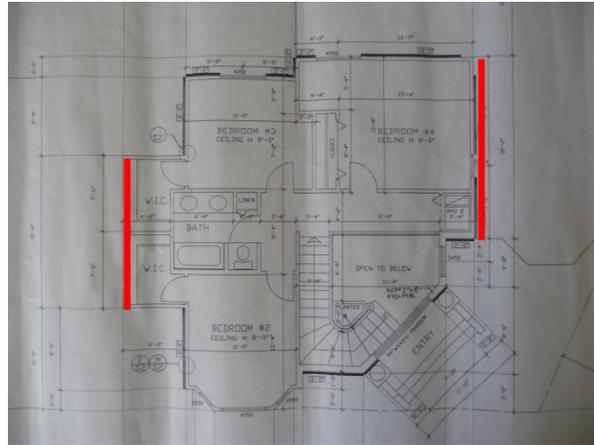
**Figure 1435** Second floor plan. Red lines indicate areas of wind washing into floor space.

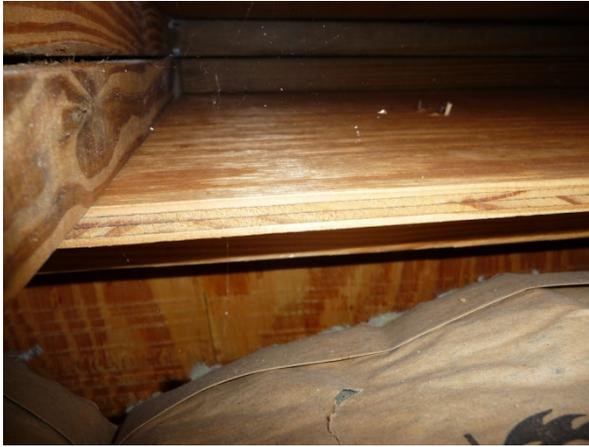
Windwashing is also an issue for some portions of kneewall on second floor. Figure 156 shows view upwards inside a wall section without insulation.

**Figure 1446** View looking up into open wall cavity from east attic shows no insulation in this wall next to walk-in closet.

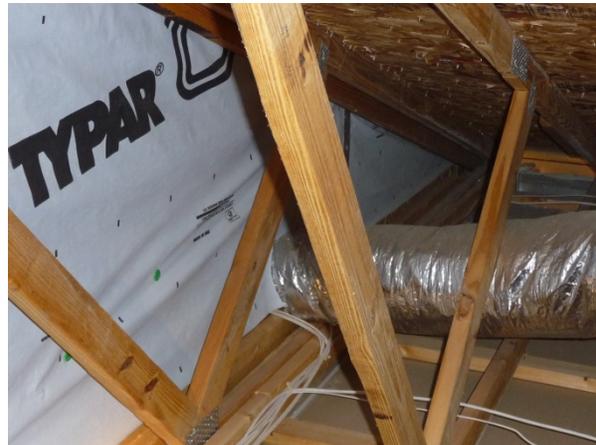
This home only had 80 in<sup>2</sup> of opening of second story floor space into attic areas. There were no other complimentary holes from floor space into other attic spaces opposite of the garage attic. Almost all the floor space was covered by plywood and house wrap (Figure 158). Most of the kneewall areas were also covered by plywood and house wrap except for a large area around the stairwell. This area only had R11 batt insulation that was sagging some with air space between the batt and interior drywall surface seen in Figures 159-160. The open air space between the batt and wall allow for a good potential of wind washing which can be seen in figures 161-162 that follow.

Figure 158 Portions of kneewall and floor space were covered with plywood and house wrap.
