## Final Report

### **Investigating Solutions to Wind Washing Issues in 2-Story Florida Homes; Phase 1**

FSEC-CR-1842-09

December 31, 2009

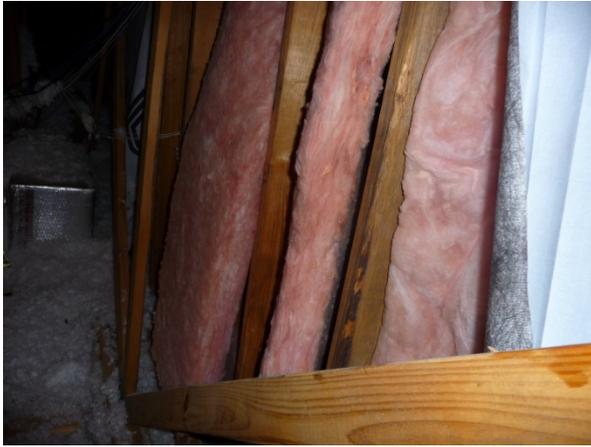
**Figure 159** Stairway kneewall view from attic with batts away from wall.

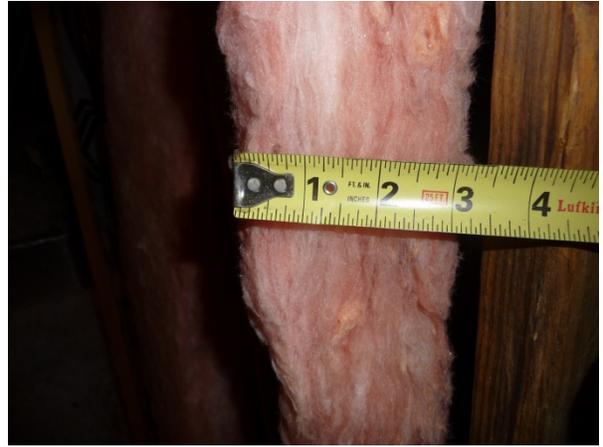
**Figure 160** Air space between R11 batts and wall allow hot air in contact with interior drywall.

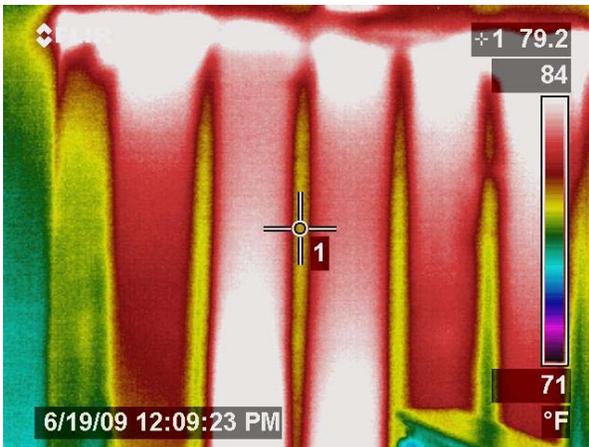
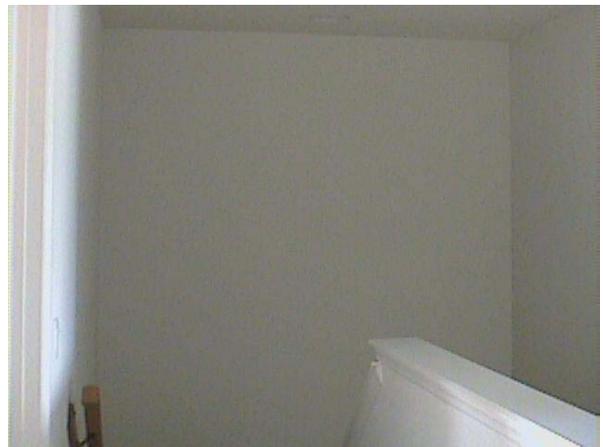
**Figure 161** Infra red image of indoor kneewall at stairway

**Figure 162** Photo of IR image to left.

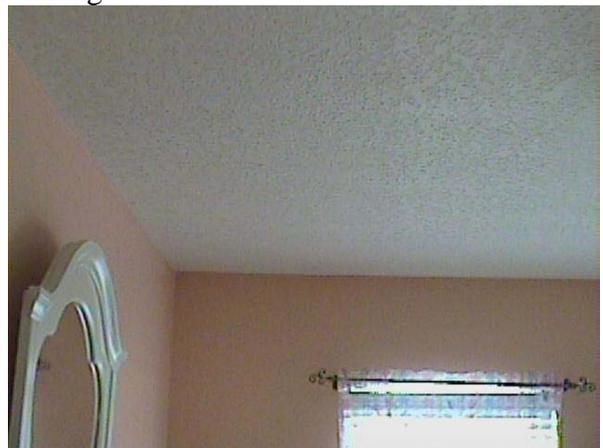
Some ceiling areas also were not insulated well. Figures 163-166 below show very hot areas from inadequate insulation placement on 2<sup>nd</sup> floor ceiling.

**Figure 164** Photo of IR image to the left.

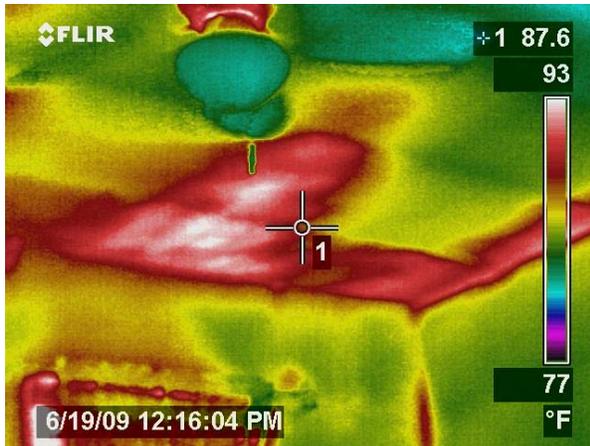
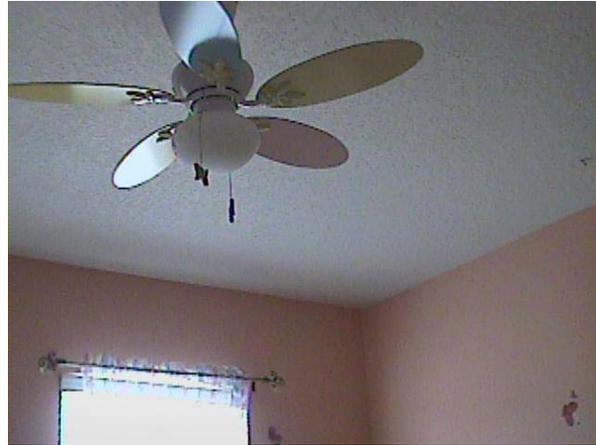
**Figure 165** Another hot ceiling in front right 2<sup>nd</sup> floor bedroom.

**Figure 166** Photo of IR image to the left.

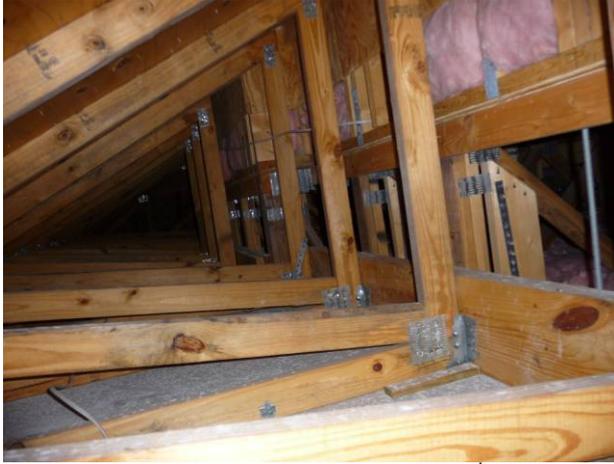
There was one significant area where attic air could move into the main 2<sup>nd</sup> story floor space creating a good potential for wind washing. The entire span of the north face of the floor space is open and can be seen in Figure 169. This is an area of approximately 20 ft<sup>2</sup>. The east and west sides of this floor area are mostly blocked by batt insulation with some gaps visible. The floor space under the bonus room consists of solid floor joists running east to west with the open ends in attic blocked by R11 batts in most cases (Figure 170). There is also batt insulation inside the bonus room floor cavities.

**Figure 169** North attic section with open 2<sup>nd</sup> story floor space. Insulation batts are located inside the floor space on the ceiling of the first floor.

- Place an air and thermal barrier over the open floor space area in the north attic section (Figure 169). This can be done by simply using rigid board cut to fill in the opening within the same plane as the attic kneewall. Then add batt insulation over this for a total insulation value of at least R19. Another method is to have a contractor familiar with expanding spray foam come to foam insulate the open area on the north side and the east and west sides of the main 2<sup>nd</sup> story floor space. Have the contractor also spray the exposed ends of the bonus room floor cavity inside both attic sections on east and west sides of this room.

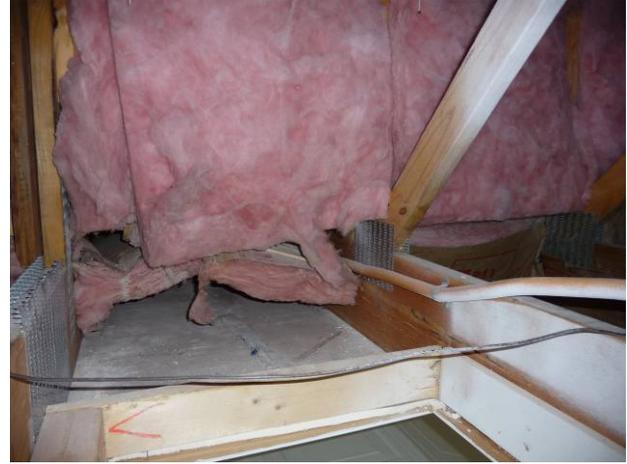
**Figure 170** Open section of bonus room floor space near garage attic access.

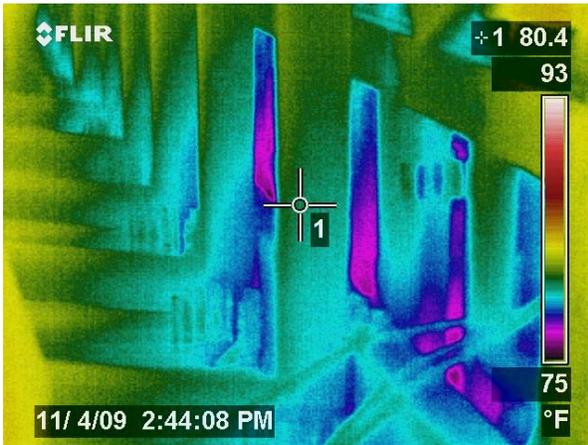
Figures 171 and 172 show an infra-red image taken inside the attic space. Both images show cool floor space air displaced onto lower attic floor areas causing cooling of unconditioned attic. The attic was not nearly as hot as it is during summer weather, but the roof deck of an east exposed roof section shows interior roof temperature of about 93 degrees F in Figure 172.

**Figure 171** IR image of open floor space of 2<sup>nd</sup> story in north facing attic section. Cool floor space air spillage resulting in cooling of unconditioned materials. Indoor temperature 75 deg °F.

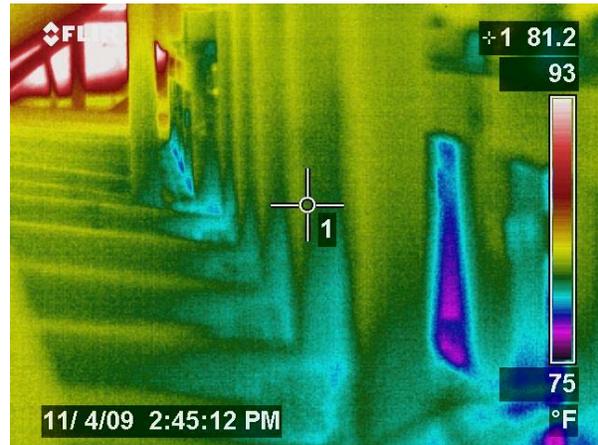
**Figure 172** IR image of open floor space with east hip roof section in background shows roof deck only 93 deg. °F. North attic section about 89 deg. °F.

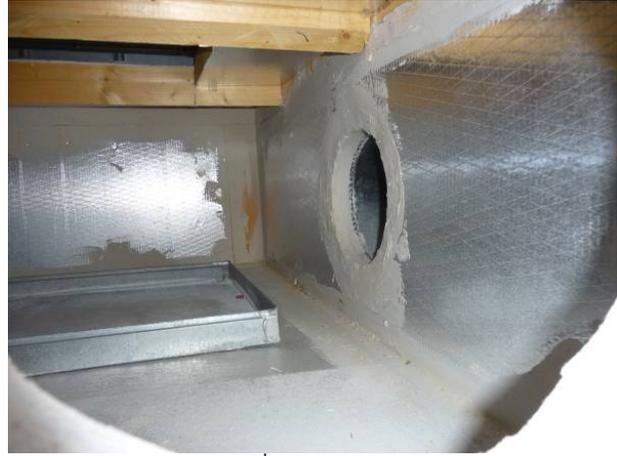
**Figure 175** Inside of 2<sup>nd</sup> story support platform sealed well with mastic on seams and duct connections.

The RLF was measured on the both AC systems. The measured RLF on the first floor system was 8.5%. This means that about 8.5% of the total system airflow was being drawn from outdoors (or unconditioned space). The source of return leakage has been previously discussed. This test was also repeated on the second floor system and found the RLF to be 0.8%. Inspection of this return found that it was sealed well using duct mastic at seams and connections as seen in Figure 175.
