## Partnership for High Performance Housing Draft Final Report

FSEC-CR-1911-12

March 12, 2012

Building America

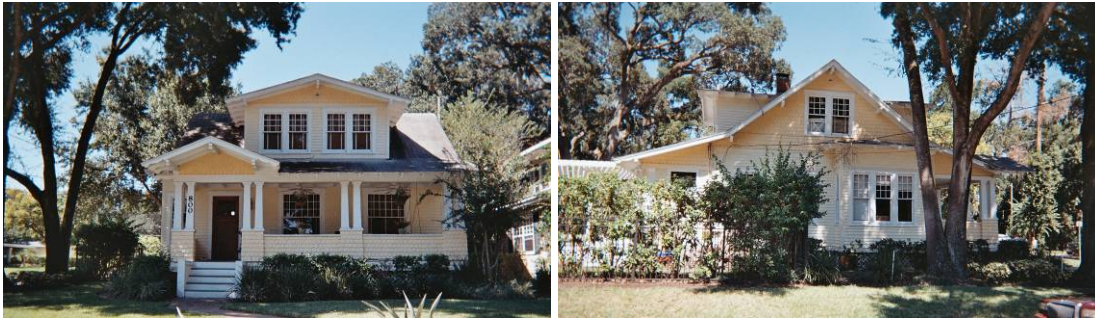
**Figures 2-3. EH-01 front (east) and side (south) facades of Craftsman style retrofit candidate.**

Large double hung windows typical of the Florida vernacular design were designed to promote natural ventilation. The window to floor area ratio is 18.4%. Shading from porches and trees limits direct solar gain; however, the window frames appear to be a large source of infiltration. Specifically, the penetrations in the window frames that allow movement of the corded weights that raise and lower the heavy windows must be left open to facilitate function. During the blower door test, air flow at these points and around electrical switch and outlet plates was the most notable.

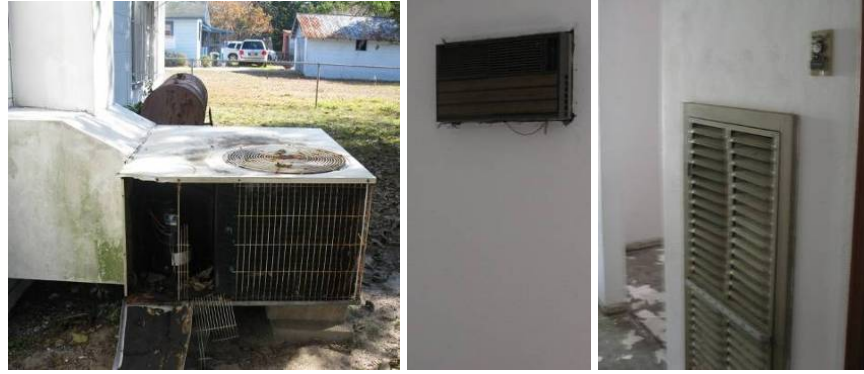
- a forced air, SEER 10, package unit central air conditioner with electric resistance heating,
- two older air conditioner window units, and
- an old abandoned furnace built into an interior wall.

**Figures 7-9. EH-02 pre-retrofit package unit (left), wall unit (center), abandoned furnace (right)**

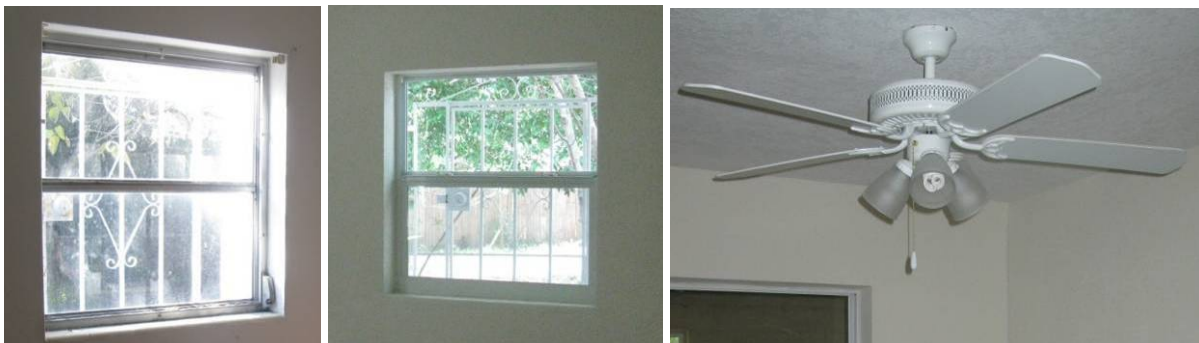
**Figures 10-12. EH-02 pre-retrofit awning window (left), post-retrofit Low-E (center), post-retrofit fan with compact fluorescent light bulbs (CFLs) (right).**

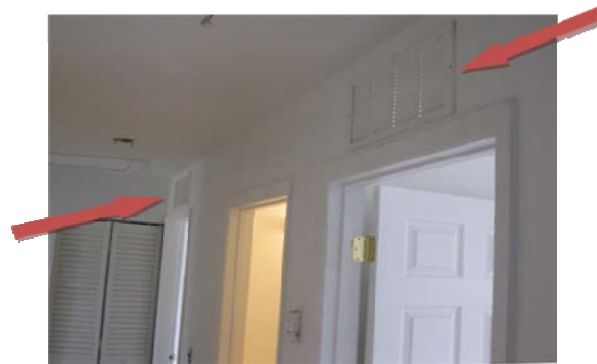
slightly depressurized (-0.5 pa), and there was not excessive pressure built up in any of the bedrooms. Therefore, the existing above door transfer grilles are doing an adequate job of balancing mechanically induced house pressures. See Table 16 for a summary of the post-retrofit pressure mapping results. Figure 17 is a picture of above door transfer grilles.

**Figure 17. Retrofit EH-03. Above door transfer grilles.**

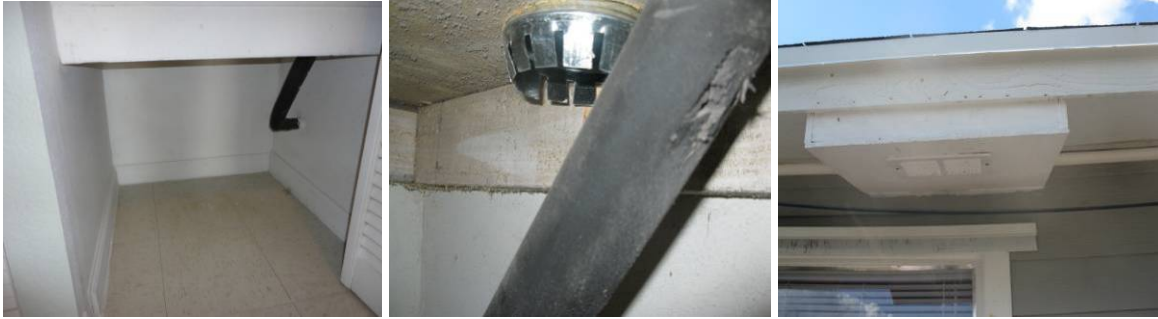
**Figures 18-20. EH-03 pre-retrofit return plenum (left), outside air ducted into the post-retrofit return plenum (middle), soffit retrofit for the air intake (right)**

As noted earlier, the existing mechanical system was determined to have several years of useful life and was not slated for replacement. The partner agreed to work with researchers, however, to bring fresh air into the home via the mechanical system. Our recommended passive, runtime ventilation strategy involves connecting duct work from the outside into the return plenum near the air handler where it is mixed with house air when the system is running. The outside air is drawn through an inlet mounted in the soffit. In this design, the outside air is being filtered at the entry to the air handler rather than at the soffit. We have found partners, in general, are reluctant to install filter back grilles in the soffit for the outside air. The filter-back component requires depth at the soffit to accommodate a manufactured or fabricated boot. For low pitch, there is not adequate vertical space to accommodate this component. Additionally, partners are skeptical that residents will replace an outside filter. The reasoning seems to be concern over general awareness of the filter in the long term as well as lack of availability of correct size filters from the retail outlets. Since the outside air must be filtered prior to crossing the cooling coil, the configuration implemented in this house has been accepted. An insect screen however was provided at the intake. Figures 18-20 show images of this installation.

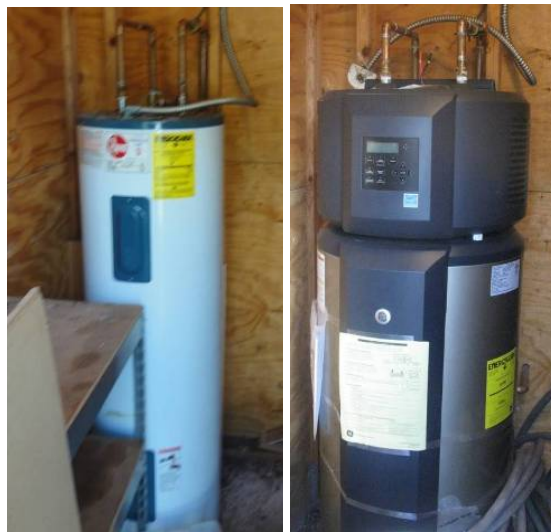
**Figures 21-22. EH-03 pre-retrofit electric tank water heater, EF = 0.88 (left), hybrid heat pump water heater, COP = 2.35 (right)**

The attached, unconditioned storage room measuring 7'x 8'x 9', was large enough to house a heat pump water heater. The installation of the hybrid water heater with heat pump (Figures 21-22) in this location has the added benefit of dehumidifying and cooling this storage area and the attic, which the room is open to.

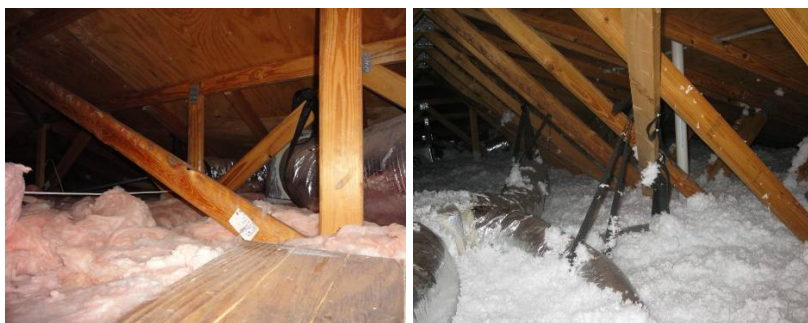
**Figures 23-24. EH-03 pre-retrofit (left) and post-retrofit (right) ceiling insulation**

The existing ceiling insulation was comprised of R-19 fiberglass batts laid on top of the ceiling drywall. Blown-in fiberglass insulation was added to the existing batt, yielding R-38 total. Figures 23-24 illustrate the pre- and post-retrofit ceiling insulation.

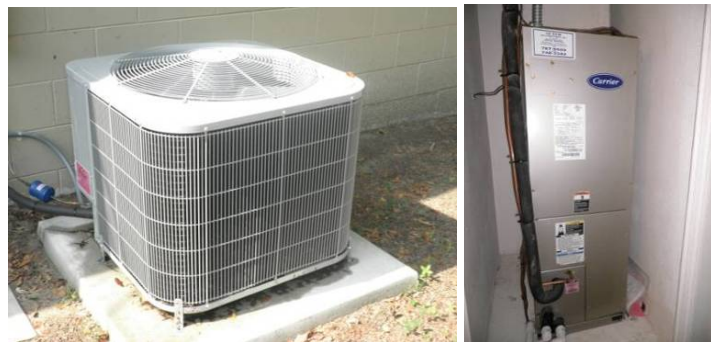
**Figures 27-28. EH-04. Replacing the 9 SEER air conditioner and gas furnace with a 13 SEER heat pump accounted for the greatest reduction in estimated annual energy cost (\$277) of any single measure in this project.**

The mechanical contractor did not itemize the cost for duct sealing and construction of the air handler closet and return plenum from the total HVAC replacement cost, which included a two ton SEER 13 heat pump (Figures 27-28). Duct leakage was the second most significant repair, reducing the HERS Index by 16 points and saving an estimated \$207 in annual energy costs.

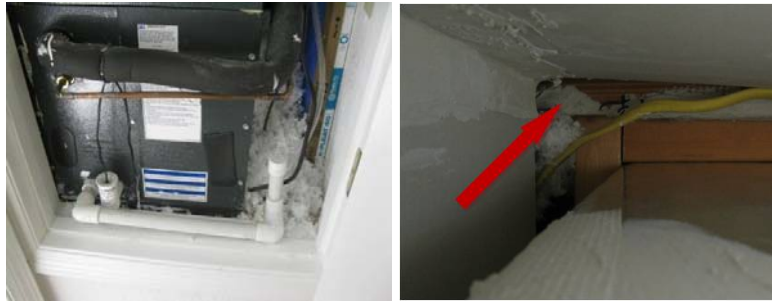
Working with limited air-handler closet space proved to be a challenge for the mechanical contractor. Unsealed holes in the ceiling of the air handler closet resulted in ceiling insulation to being pulled into the air handler closet when the mechanical system was running (Figures 41-42). Leaving a large hole in the closet is a result of poor quality assurance. Although researchers offered to retest the home, the partner declined post-corrective testing. The subcontractor returned to correct this installation. In contrast, the new return air plenum was notably well constructed by reversing the duct board (shiny side in) and sealing all seams well with mastic (Figure 43). This achieves an adequately sealed plenum; however, when researchers discussed this approach with engineering staff at one manufacturer and no known problems with this installation were in evidence; however, two concerns were raised. First, this approach is not consistent with manufacturer guidance on product use and therefore would likely not be supported in the case of a dispute involving the product in this configuration. Second, the foil side is a vapor flow retarder which should not be on the cold side of the assembly. This installation is inside the conditioned space so that the temperature and moisture conditions on

**Figures 41-42. EH-07. White attic insulation around air handler (left) fell through spaces in the closet ceiling (right, looking up at closet ceiling framing).**

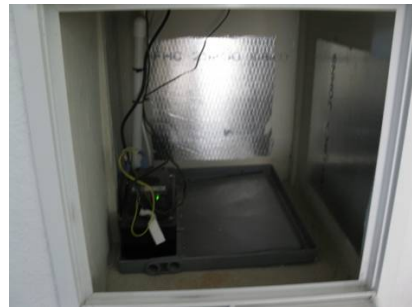
**Figure 43. EH-07. New return air plenum constructed of foil faced duct board, shiny side facing in.**

Testing of the new duct work found higher than expected leakage, especially considering the apparently well sealed return plenum. Researchers performed pressure pan diagnostics. The results of this test pointed to leakage at the small, cramped supply registers at the entrance into the enclosed porch. Inadequate work space prevented the contractor from addressing the problems near this register. Findings are presented in Table 28.

Researchers informed the partner of the pressure pan and the pressure mapping results and recommended correction action. Citing inaccessibility to the problem registers and plans for immediate occupancy of the home, the partner was unable to address either issue.

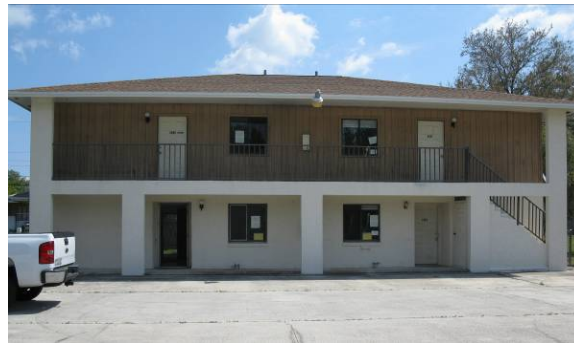
**Figure 44. EH-08-11 pre-retrofit, renovation is still in progress**

A test-in survey revealed a building with three antiquated, SEER 8 central air conditioners with electric resistance heating combined with extremely leaky duct systems ( $Q_n \text{ out} > 0.25$ ), and one replacement unit with a SEER 13 heat pump and new, fairly tight duct work. An older, 30-gallon electric water heater was installed on the interior of the units. There was shingle roof clearly at the end of its useful life. Attic insulation levels were assumed to be R-19 based on construction date because there was no attic access. Block was modeled as uninsulated, and frame walls were R-11. There were single-pane metal windows, and the ground floor units had rear-located sliding glass doors. In addition, the lighting was predominantly incandescent, and there were old, standard refrigerators in the units. The floors were wall-to-wall carpet with vinyl in the baths and kitchens.

The partner's scope of work specified high-efficiency heat pumps (SEER 16) including new ducts, a metal roof, new ENERGY STAR windows, increased attic insulation, tile flooring, and appliance replacement. Building America analysis highlighted several areas of the partner's specifications that needed refinement. Sliding glass door specifications were not called out. Furthermore, the color of the metal roof, the appliance efficiencies, and the tightness of the duct system were not specified. Building America (BA) recommendations are reflected in Table 32. Implementation of these measures is expected to reduce energy costs between \$509 and \$1,385, depending on the condition during test-in and which floor the unit is on.

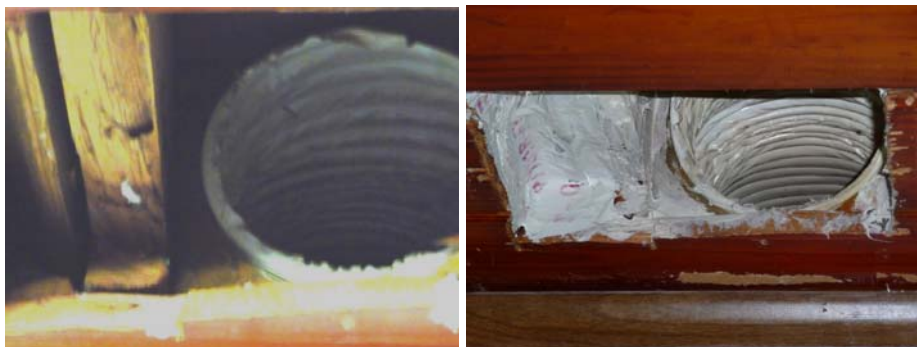
One remaining problem after rehab was the leaky cathedral roof. This area was converted from a porch to part of the living space. The soffits are vented, allowing outside air to infiltrate into the roof cavity with ease. The ACH50 post-rehab was still very high, although the rehab resulted in the ACH50 being reduced by more than half (from 34 to 16). Additional problems with this area were found in the duct system. Three supply ducts run to this area and were reused from the old, in-place duct system. These supplies were installed without using traditional “boots”. The duct was merely pulled into the ceiling cavity and allowed to blow cool air in the general direction of the porch space. Mid-point testing found this problem (Figure 47, left). The HVAC contractor repaired these three supplies by slathering mastic around the area (Figure 48, right), which created a better seal and resulted in a Qn out of 0.05.

**Figures 47-48. Pre and post rehab porch supply registers**

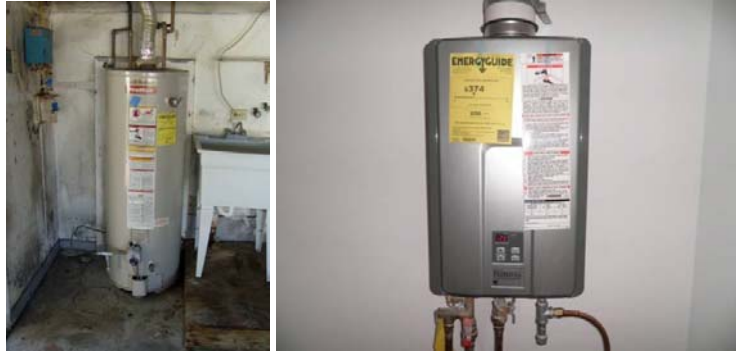
The water heater was a 50-gallon natural gas storage tank (EF 0.58) located in the detached garage (Figures 51-52). A complete list of the test-in conditions for this house is available in the analysis spreadsheet (see Appendix A). The HERS Index of the “as found” house was 122, with an estimated annual energy cost of \$3,045.

**Figures 51-52. EH-14. Switching from an exterior located gas hot water tank (left photo) to an interior mounted instantaneous tank reduced the HERS Index by 7 points and saved an estimated \$491/yr in energy use.**

A single layer of radiant barrier was installed on the interior side of all exterior walls, and the block cores were filled with injected foam insulation. The exterior was finished with an elastomeric white paint. The single-pane windows and sliding glass doors were replaced with vinyl ENERGY STAR rated double-pane glass with a U value of 0.28 and SHGC of 0.21. The gas water heater was removed from the garage and replaced with an interior mounted-on instantaneous gas water heater rated at 0.82 EF.

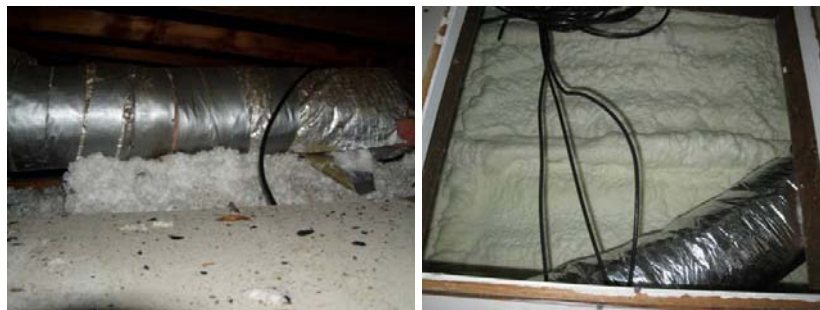
The old duct system (Figure 53, left) was replaced with R-6 flex duct, and the location of the supply ducts was brought inside by the realignment of the thermal boundary with foam (Figure 54, right). These combined renovations reduced duct leakage to  $Q_n \text{ out} = 0.006$ . Window replacement and insulation of the roof deck helped substantially tighten the house. Air infiltration was reduced from an estimated ACH50 of 22 (based on results of audits conducted in a different study) to an ACH50 of 1.99, well below the threshold that outside air would be recommended. However, no outside air provisions were implemented.

**Figures 53-54. EH-14. Old duct work with blown-in ceiling insulation pre-retrofit (Left Photo). Looking up at insulated roof deck with new ductwork inspected prior to hanging sheetrock ceiling (Right photo).**

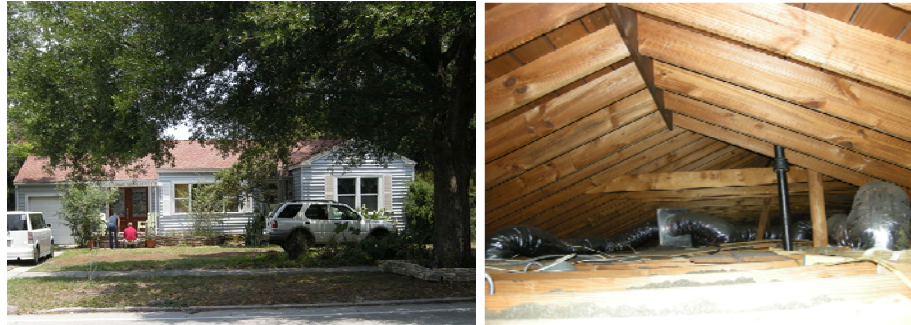
The home is well shaded on the east, south, and west faces, though the homeowner reports some discomfort on the south side of the house in the summer months and some general dissatisfaction with overall comfort. Average electric bills reported by the owners indicate \$160 to \$300 monthly for two occupants. This appears to be somewhat higher than the simulation, which includes three occupants (number of bedrooms plus one). However, the owners have not provided utility bills, so an annual total is not available. Researchers suspect that the uncontrolled air flow described below may be spurring energy use to maintain comfort conditions.

**Figures 56-57. EH-15. As found home (left). Attic insulation, head room, and roof framing (right).**

Measures influencing energy efficiency would reduce the annual energy use and cost for this home. Measures recommended at this time (Table 42) include installing R-38 (total) ceiling insulation, replacing recessed lighting fixtures with ICAT rated units (must be done prior to ceiling insulation addition), converting 80% of lighting fixtures to fluorescent bulbs, repairing damaged ducts, elevating duct runs above anticipated ceiling insulation height, and reducing infiltration by 50%. Caveats regarding the duct repair and air sealing are discussed below.

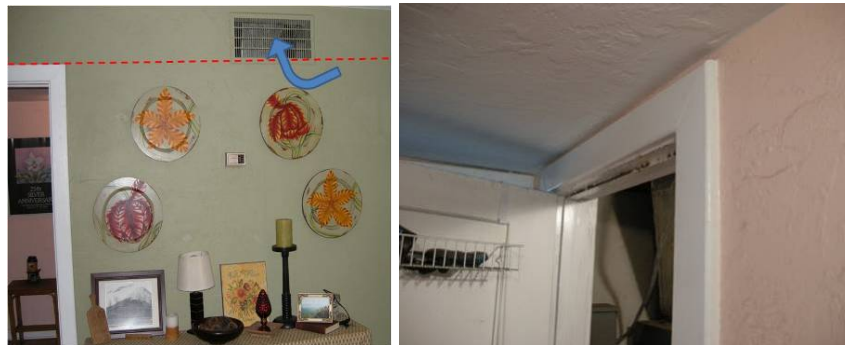
There appear to be other, deliberate passive return air flow pathways into the closet, probably from a previous mechanical system installation. These air flow pathways are apparent from adjacent rooms as wall mounted registers. Registers in rooms further away may be connected to the closet via a furred down duct chase in the hall (Figures 62-63). It is unclear how much of this passive return system is still fully connected to the rooms, though it is clearly visible from some rooms. During operation of the air handler, it is likely that depressurization of the closet is drawing air through this passive return system not only from the connected rooms but also from the adjacent attic and the interior wall cavities.

**Figures 62-63. EH-15. This wall-mounted passive return air register (left) is connected to a furred down duct chase on the other side of the wall. The bottom of the chase, indicated by the dashed line, forms the ceiling of the adjacent hallway (right).**

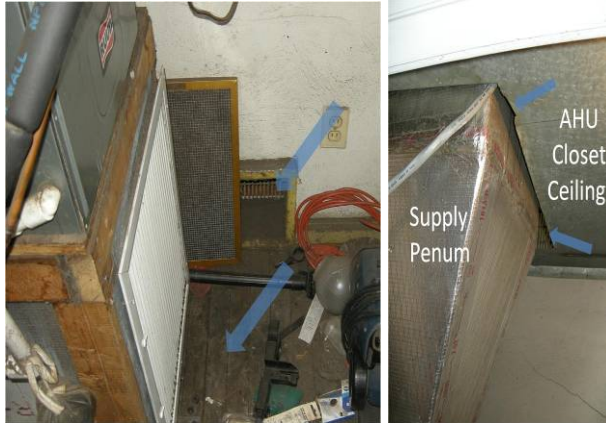
**Figures 64-65. EH-15. Uncontrolled air flow pathways in wall and floor (left) and ceiling (of closet surrounding return air plenum).**

The closet (Figures 64-65 above) also has visible air flow pathways into the attic that are not part of the passive return configuration. These pathways, as well as the passive return air system, seem to be obvious targets for improving the integrity of the house's air barrier. The practicality of identifying and eliminating the complex air flow paths would require further investigation.

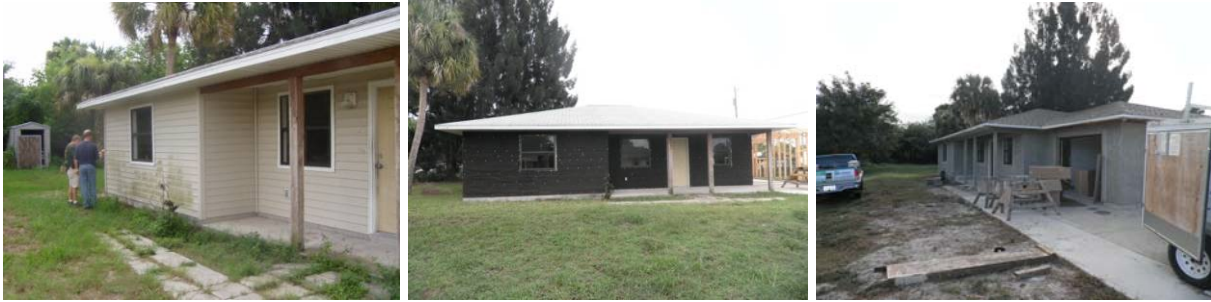
At the time of test-in, sheetrock had been removed from the lower half of all exterior walls exposing the fiberglass insulation. Mold was observed along the bottom wall plate and in the lower half of the stud bays. As a result, a blower door test was not conducted, and BA default values for infiltration were used to formulate the initial HERS Index of 107. The outside HVAC compressor was missing at the time of test-in, but was reported to be a SEER 12, 2-ton unit with interior air handler and electric resistance heating. Windows are single-pane, clear glass. The walls are insulated with R-13 fiberglass batts, and the ceiling is insulated with blown-in fiberglass insulation to R-19. The distribution system consisted of a single return with supply ducts (R-6 flex ducts) located in the vented attic. The duct system was dismantled during test-in and default values were used for duct tightness calculations. Domestic hot water is supplied by a 40-gallon electric water heater with an EF = 0.92. More detail on the "as found", minimal improvement and deep energy retrofit measures is available in Table 46.

**Figures 69-71. EH-17 pre-retrofit (left) midpoint-retrofit (center), December progress (right)**

Measures recommended in the deep energy retrofit package include increasing attic insulation to R-38, replacing exterior doors with insulated doors ( $U=0.21$ ), installing a SEER 14 HVAC heat pump (HSPF 8.5), reducing duct leakage -  $Q_n$  out = 0.04, installing an ENERGY STAR heat pump water heater with COP of 2.3, and installing a minimum of 80% CFL lighting. Implementation of these measures would result in a HERS Index of 62, a 42% reduction, and a projected savings in annual energy costs of \$683/yr. A detailed list of the improvement measures can be found in Table 46. Saving and HERS reduction of the individual improvements are located in Appendix A of this report.

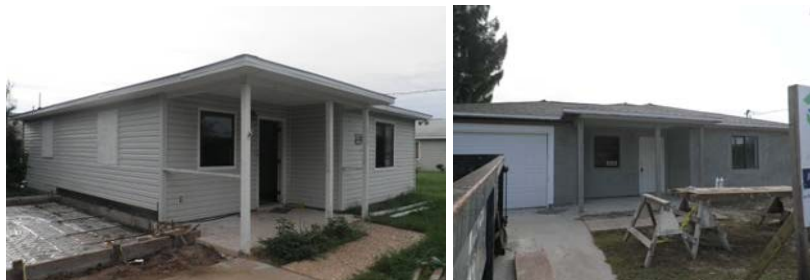
The initial HERS Index for this house was 97. The outside HVAC compressor was missing at the time of test in; however, it was reported to be a SEER 12, 2-ton unit with interior air handler and electric resistance heating. Windows are single-pane clear glass, walls are insulated with R -13 fiberglass batts, and the ceiling is insulated with blown-in fiberglass insulation to R-24. The distribution system consisted of a single return with supply ducts (R-6 flex ducts) located in the vented attic. Total duct leakage (Qn, total) measured 0.125, and leakage to outside (Qn, out) was 0.065. Domestic hot water is supplied by a 40-gallon electric water heater with an EF = 0.92. More detail on the “as found”, minimal improvement and deep energy retrofit measures is shown in Table 49.

**Figures 72-73. EH-18 pre-retrofit (left) and midpoint-retrofit (right).**

Measures recommended in the deep energy retrofit package include R-38 ceiling insulation, reduced whole house infiltration to ACH50  $\leq 6.0$ , installation of a SEER 14 HVAC system with 8.5 HSPF heat pump, window replacement with ENERGY STAR, low-E windows,  $U = < 0.60$ ,  $SHGC = < 0.27$ , and installation of an ENERGY STAR heat pump water heater with a COP of 2.3. Implementation of these measures would result in a HERS Index of 59, a 37% reduction, and save an estimated \$342 on annual energy costs from minimal improvements required by Florida building code. Table 48 details the anticipated savings of the recommended improvement measures.

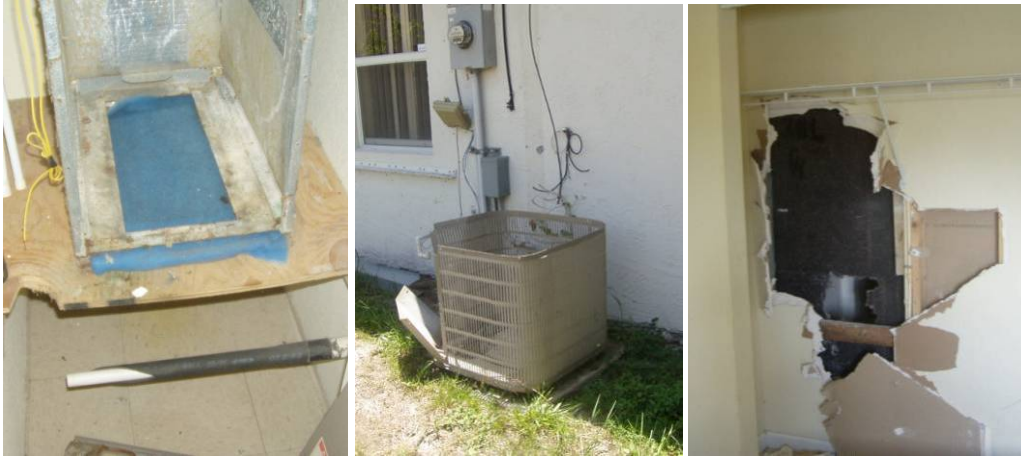
**Figures 76-78. EH-19 pre-retrofit air handler (left), compressor (center), interior wall destruction (right)**

The air heating and conditioning system was a central, forced air system with a SEER 12 air conditioner and electric resistance heating (Figures 76-77). The property had been vandalized and some materials stolen (Figure 78). Both the air handler and the compressor had been gutted, and the bathrooms and the laundry area had large wall penetrations where plumbing lines had been removed. Since the envelope was compromised and the air handler was not intact, researchers were unable to conduct whole house leakage and duct leakage tests. In order to perform energy modeling, averages from prior research were used for pre-retrofit whole house air leakage ( $ACH_{50} = 11$ ) and duct leakage ( $Q_{n,out} = 0.13$ ).

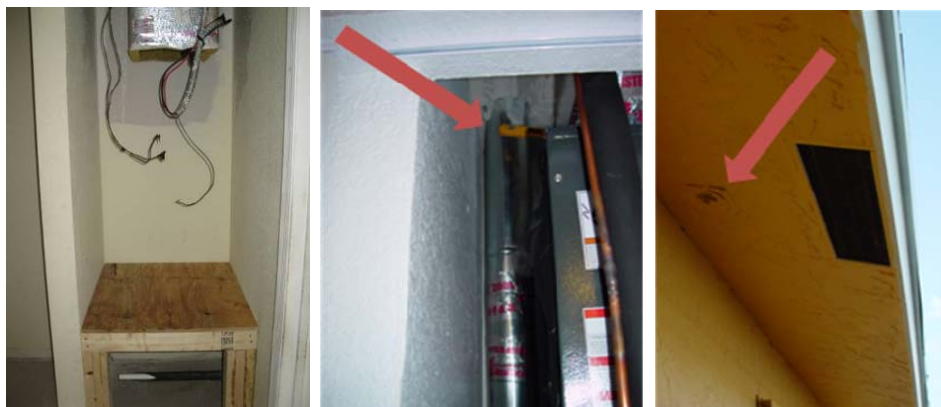
**Figures 82-84. EH-19 mid-point construction of air handler closet (left), post-retrofit incorporation of outside air ventilation into air handler closet (center), post-retrofit return air intake at soffit (right)**

Confined by limited space, the mechanical contractor performed a fair job of retrofitting the air handler cabinet with a platform return, installing the new, larger air handler, and incorporating the outside air runtime ventilation detail. The post-retrofit duct leakage test result was  $Q_{n,out} = 0.052$ ; therefore, the newly constructed platform return was fairly well sealed. However, the access to the plenum remained behind the airflow-restricting louvered doors rather than on the same plane as the hallway wall. The partner incorporated an existing attic ventilation duct into the outside air runtime ventilation scheme. This did not allow filtering at the intake, and the opening was ignored by the painting contractor who painted over it, leaving it partially obstructed. Post-retrofit pictures of the air handler closet and return plenum are shown in Figures 82-84.

Researchers found a couple of problems with this retrofit. The design of the mechanical closet was lacking in that the well-constructed return platform was blocked by airflow-restricting louvered doors, and a lack of central oversight was exemplified by the painting over of the outside air intake.

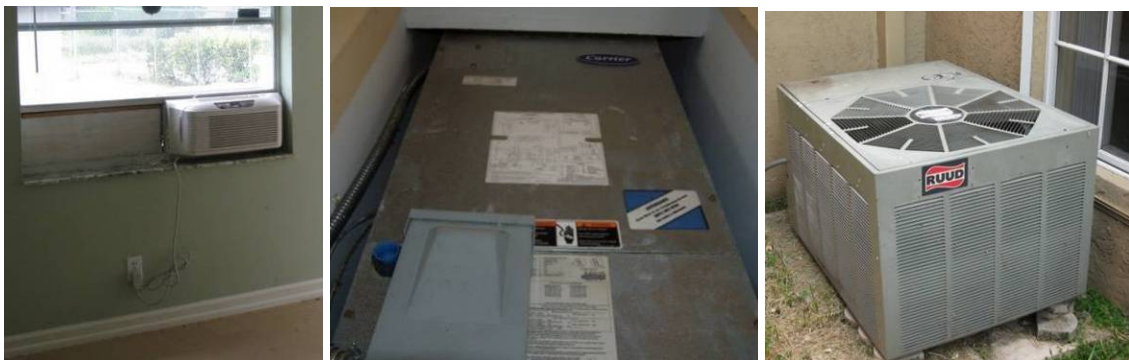
**Figures 93-95. Retrofit EH-21 pre-retrofit wall unit (left), Pre-retrofit condenser (center), pre-retrofit air handler (right)**

The air heating and conditioning systems included a window air conditioning unit and a forced air, SEER 10, central air conditioner with electric resistance heating. The air handler was in a narrow interior closet (Figures 93-95).

Results from the whole house air tightness test were high (ACH50 of 15.05). The air handler closet was a primary source of leakage. Other sources were the small storage compartment under the stairwell and a pocket door into the upstairs bathroom.

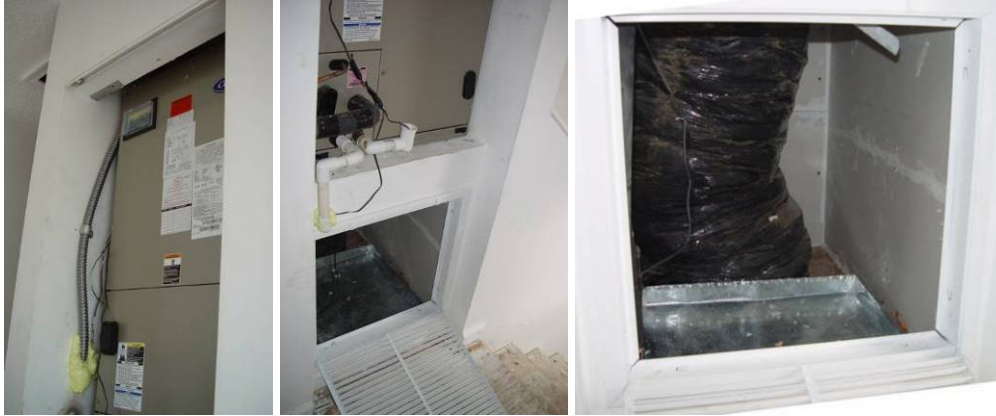
**Figures 98-100. EH-21 post-retrofit air handler closet (left), post-retrofit closet (center), post-retrofit open return with airflow-restricted louvered doors (right)**

The new air handler was installed into the existing, narrow air handler closet, and it proved to be challenging. The mechanical contractor left a hole, roughly 4"x15", between the closet ceiling and the attic. After several failed attempts, the partner successfully patched the gap with a piece of drywall and caulk to seal the seams. The confined space did not allow the partner to incorporate outside air ventilation, a detail they have been incorporating into the other retrofits we partnered on. The mechanical distribution system was poorly designed, with a supply trunk running through the platform return, and this was sealed with caulk, rather than mastic. Access to the return plenum was behind airflow-restricting louvered doors, rather than on the same plane as the hallway wall. Figures 98-100 show post-retrofit pictures of the air handler closet.

The air handler was built into a confined space, and the mechanical contactor failed to patch a large hole leading from mechanical closet ceiling into the attic. Furthermore, a supply trunk running through the return platform and lack of mastic used to seal the plenum seams resulted in

some avoidable duct leakage. This lack of quality assurance and central oversight indicated a gap in the retrofit contracting paradigm.

The post-retrofit duct leakage test results were much improved ( $Q_{n,out} = 0.065$ ), with room for improvement, nonetheless. Researchers suggested that mastic be used to better seal the seams of the return plenum. The whole house leakage ( $ACH50 = 6.15$ ) was drastically improved over the pre-retrofit condition.

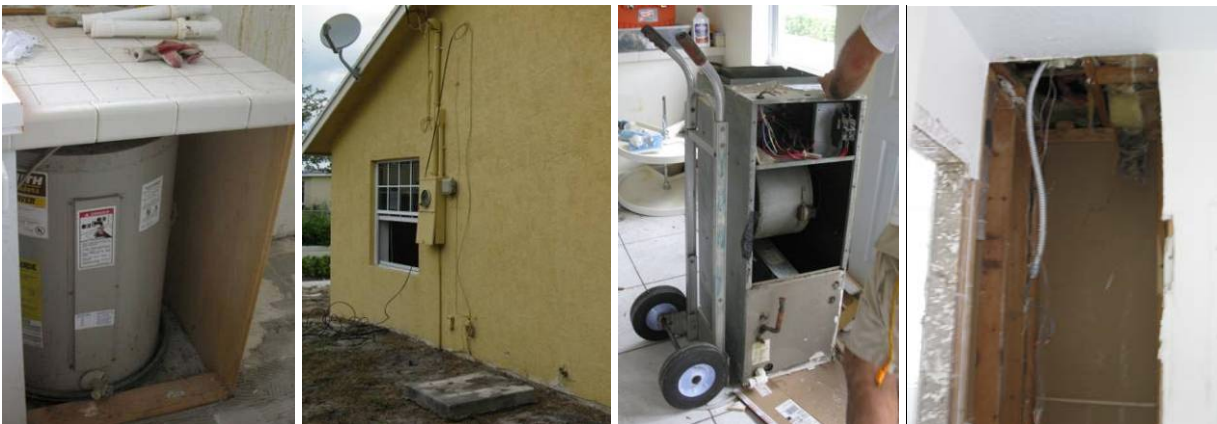
**Figures 103-106. EH-22 pre-retrofit water heater (left), missing compressor (center left), dismantled air handler (center right), air handler closet (right)**

The air heating and conditioning system was a central, forced air system that researchers estimated to be a SEER 10 air conditioner with electric resistance heating. The compressor had been stolen (Figure 104). In addition, the air handler had been disassembled (Figure 105-106) by the partner prior to the house being selected for the study. Broken windows and a missing front door compromised the house envelope. Researchers were unable to conduct whole house leakage and duct leakage tests for the above stated reasons; thus, averages from prior research for pre-retrofit whole house air leakage (ACH50 = 11) and duct leakage ( $Q_{n,out} = 0.13$ ) were used for modeling purposes.

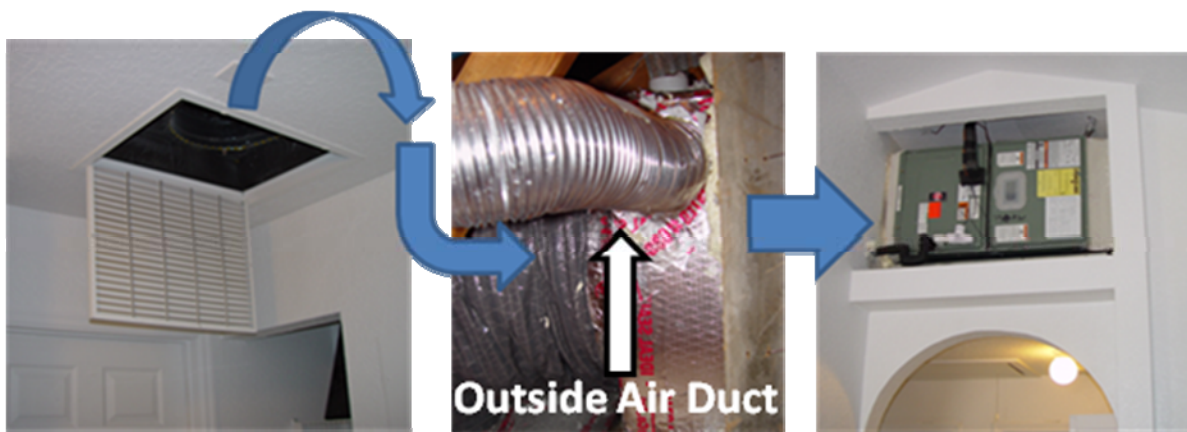
**Figure 107. EH-22 post-retrofit central return (left) outside air intake ducted directly into air handler plenum upstream of return filter (center), air handler mounted internally, adjacent knee wall, with horizontal air flow (right)**

The mechanical system retrofit was this project's most challenging measure. The location of the existing air handler was too small to house the new unit. To keep the air handler in the interior space, the partner used a pedestal area created where the cathedral ceiling meets two knee walls, installing the unit for horizontal air flow. The confined space was not large enough to incorporate a return; rather a single return was installed in the adjacent attic space. (Figure 107) Despite a difficult configuration, the partner attempted to incorporate outside air via runtime ventilation. The system design failed in three areas, however: First, the outside air damper worked in reverse pulling shut during system run time. Second, no interior occupant control was present, nor was installing one aesthetically feasible since the outside air duct never entered the interior space. Third, the outside air entered the system unfiltered since there was no filter at intake, and the outside air duct entered the return plenum, downstream of the return filter.

Since the house was not exceptionally tight, and because an aesthetically pleasing solution was unlikely, researchers decided the best course of action was to abandon the attempt to incorporate outside air. With partner agreement, researchers assisted the partner with a method for disabling the outside air, which included removing the duct at the entrance into the plenum and at the intake. The plenum was patched with a snugly fitting piece of duct board cut the same dimensions as the hole; seams were then sealed with mesh and mastic. The intake collar was taped over with UL 181 rated tape.
