Uncontrolled Air Flow in Non-Residential Buildings

Final Report

FSEC-CR-878-96 April 15, 1996

Hondo Solar Energy Center 1679 Clearlake Road Cocoa, FL 32922-5703 Prepared by: James B. Cummings Charles R. Withers Neil Moyer Philip Fairey Bruce McKendry

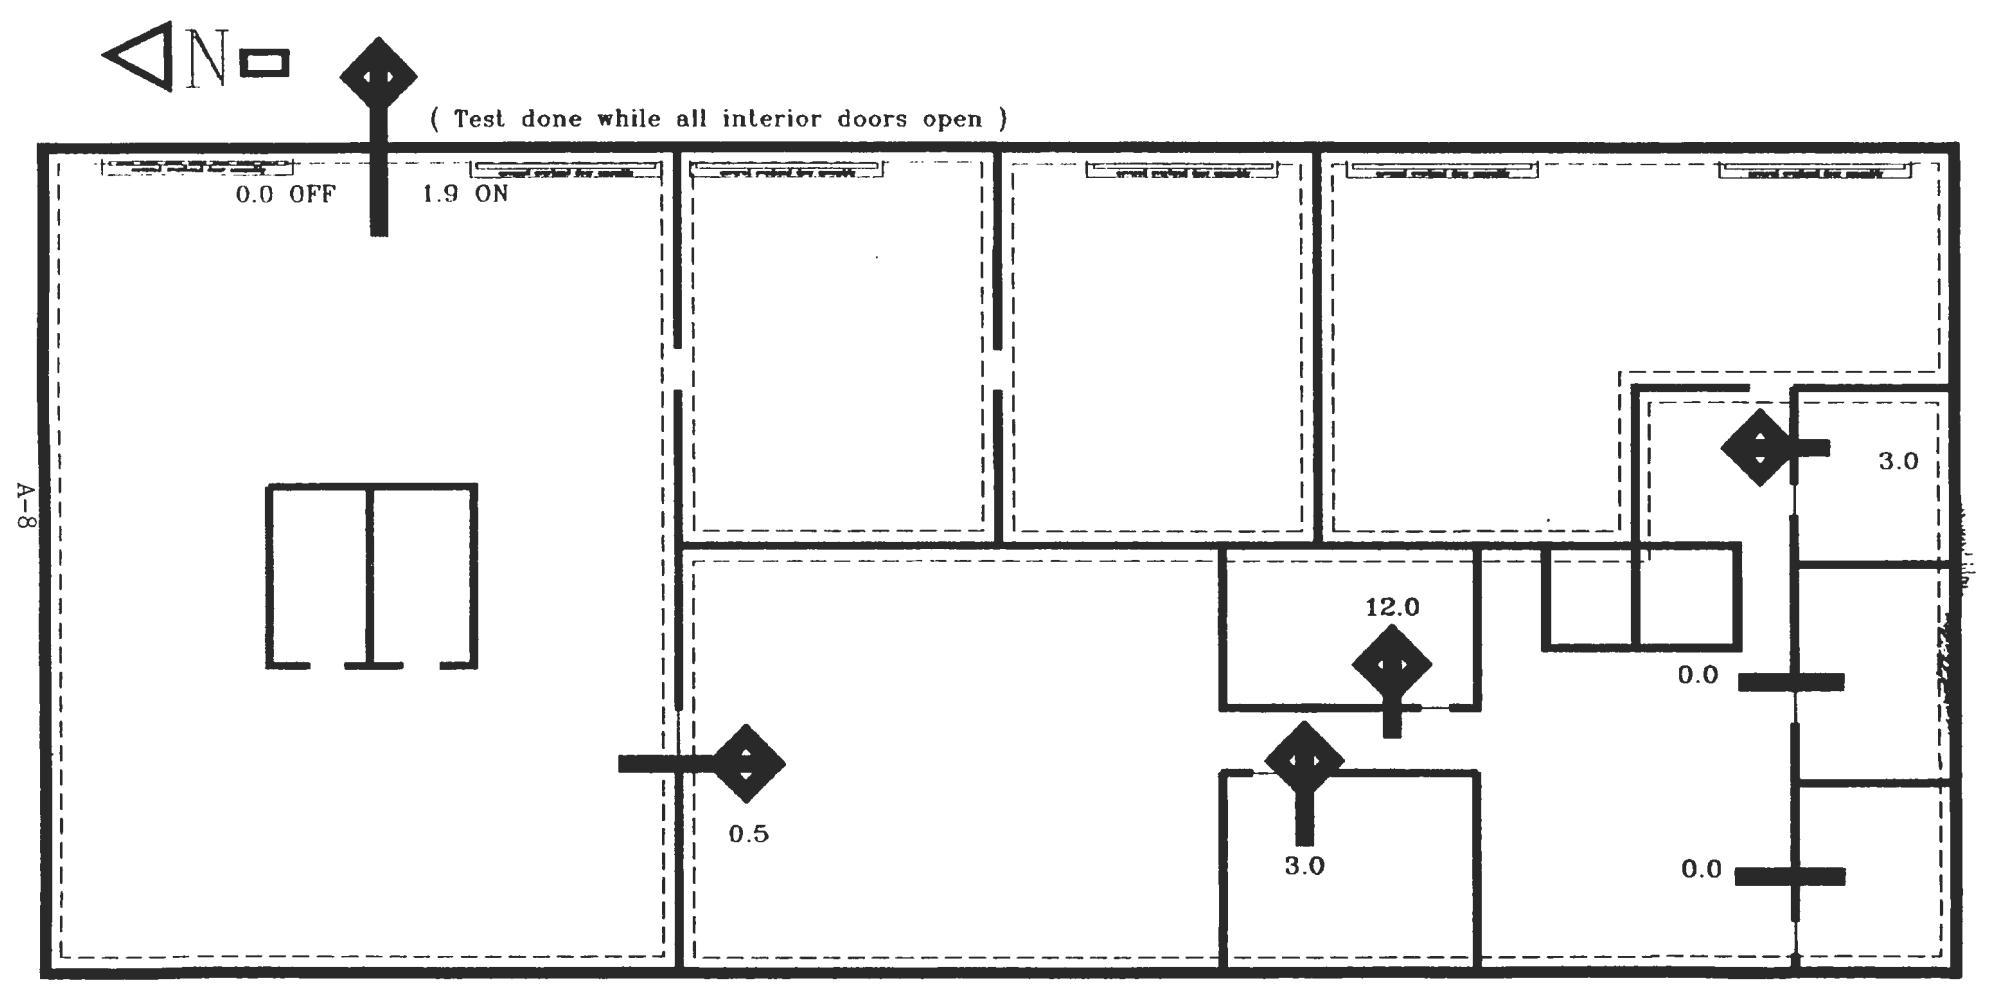
C: Return main flex 50% disconnected from unit

B: 12" flex dropped from main supply duct Measured flow from main = 785 cfm D: Flex duct with many kinks

Pressures created with Air Handlers operating

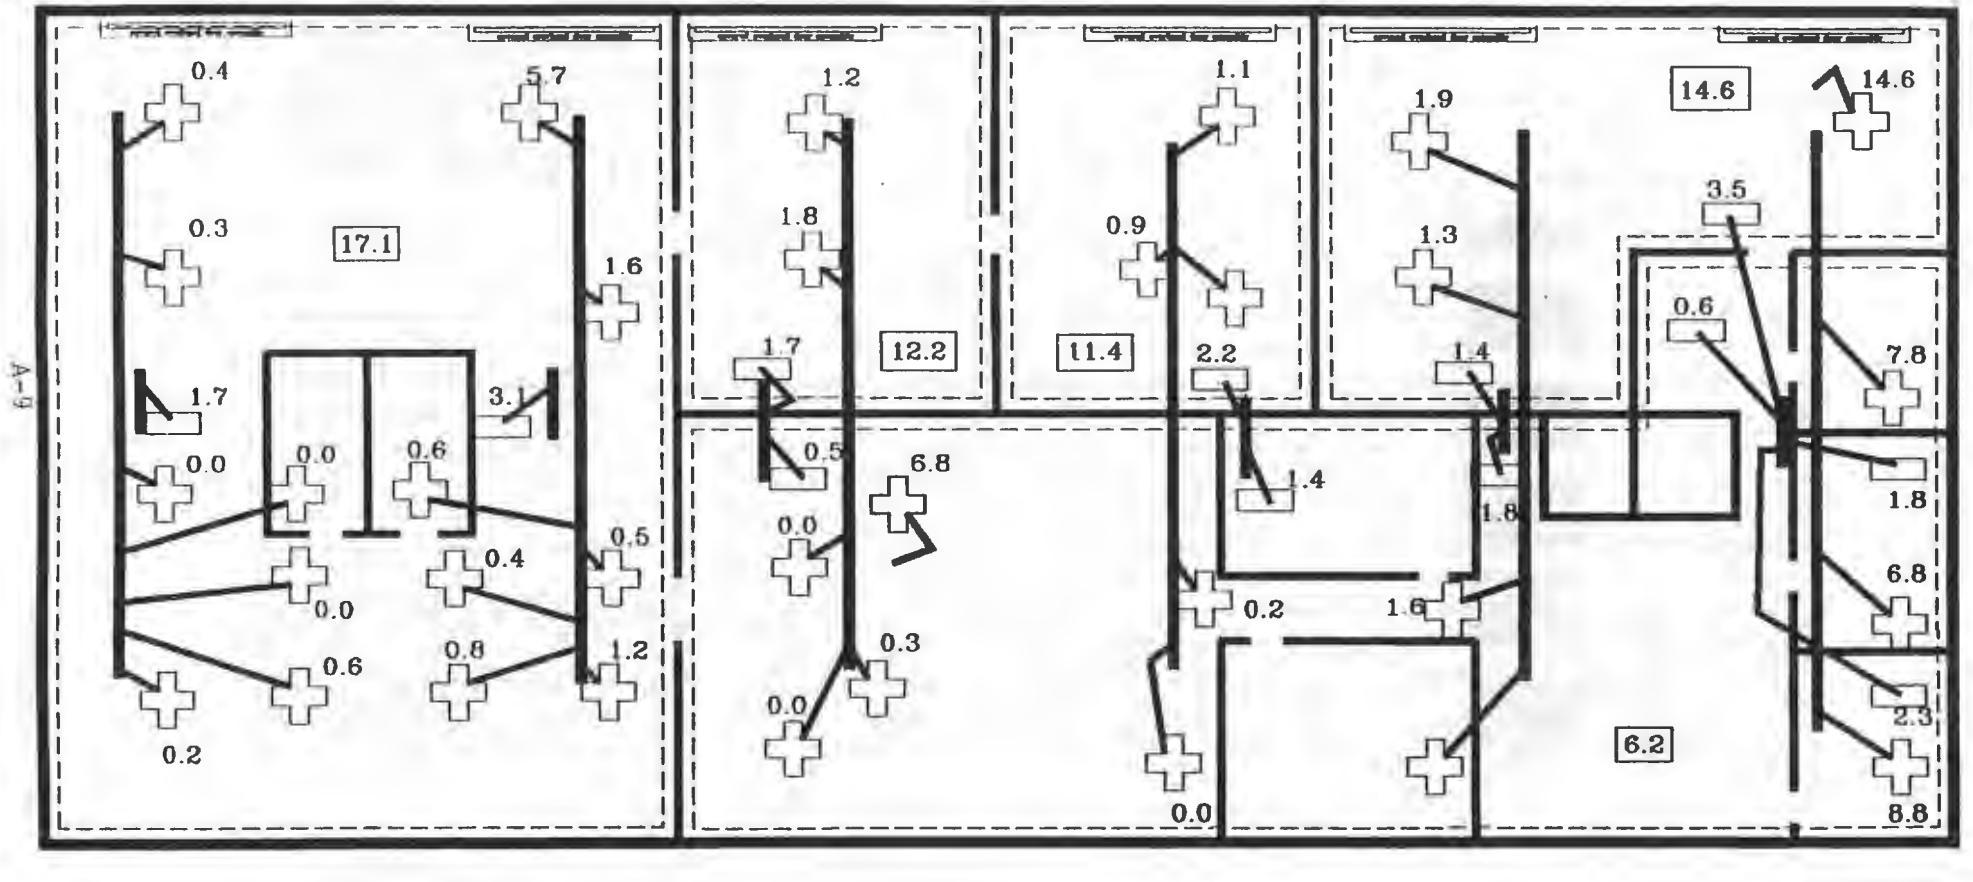
Pressure Pan readings with building depressurized to 25 pascals
