# **Opportunities for Energy Conservation and Improved Comfort From Wind Washing Retrofits in Two-Story Homes - Part II**

FSEC-PF-450-10

September, 2010

Charles Withers  
James Cummings

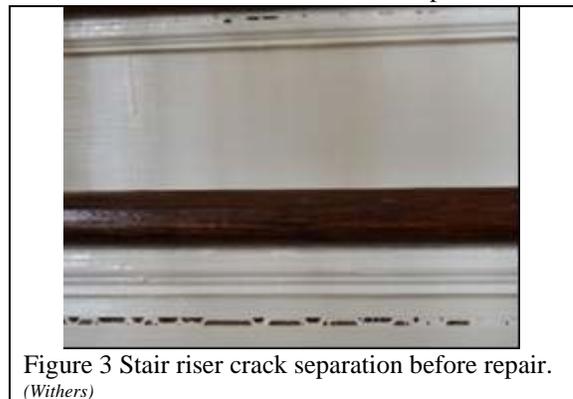
The homeowner also brought to our attention warping and cracking of the grand staircase in the front foyer of the home. Upon inspection it became clear that the rear of this staircase could be well-connected to the interstitial floor cavities which are well-vented to the west-facing soffits. We hypothesize that prevailing winds (coming from the east from the nearby ocean) drive moist outdoor air into the interstitial floor cavities where it interfaces with the backside of the stair case promoting warping and separation of the wooden risers and treads as wood adsorbs moisture. Figure 3 illustrates cracking of the wooden risers. Wood moisture content was measured with a moisture meter before repair and

was found to vary from 13.1% moisture content at the top of stairs down to 9.5% moisture content towards the bottom of the stairs. The average moisture content of wood in the staircase before retrofit was 10.9%. By comparison, wood furniture inside the home had a moisture content around 7.5% to 8%, within expectations for wood located in a humidity controlled environment. The average wood moisture declined from 10.9% to 9.0% after retrofit. Cracks in the stairs, which were quite prominent prior to repair, had nearly closed within about 6 weeks of the wind washing repairs.

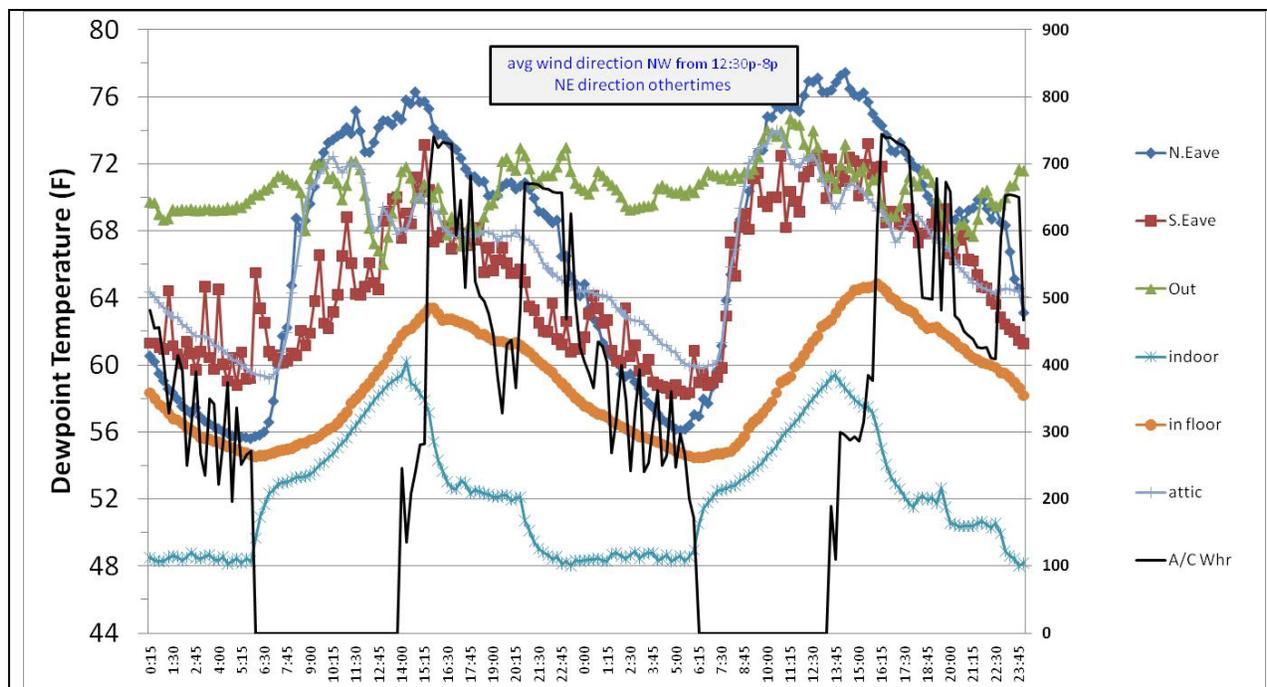
Figure 17 Graph of H11C dew point temperatures and A/C energy over two days shows patterns between A/C runtime and cool dry air from indoors making its way out to the soffit eave areas. Right Y-Axis is cooling energy in Watt-hours.

Swings in dew point temperatures can also be (unexpectedly) seen in various building cavities and buffer zones that are not normally conditioned. First, we notice that the attic dew point temperature dropped substantially during the period that the AC system runs, declining from about 72°F to about 60°F. Similar patterns can be observed for the north eave and the south eave. Additionally, the floor cavity also modulates up and down, following a pattern that is part way between the conditions at the eave vents and indoors, illustrating the fact that the floor cavities are well connected to outdoors and to unconditioned buffer zones of the house.

It appears from this, that duct leakage is creating a mechanical driving force that displaces air through the floor cavities into the eaves and attic spaces. Additionally, it is known that the wind pushes air from the floor cavities into the eaves. On three different occasions, researchers felt and measured (temperature and RH) pulses of cool dry air that were being pushed into the south eave space. These pulses coincided with significant wind from the north at times when the air handler was off.

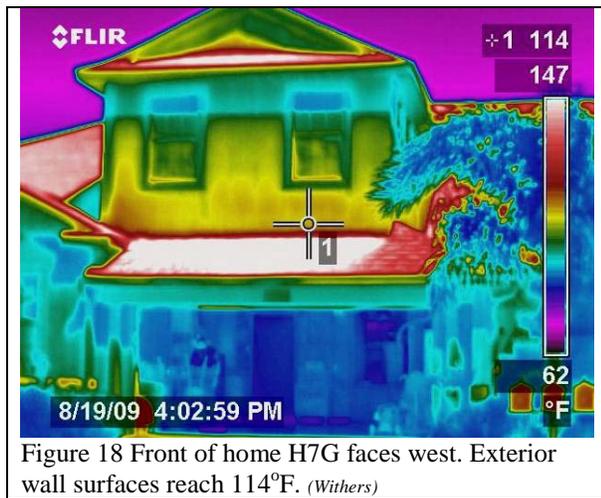
Figure 18 Front of home H7G faces west. Exterior wall surfaces reach 114°F. (Withers)

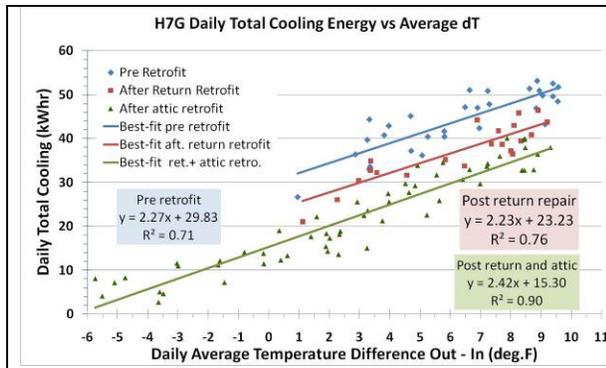
Duct repair and wind washing repairs each produced substantial energy savings. Based upon the annual energy analysis (using TMY data), duct repair produced 2,207 kWh in energy savings (24.7%; \$257) per year. Implementation of wind washing repairs produced another 2,232 kWh energy savings (33.1%; \$254) per year. Combined, the duct repair and the wind washing repair reduced annual space cooling energy use by 49.6% (Figure 22).

Figure 22 H7G cooling vs. temperature difference for pre-repair, for post duct repair, and for post wind washing repair.
