# Effective Floor Cavity and Knee Wall Construction Techniques in Two-Story Homes in Hot Climates

FSEC-PF-467-16

ASHRAE Thermal Performance of the Exterior Envelopes of Whole Buildings XIII  
International Conference, Clearwater, FL – December 2016

Charles R. Withers, Jr.

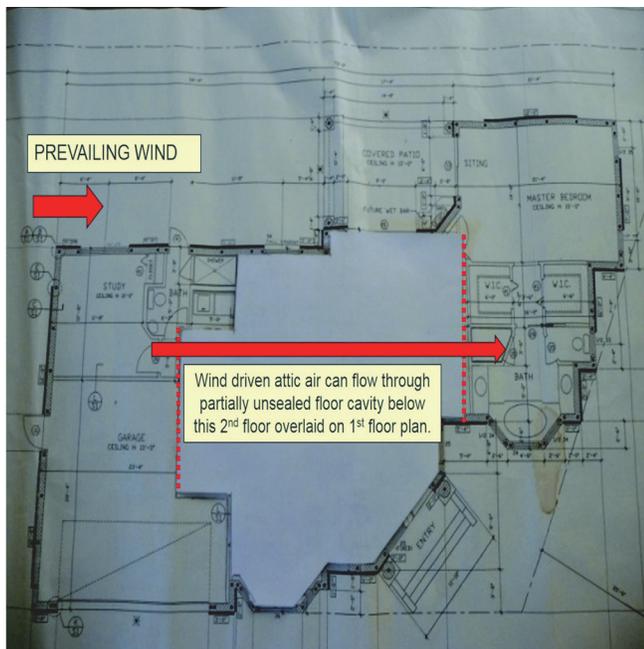
**Figure 1** (a) Conceptual illustration of wind washing through floor cavity shown on a floor plan. (b) View from within attic of poorly insulated knee wall and floor cavity with areas of missing and compressed batts. Batts were dirty from years of air movement across them. Attic soffit vent is nearby in dark left region of photo.
