Energy Retrofit Field Study and Best Practices in a **Hot-Humid Climate**

J. McIlvaine, K. Sutherland, and E. Martin Building America Partnership for Improved Residential Construction

March 2013

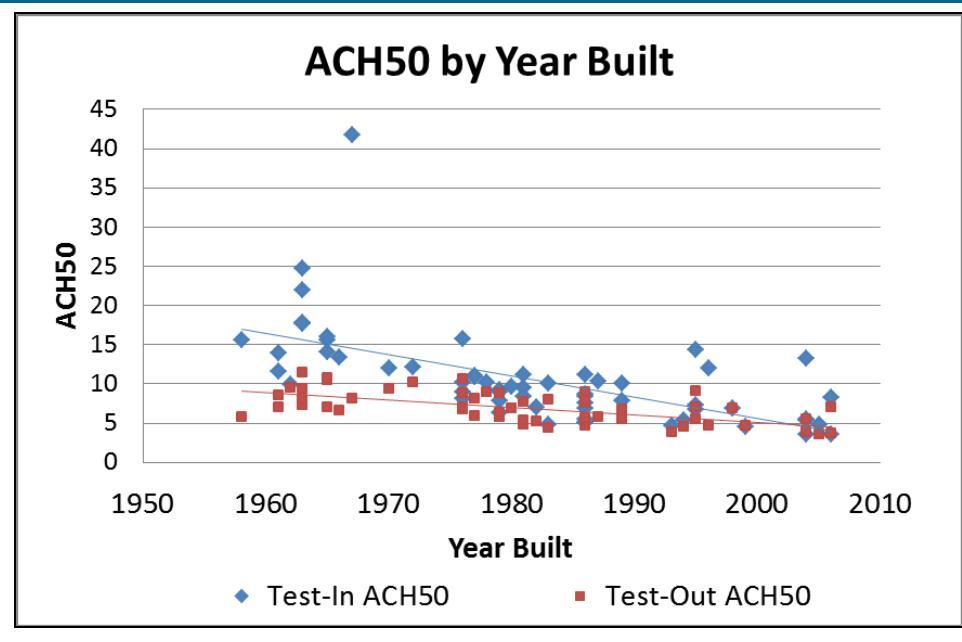
Figure 15. Scatter plot for whole-house airtightness test results (ACH50) by vintage for homes tested pre- and post-retrofit (n = 59)

For the 59 homes, pre-retrofit ACH50 ranged from 3.6 to 41.8 with an average of 10.5. All but one home had ACH50 < 25. When test-in results were high, auditors identified airflow pathways and provided that information to the partner. In Florida's hot-humid climate, high infiltration rates are less detrimental than they are in climates with larger temperature differentials between outside and conditioned spaces. It is less beneficial and less cost effective to expend labor on *extensive* air sealing efforts in the hot-humid climate. Air sealing efforts necessary to achieve the target ACH50 test result include sealing around drywall penetrations (for supply and return registers, dryer vents, wiring, lighting and fan fixtures, and plumbing), replacing missing plumbing access panels, correcting poor window and door closure, eliminating recessed lighting, and installing gaskets at attic access panels in the conditioned space (Figure 10 and Figure 16).

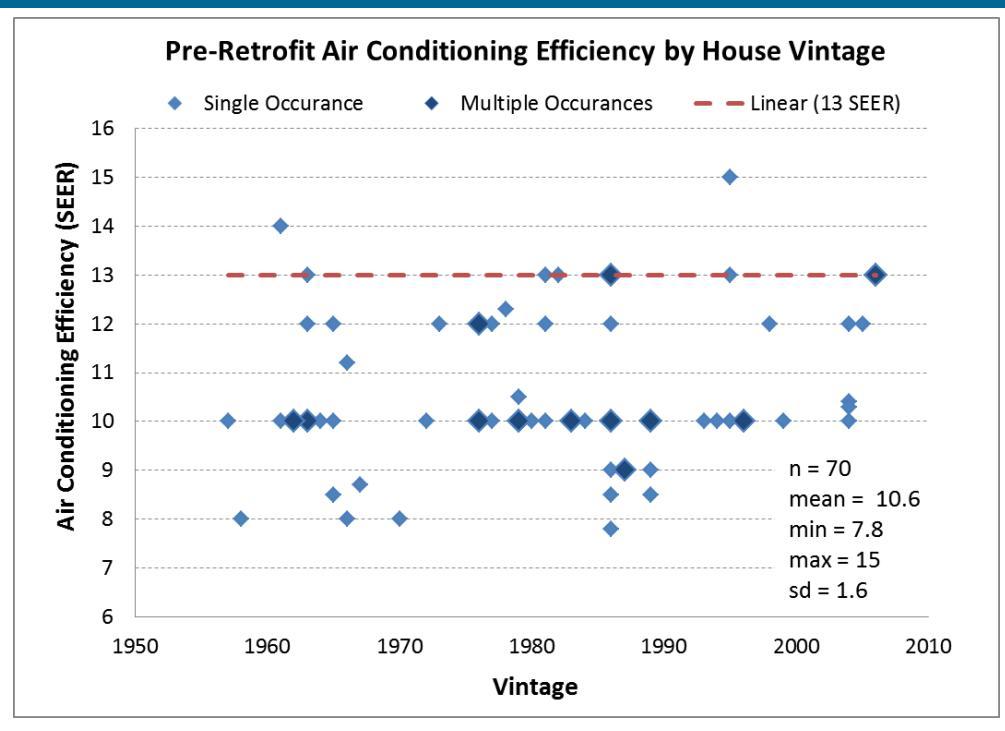
Figure 20. Pre-retrofit AC efficiencies (SEER) by house vintage (n = 70)

The pre-retrofit cooling efficiencies, including some estimates as described above, ranged from SEER 7.8 to 15, with a mean of SEER 10.6, and an sd of 1.6 (Figure 20). Only 10% met or

exceeded SEER 13, the current federal minimum efficiency allowed for AC manufacture and sale, denoted by the red line in Figure 20. Over 60% of the AC equipment (43 units) was SEER 10 or lower efficiency. For many of these homes, installing an air conditioner with a SEER of 13 would have been a dramatic improvement. Note that savings (and costs) for higher SEER AC replacements are quantified in comparison to this federal minimum, because nothing lower could have been installed. For example, annual energy cost for a SEER 15 replacement was compared to the annual energy cost for a SEER 13 replacement, rather than the original SEER 8 equipment. For more detailed discussion of this concept, see Appendix B.

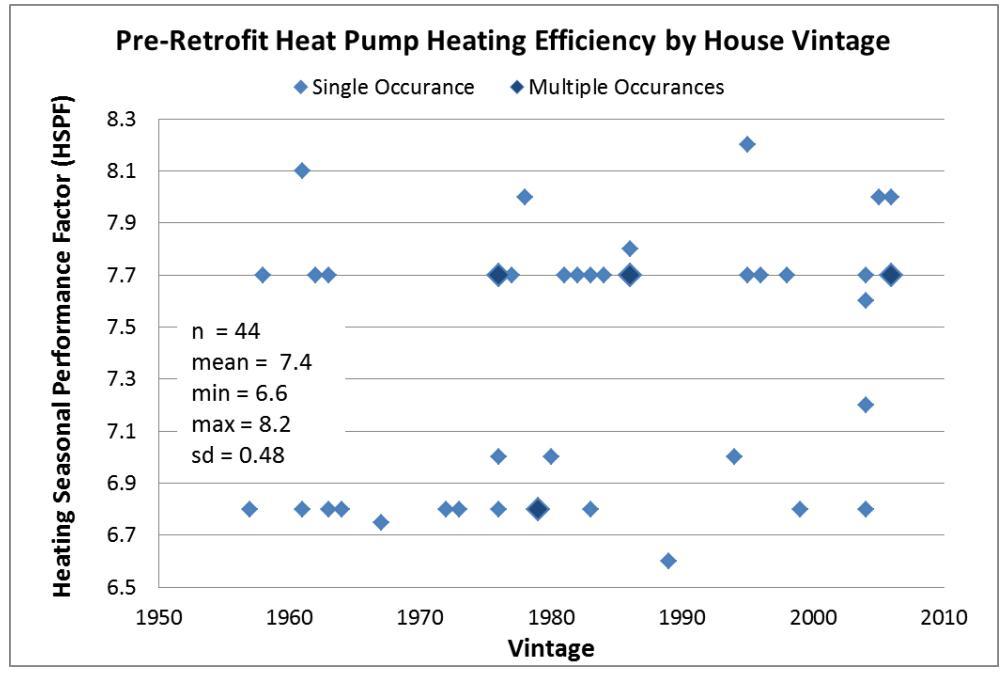
Figure 21. Pre-retrofit heat pump heating efficiencies by house vintage (n = 70)

Heating systems were predominantly electric. Twenty homes had central electric resistance heating systems (coefficient of performance [COP] of 1), which is sometimes referred to as an electric furnace. The remaining 44 homes had air source electric heat pumps. Figure 21 shows that pre-retrofit heat pump heating efficiencies ranged from 6.6 to 8.2 heating seasonal performance factor (HSPF), with a mean of 7.4 (sd = 0.48). Six homes had gas furnaces at pre-retrofit with efficiencies ranging from 0.76 to 0.80 annual fuel utilization efficiency (AFUE).

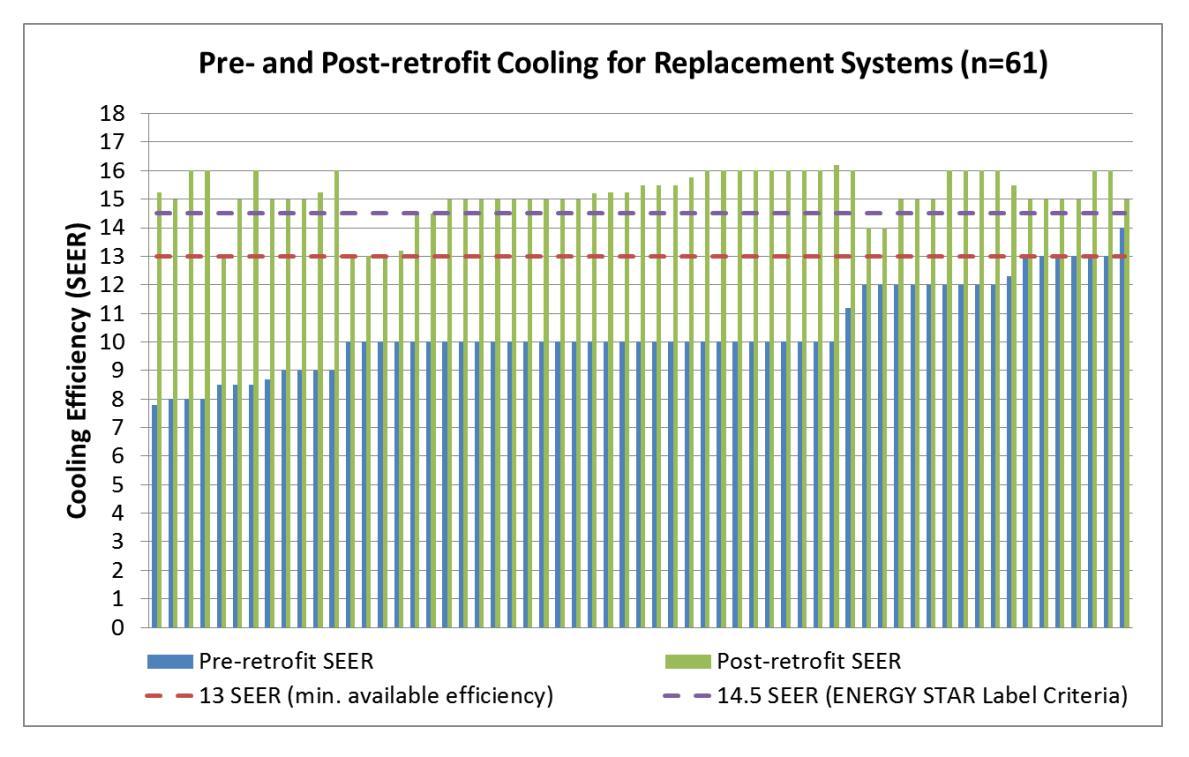
Figure 22. Mechanical system cooling efficiency at pre- and post-retrofit audit

Average SEER improvement was 49%. All the SEER 10 and lower units were replaced. One home had its compressor replaced with a like kind. Only five of the 61 replacements were SEER 13 units, the current federal minimum efficiency. Only two others fell below 14.5, the current specification for ENERGY STAR-labeled air conditioners (dashed purple line on Figure 22). The rest were SEER 15 or higher with a maximum of 16.2. In two cases, cooling efficiency doubled from SEER 8 to SEER 16.

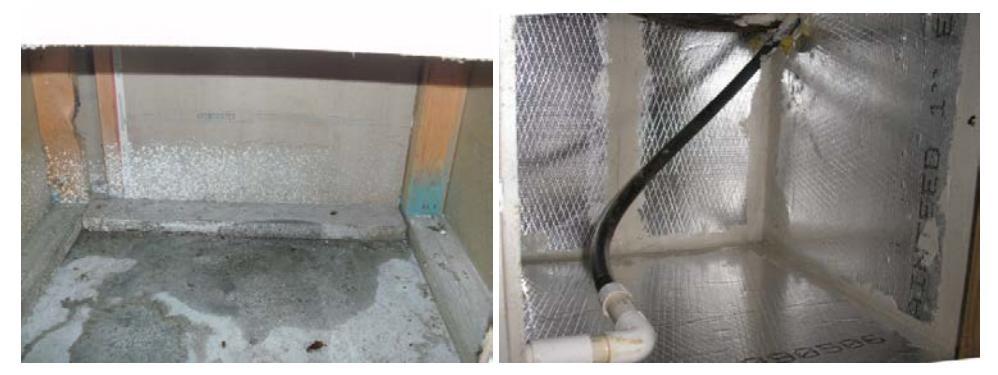
- Forty homes. Upflow AHU in conditioned space, usually in a dedicated closet (Figure 24), mounted on either:
 - A framed AHU platform with a wall-mounted filter-back return grille (Figure 24) and a central return plenum formed by a cavity under the platform. In many homes, the cavity was unfinished (Figure 25, left). Finished cavities were formed by sealed duct board (Figure 25, right) or drywall.

Figure 25. Return plenums were formed by either unfinished, open framing (left) or sealed duct board (right) or drywall.

The best practices related to AHU replacement are modeled after the Florida Residential Mechanical Code requirements for new homes. These include finished and sealed return air plenum, mechanically fastened and sealed supply plenum connection to the AHU, finished closet walls and ceiling (when applicable), provision of 4-in. clearance around the AHU. Additional best practices not related to new construction code include ACCA Manual D return sizing, sealing the gap between the supply plenum and ceiling drywall, and sealing the gap between the return plenum and the AHU platform.
