# Where Should We Focus Efforts to Improve Building Energy Code Enforcement Rates? Results From A Research Study in Florida

FSEC-PF-458-14

Charles Withers, Jr. and Robin Vieira  
Florida Solar Energy Center

2014 ACEEE Summer Study on Energy Efficiency in Buildings

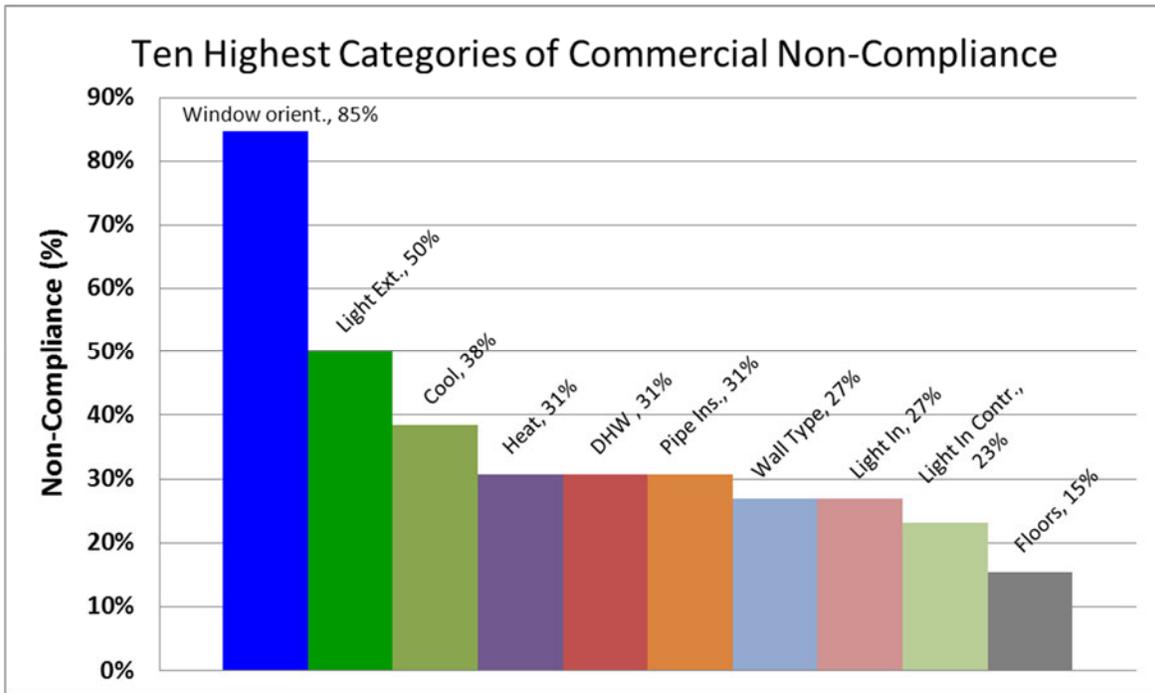
Figure 1 below shows the rates of non-compliance for the ten highest categories. The five highest categories are: window orientation, exterior lighting, cooling efficiency, heating efficiency and domestic hot water efficiency. The annual energy impact of window orientation also largely depends upon total glass area, presence of shading, and window performance characteristics.

Figure 1. Top ten highest non-compliance categories.

# Non-Comply	% Non-Comply		# Non-Comply	% Non-Comply
Conditioned Area [ft <sup>2</sup> ]	1	3.8	Light Exterior Controls	0	0.0
Space Classification	2	7.7	Duct Thermal Efficiency	0	0.0
Floors	2	15.4	Air Distribution	0	0.0
Wall Type	7	26.9	Cooling Systems	10	38.5
Wall R Value	2	7.7	Heating Systems	8	30.8
Roof	3	11.5	Ventilation Control	3	11.5
Window Performance	0	0.0	DHW Systems	8	30.8
Window Orientation	22	84.6	Piping Insulation	8	30.8
Window Shade	0	0.0	Joints/Cracks	0	0.0
Light Power Indoor	7	26.9	Plant	2	7.7
Light Interior Controls	6	23.1	Other Compliance	2	7.7
Light Power Exterior	13	50.0

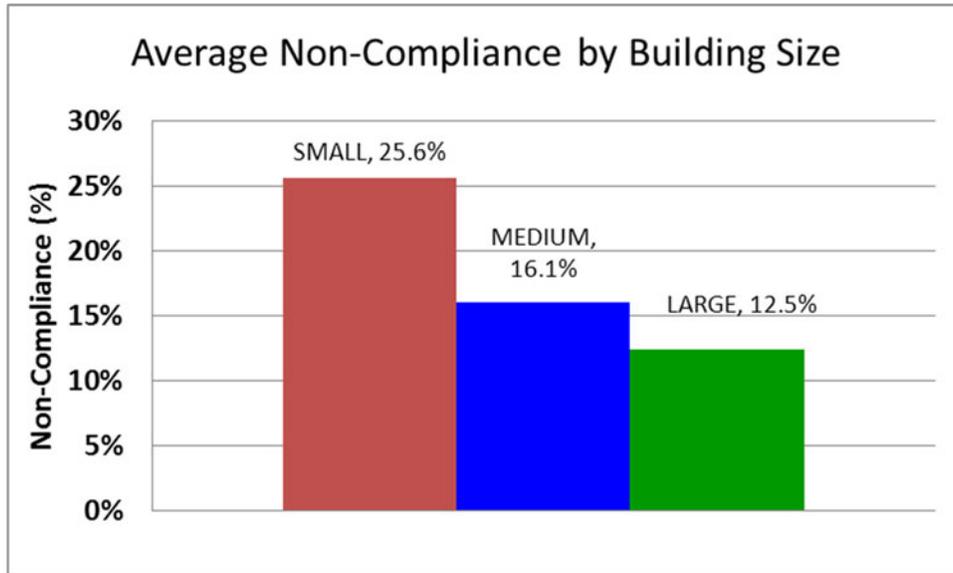
A trend is indicated when the average non-compliance is sorted by the building size category as illustrated in Figure 2. The average non-compliance by building size is about 26% for small, 16% for medium and 13% for large buildings showing a trend for better compliance enforcement as buildings become larger.

Figure 2. Average non-compliance sorted by building size classification.

Blg.ID	% Non-Comply	Blg.ID	% Non-Comply
1CS	29	14CM	9
2CS	10	15CM	5
3CS	24	16CM	5
4CS	41	17CM	29
5CS	36	18CL	24
6CS	33	19CM	24
7CS	19	20CL	9
8CM	15	21CS	33
9CS	19	22CS	38
10CM	19	23CM	5
11CL	19	24CL	5
12CM	29	25CS	0
13CM	18	26CL	6

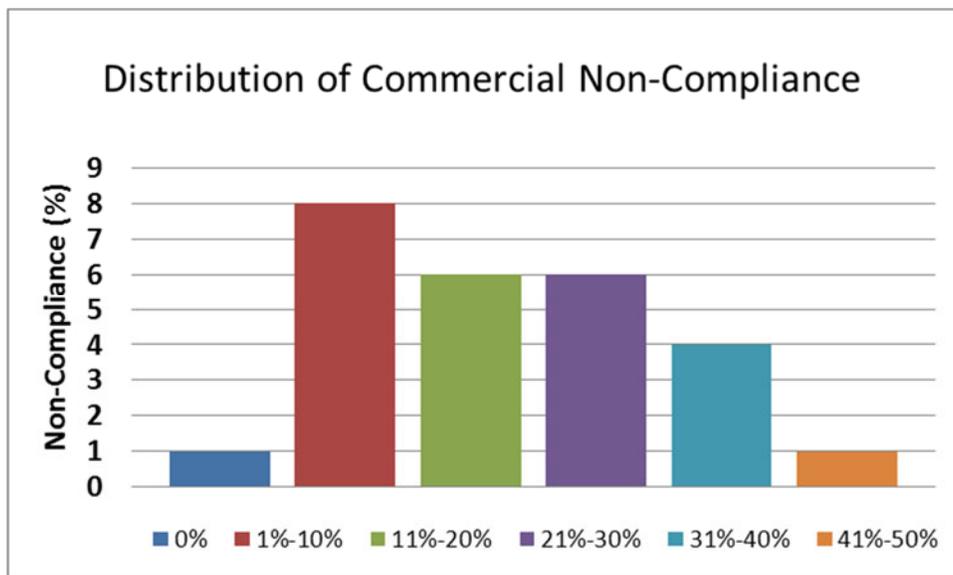
Figure 3 illustrates the number of audited buildings that fell into bins of percentage of problems. Just one of the inspected buildings had no compliance issues. Nine of the 26 buildings had 10% or fewer issues; however 16 buildings had over 10% non-compliance issues. When you consider that 24 buildings had some non-compliance issues at permit time, there are significant enforcement issues both during permitting and inspection.

Figure 3. Frequency distribution plot for commercial energy code compliance. The height of each bar represents the number of inspected buildings that had the binned value of non-compliance issues.

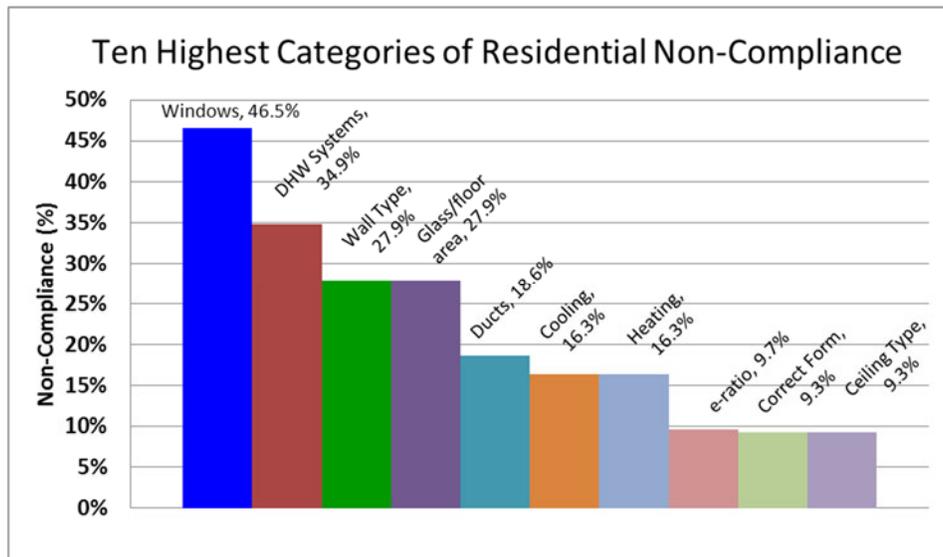
Figure 4 below shows the rates of non-compliance for the ten highest categories. The most common non-compliance was in the Windows category at a rate of 47%. Window non-compliance was related to window area, orientation or shading related errors. Window U value and SHGC labels are removed when the home is completed; however window performance data was available in about 3 houses. In those cases we confirmed that the installed performance data met or exceeded the claimed efficiency. Non-compliance could be counted based on performance rating if the claimed window performance was not plausible.

Figure 4. Top ten highest residential non-compliance categories.

After windows, the next five highest rates of non-compliance occurred in domestic hot water heating (35%) where the claimed EF was higher than installed, glass/floor ratio (28%) where the ratio claimed was lower than installed, Walls (28%), Ducts (19%) and Cooling and Heating each having 19% non-compliance. The reason for wall non-compliance was usually related to over-stated R-value on code forms or significant wall area errors. Duct issues were typically related to wrong claimed location (indoor versus attic) or claiming much smaller duct surface area than installed. Non-compliance in cooling and heating was due to installation of lower efficiency equipment in half of the cases. Most of the time the SEER difference was about 1 SEER lower and HSPF about 0.3 lower. The other half of non-compliance in heating and cooling was noted for installation of significantly oversized equipment. Figure 5 illustrates the audited buildings that fell into bins of non-compliance.

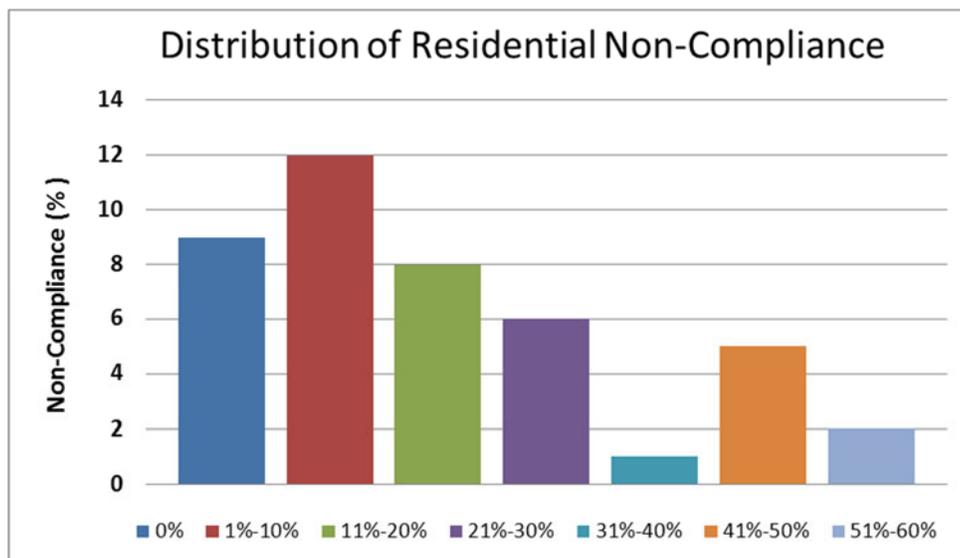
Figure 5. Frequency distribution plot for residential energy code compliance. The height of each bar represents the number of inspected buildings that had the binned value of non-compliance issues.
