Managing the Drivers of Air Flow and Water Vapor Transport in Existing Single-Family Homes

*Building America Partnership for
Improved Residential Construction*

Revised October 2012

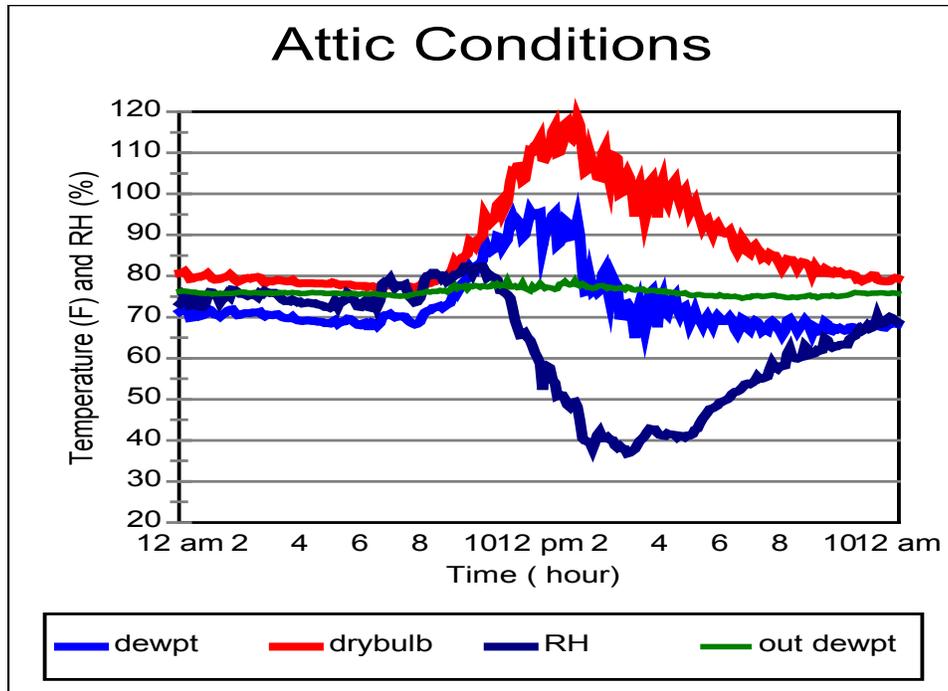
Figure 1. Attic dry bulb and dew point temperatures, attic RH, and outdoor dew point temperature in a Florida home.

Hotter air can hold more water vapor, so RH goes down as air temperature goes up. For each 10°F increase in air temperature, RH goes down by about 26%, assuming that the absolute water vapor content of the air remains constant. The water vapor capacity of the air increases by about 38% for each 10°F rise in air temperature (Table 1). When RH is held constant at 50%, total energy (enthalpy; H) contained in the air also increases substantially as temperature and humidity ratio increase, by almost exactly 23% per 10°F rise. This sharp rise in enthalpy, as the attic becomes hotter, has important implications for cooling loads created by attic air transported into the house.

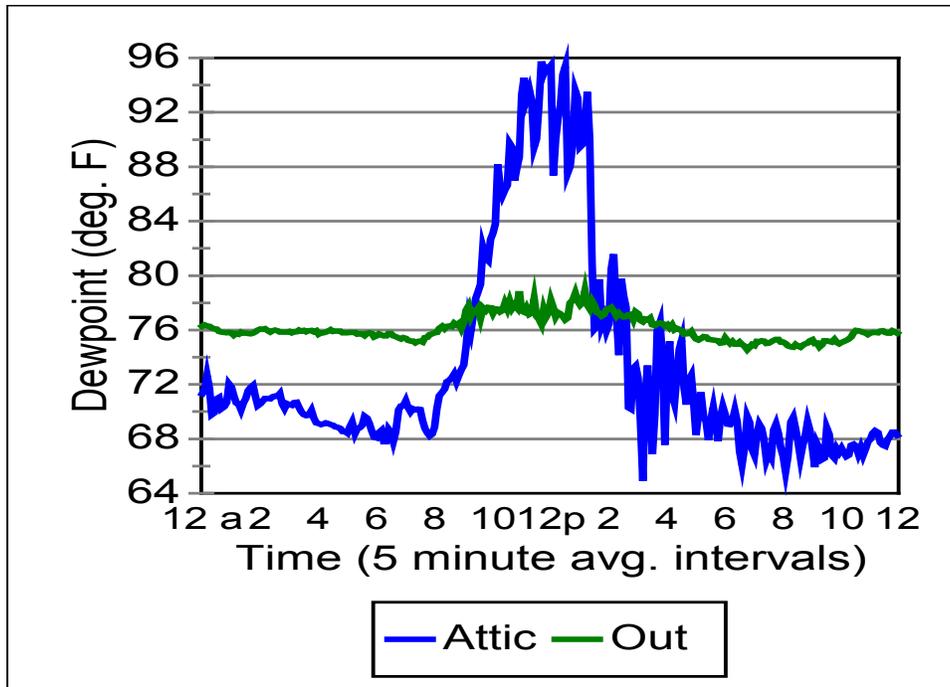
Figure 2. Attic dew point temperature swings widely as the attic temperature rises and falls (Florida home October 4, 1998)

As attic temperature rises and RH declines, the rate of desorption increases, which has the effect of drawing adsorbed moisture away from attic building materials. Water vapor removed from wood and other materials in the attic enters the attic air, pushing up the attic dew point temperature (Figure 2). In this particular Florida home, dew point temperature rises to about 95°F when outdoor dew point temperature is about 77°F. This spike occurs during a time of day when the A/C system runtime is increasing, thus creating the potential for substantial increases in cooling energy use and indoor RH, as attic air finds its way into the house from duct leakage and other forms of uncontrolled airflow.

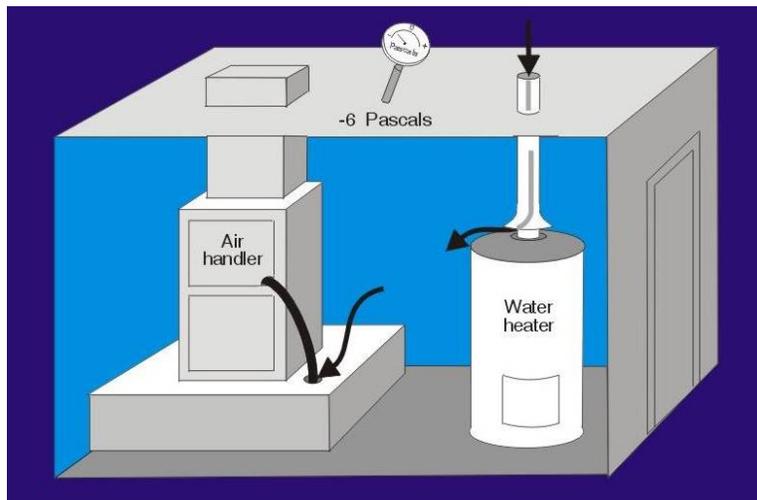
Figure 3. Return leaks in a mechanical room create depressurization which causes air to be drawn into the room from outdoors and potential combustion safety problems.

vent (Figure 3). In addition to creating a combustion safety hazard, this introduces heat from outdoors and retains combustion heat in the house. Return leaks can create small or large energy impacts depending upon the temperature and water vapor content of the air drawn into the leak. At one extreme, air drawn from a hot attic can overwhelm the cooling capacity of an A/C system. A 15% return leak from an attic with peak conditions of, say, 125°F and 75°F dew point temperature can diminish the cooling capacity and efficiency of an A/C system by more than 50% (Figure 4).

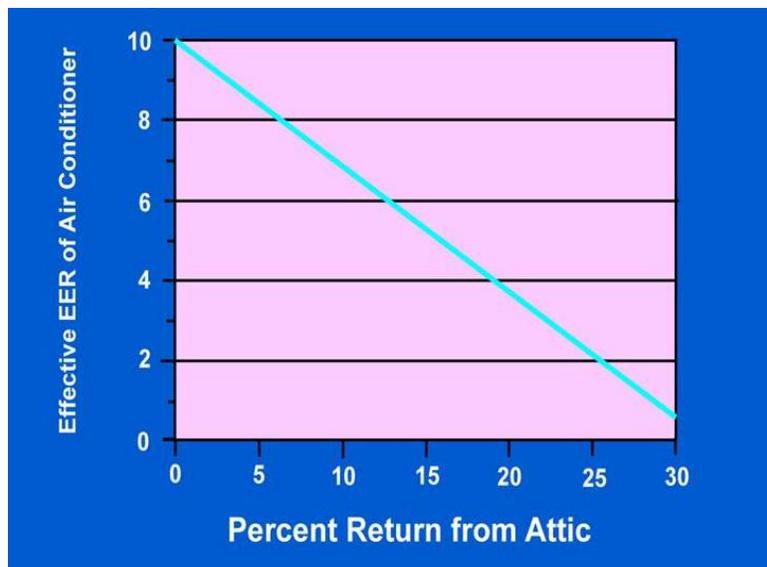
Figure 4. Cooling energy efficiency ratio versus the return leak percent (from attic), assuming attic conditions of 120°F dry bulb and 75°F dew point temperature.

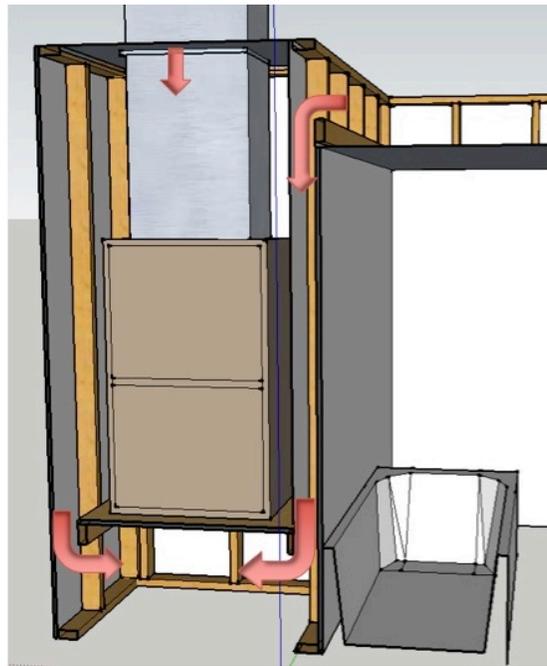
Figure 5. Duct leakage from attic is pulled through pathways in walls. In one extreme case, 55% of the return leakage originated from the attic.

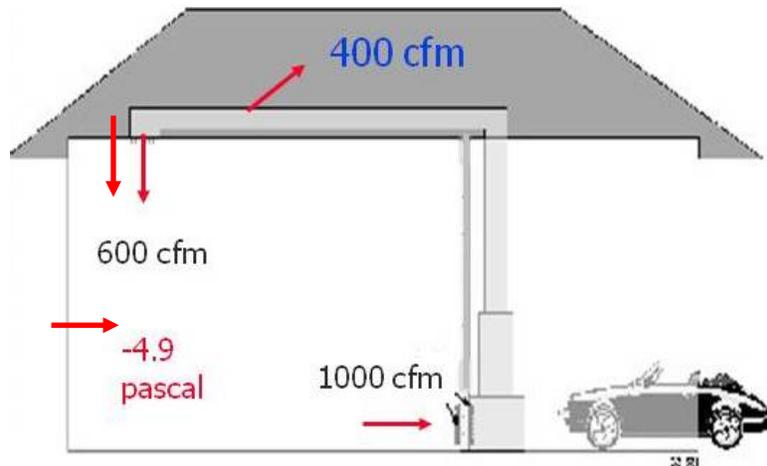
Figure 6. A supply leak of 400 CFM produces space depressurization, which causes 400 CFM of air to be drawn into the house from outdoors and attic.

By contrast, dominant supply leaks can cause a substantial increase in indoor RH, because the supply leakage creates space depressurization, which in turn draws air into the house through all pathways in the envelope. Figure 6 shows that a supply leak of 400 CFM causes space depressurization of -4.9 Pa, which in turn draws 400 CFM of air into the house from outdoors and the attic. During hot and humid weather, high dew point air can be drawn into the house from various sources; outdoors, from the crawlspace or basement, from an attached garage, or from the attic. Depending on the quantity of the net supply leakage (net supply leakage = total supply leakage – return leakage), indoor RH can rise as much as 10 percentage points.

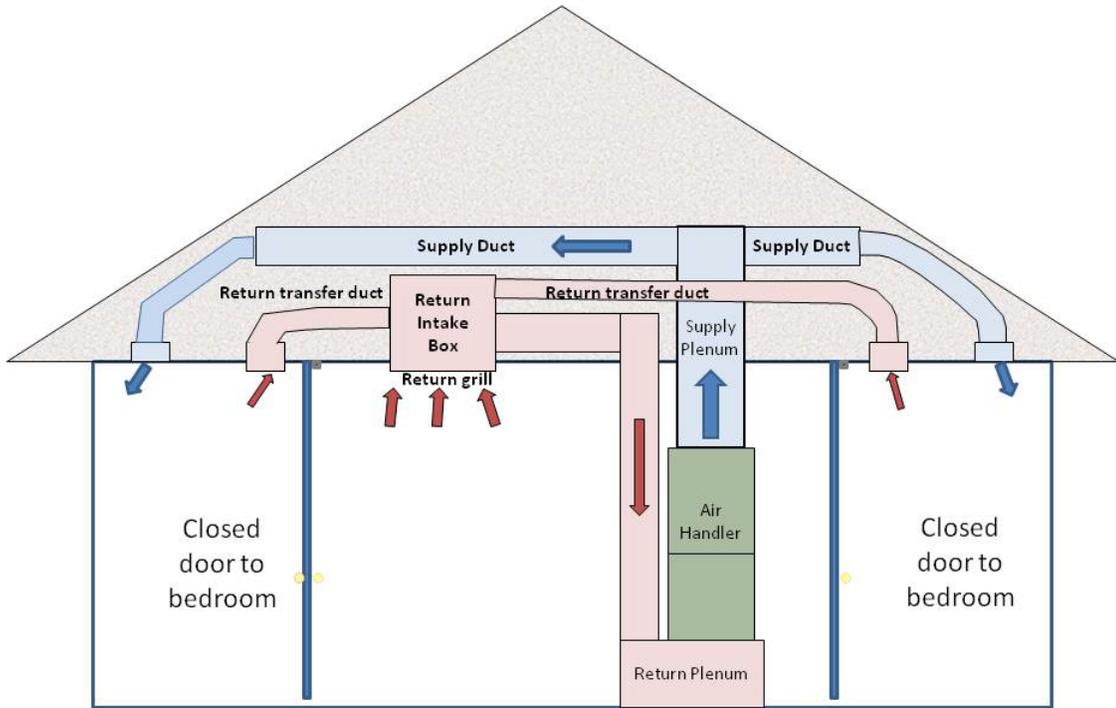
Figure 7. Hybrid ducted return transfer shown from two rooms to a return intake box (Withers).

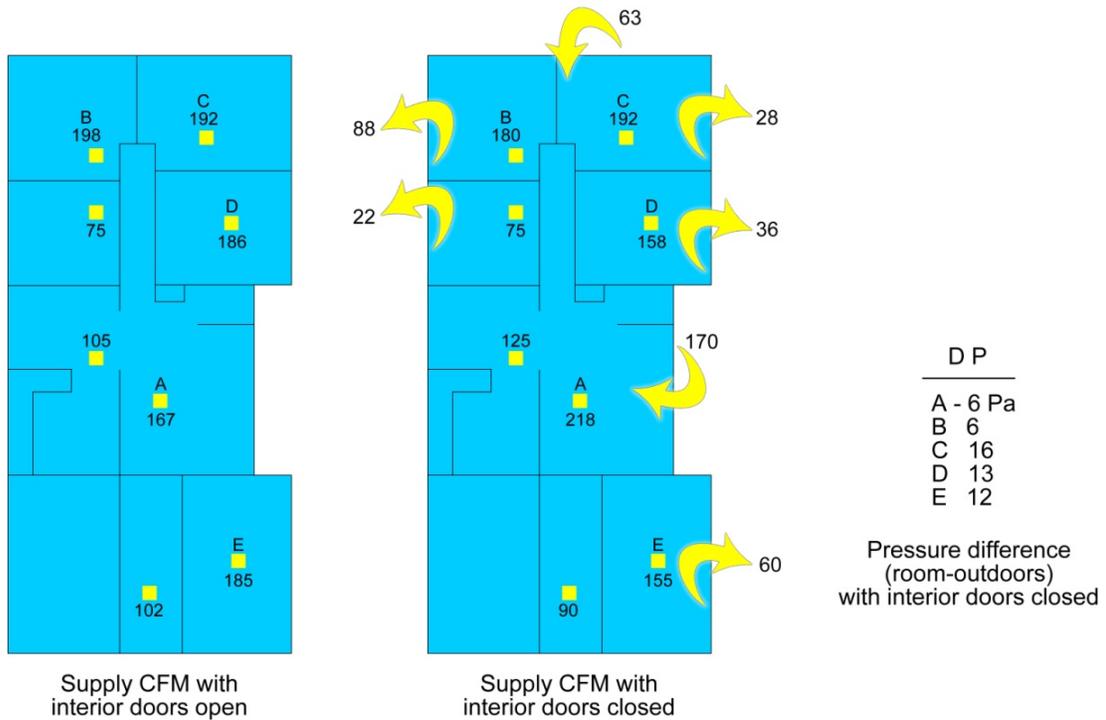
Figure 8. Pressure mapping results in a house with a central return and closed interior doors.

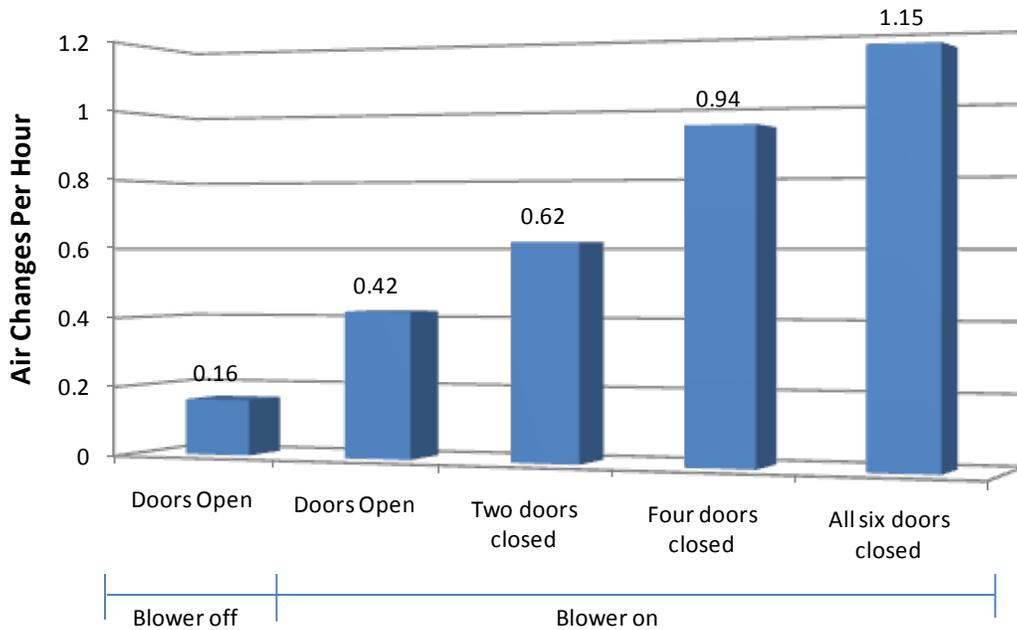
Impact upon infiltration of closing interior doors when air conditioner blower is running

Figure 9. Air infiltration impacts of duct leakage, unbalanced return air, and incremental closing of interior doors.

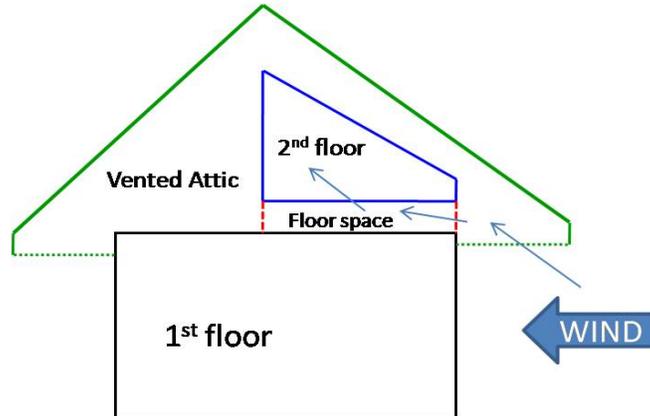
Figure 10. Wind-driven attic air is pushed into the space between floors.

Wind washing—air from outdoors penetrating into the interstitial cavities of the house—is a variation on natural drivers. In this case, the primary driver is wind and the pathway is typically openings from attic spaces or outdoors into interstitial cavities. Figure 10 illustrates a particular form of wind washing that is rather common in homes in the southeastern United States. In this case, wind can drive air from an attic space above a first-floor portion of the house into floor cavities that are located between the first and second stories of the house (Figure 11). In many cases, wind washing airflow does not directly enter into the conditioned space of the house. Rather, the air remains largely contained within these interstitial cavities and at least partially separated from the conditioned air. Once the hot or cold air penetrates into the interstitial cavities, it bypasses the thermal envelope of the house and can readily conduct heat or cold into the conditioned space (Figures 12 and 13). To some extent, however, air can also flow from the interstitial cavities into the conditioned space through openings in the floor of the second story or the ceiling of the first story. Alternatively, duct leakage may interact with wind washing and draw air from these cavities and deliver it into the space.

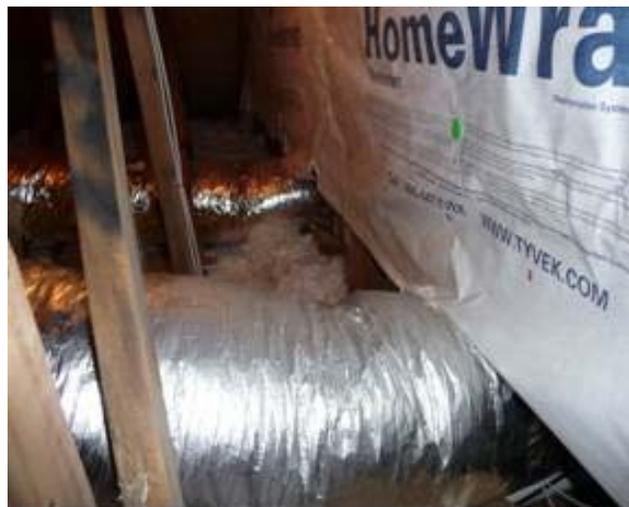
Figure 11. Flex ducts going from an attic space into the interstitial floor cavity under a portion of the second story conditioned space.

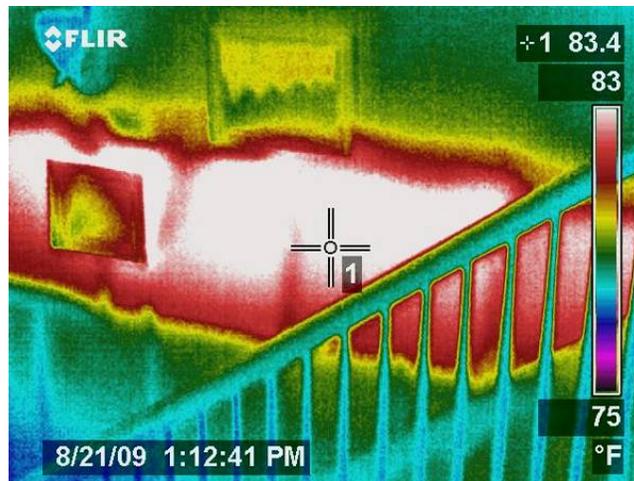
Figure 13. Infrared image of stairwell showing elevated wall temperature from hot air in an interstitial floor cavity. Note location of pictures and light fixture.

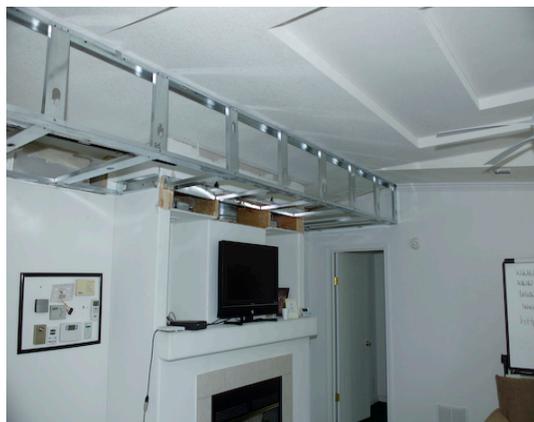
Figure 15. Interior duct system under construction. Metal framing is used to construct a chase that will hide the ducts from view once covered with drywall. The chase should be tight to the attic and leakier to the room.

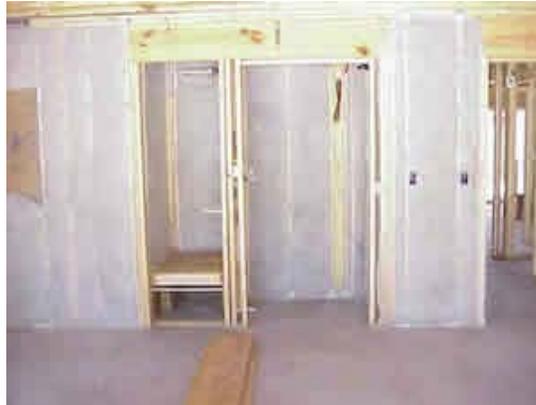
Figure 16. An insulated garage closet located will house an AHU. A weather stripped door will isolate the closet from the garage. A vent from the closet to indoors would also further enhance the system operating efficiency.

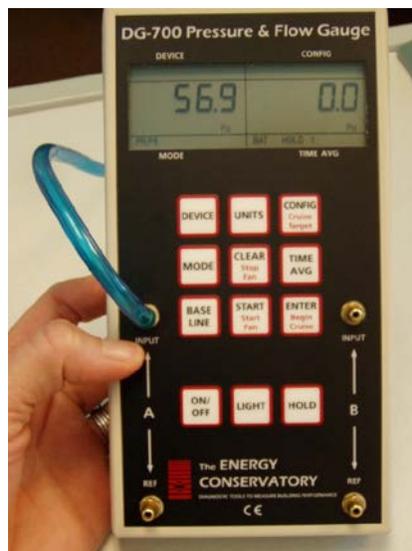
Figure 17. Pressure mapping can be performed using a manometer.

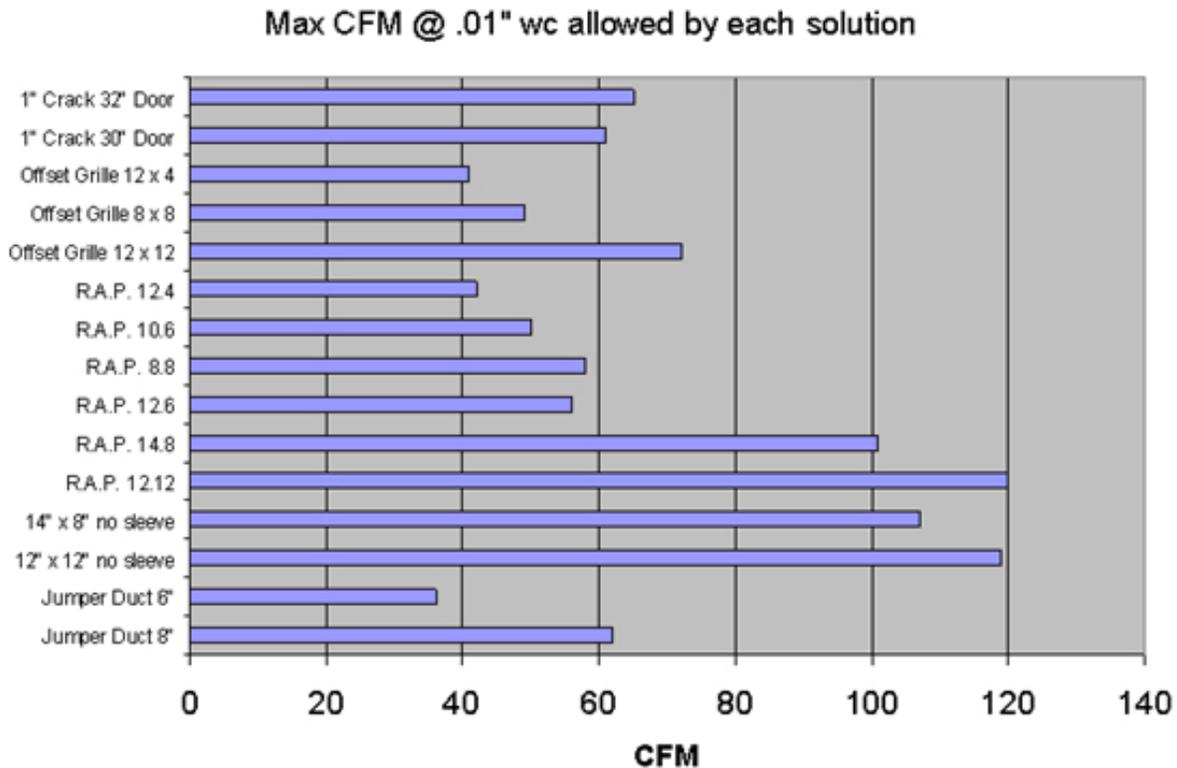
Figure 18. Achievable airflow rates using various return air paths from closed rooms for a given supply at a room pressure of 0.01 in. w.c. (2.5 Pa) with respect to the return zone. For example, an 8-in. jumper duct could be used to maintain 2.5 Pa in rooms with supply air up to 60 CFM. Excerpt from www.ba-pirc.org/casestud/return_air/index.htm.

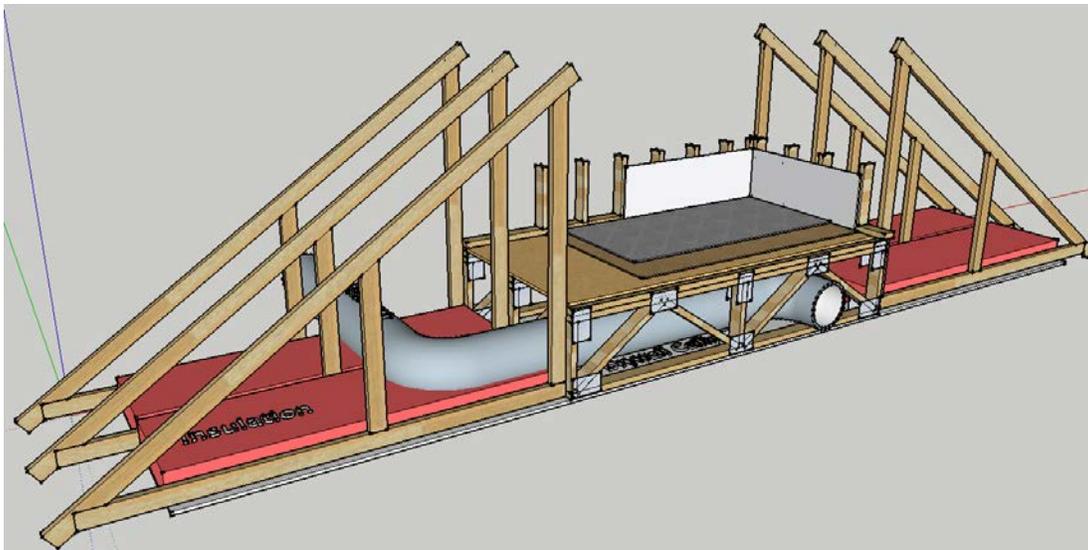
Figure 19. A supply duct is located within the interstitial floor cavity of an upstairs bonus room. The floor cavity is open to an adjacent attic space allowing high dew point air to contact the cool outer jacket of the duct.

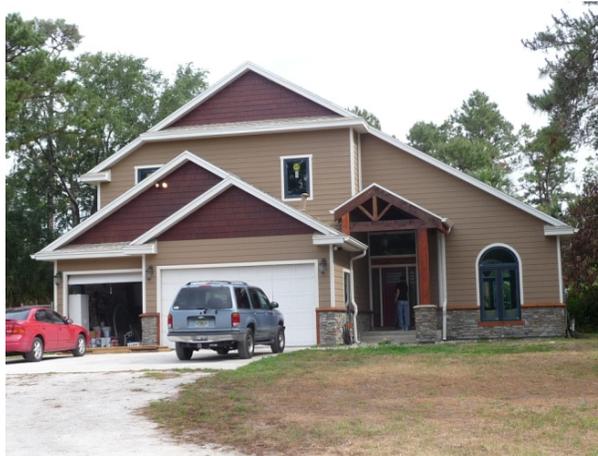
Figure 20. Home with one attic space over garage that abuts second floor wall and floor cavity.

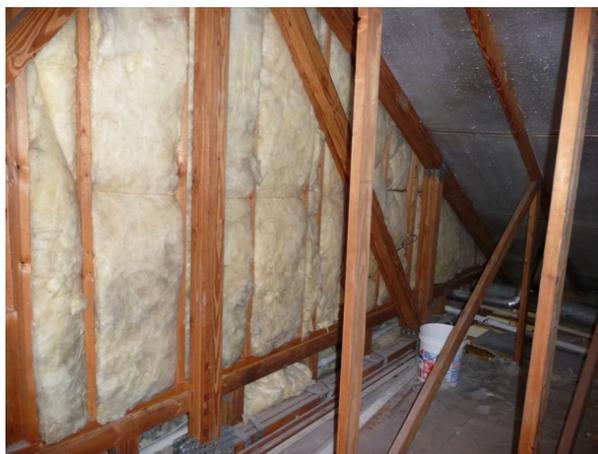
Figure 21. View of kneewall and portions of open floor cavity as seen from inside the attic.

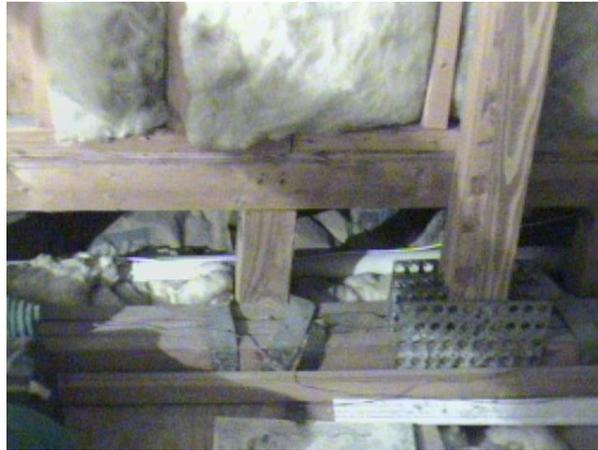
Figure 22. Close-up view of entry to open floor cavity.

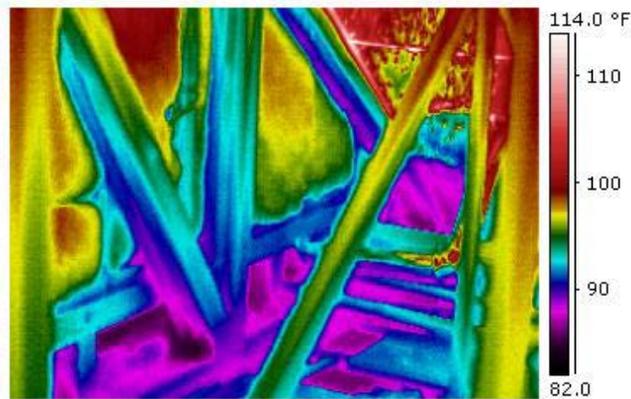
Figure 23. IR image from inside attic before repair shows much cooler area at the bottom where air from floor cavity is displaced into attic.

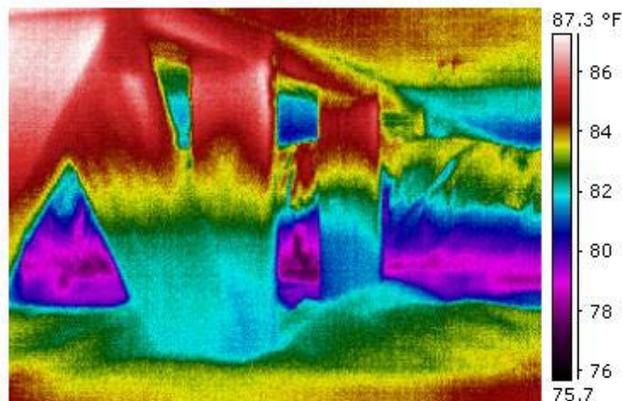
Figure 24. IR image inside floor cavity shows thermal stratification of air, with hotter air at top against second-story floor and cooler air at bottom.

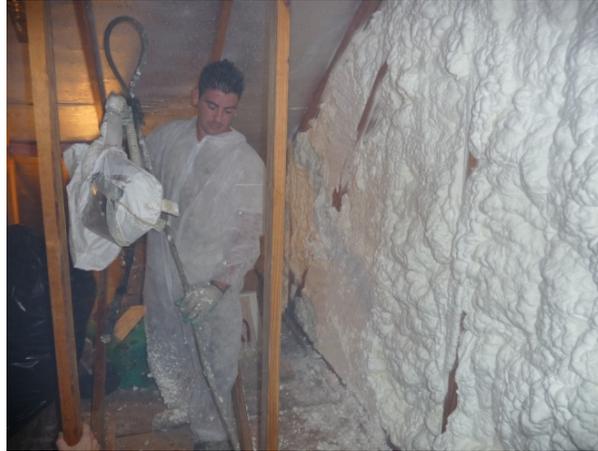
Figure 25. View of kneewall and floor cavity after being sealed with low density expansive foam.

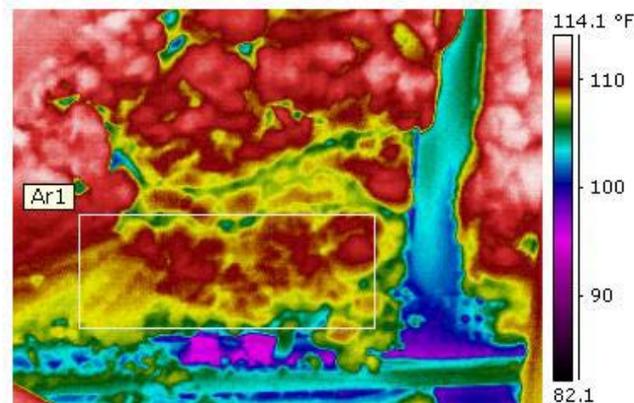
Figure 27. After sealing, the average temperature of the insulation sealing the floor space is about 110.6°F as seen from the attic.

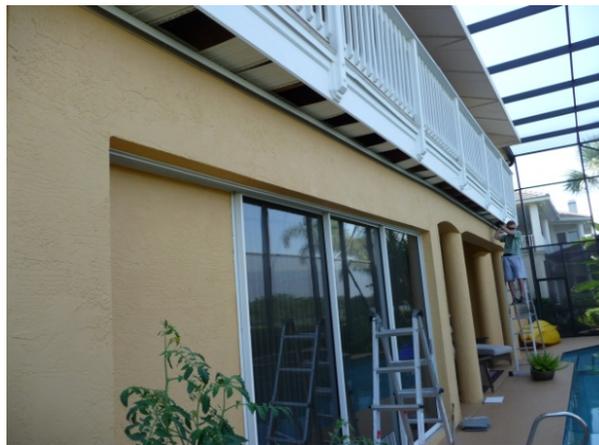
Figure 28. Soffit vent panels removed for inspection and access to seal air pathways from eave into floor cavity.

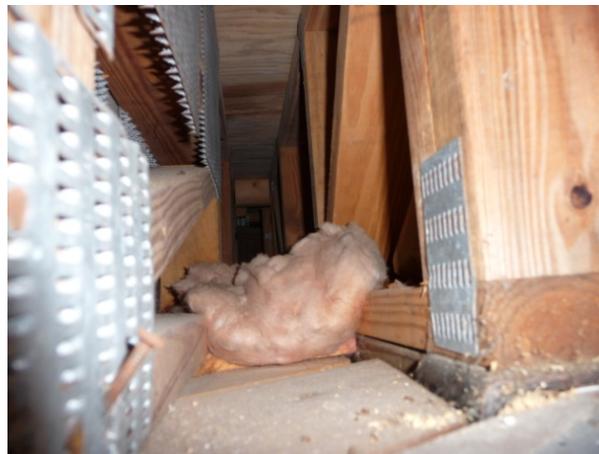
Figure 29. View from the vented eave cavity that is well-connected to second-story floor cavity.

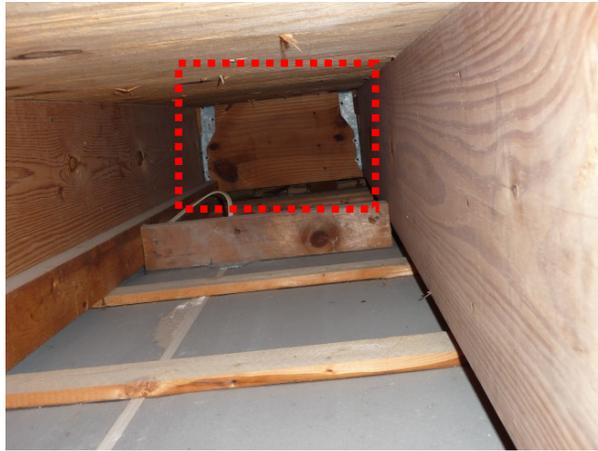
Figure 30. View from eave toward floor cavity shows pathway to floor under joist braced at back, which would be the ideal place for the air and thermal barrier in this construction.

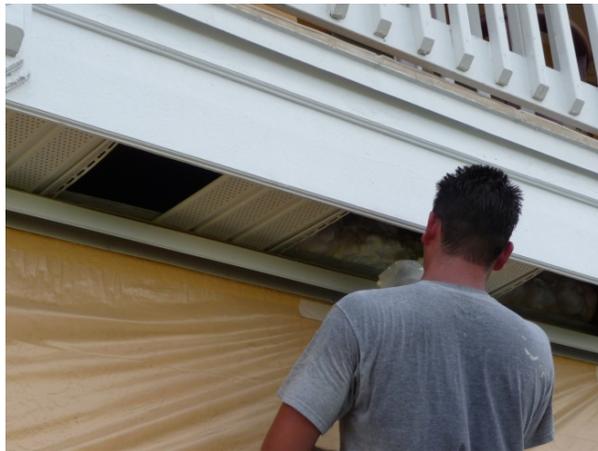
Figure 31. Opening to floor cavity is sealed by application of foam to create an insulating air barrier between each floor joist.

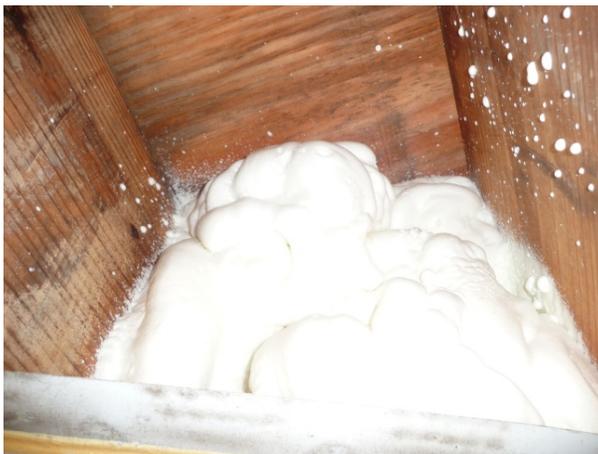
Figure 32. Floor joist cavity is sealed from vented eave.

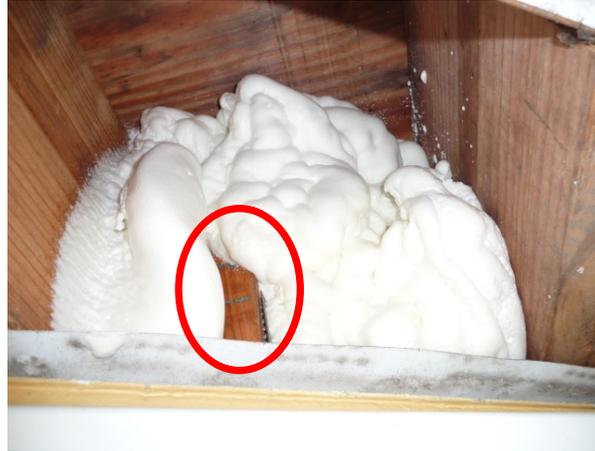
Figure 33. Spray foam expands considerably and conforms effectively around the end of a floor truss section within a floor joist.

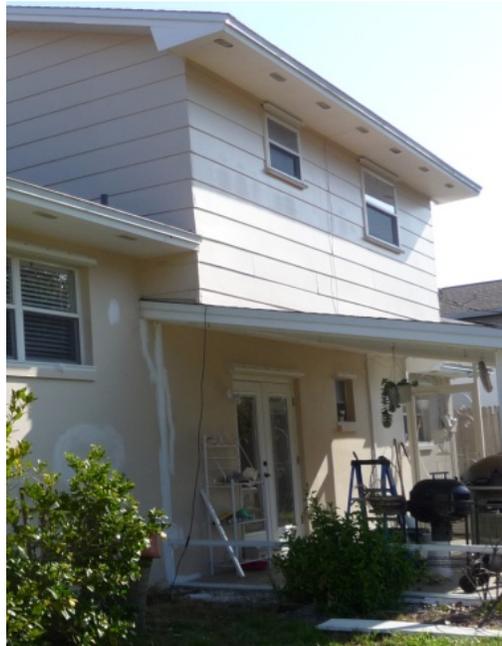
Figure 34. Second-story floor cavity has cantilevered section that was vented on the back side of home.

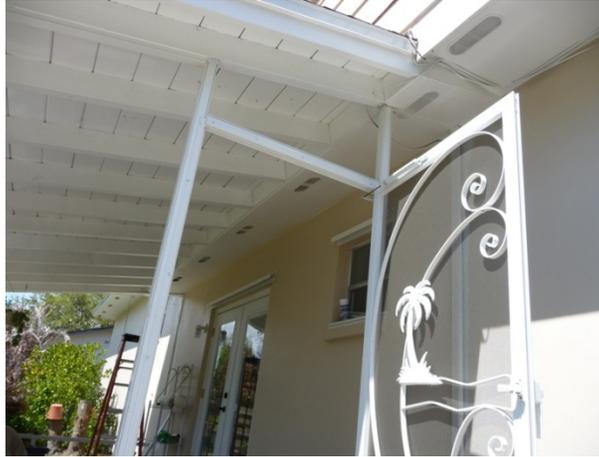
Figure 35. Oval shaped soffit vents can be seen on the underside of cantilevered floor section.

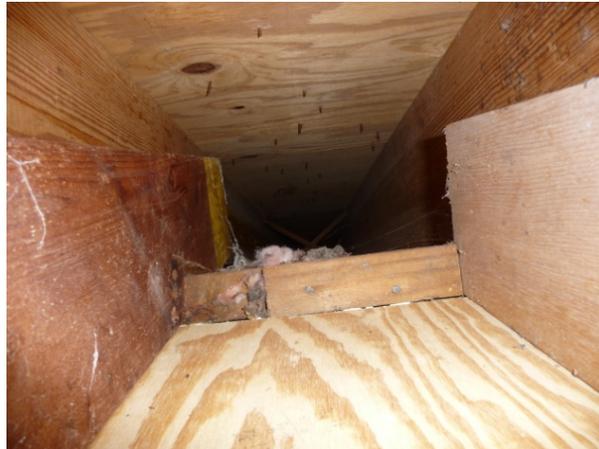
Figure 36. Connection from vented eave to floor cavity where no insulation was found.

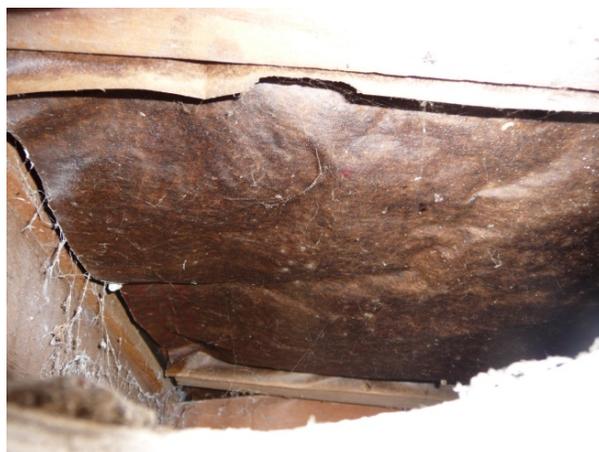
Figure 37. Insulation batts were present in most of the eave areas providing some thermal protection for the floor above. However, because the batts did not fit tightly between the joists, they allow airflow to move into the floor cavity.

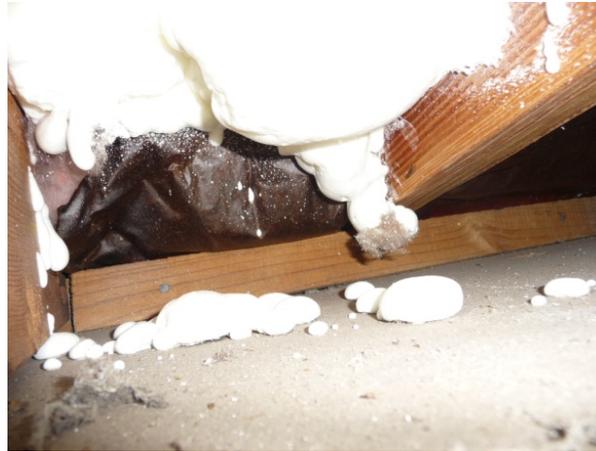
Figure 38. First, the foam spray gun is inserted into the soffit vent hole to apply foam insulation to the floor deck above, beyond the top of the exterior wall.

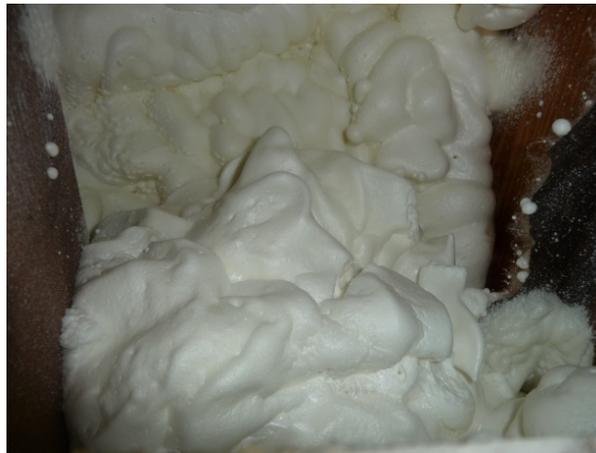
Figure 39. The next step is to complete the seal from floor deck vertically down to the bottom of the soffit surface. This is done between each joist section.

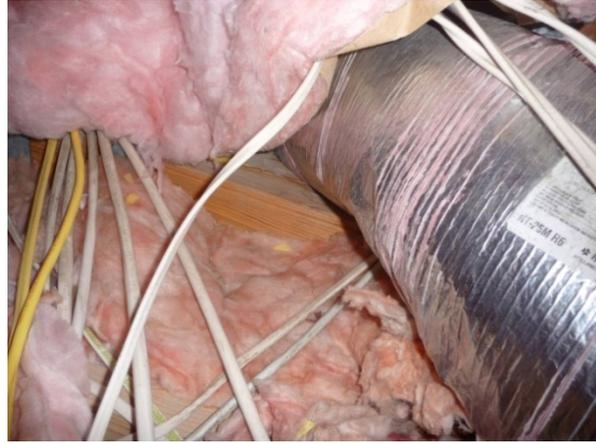
Figure 40. Batt placed against supply duct by homeowner.

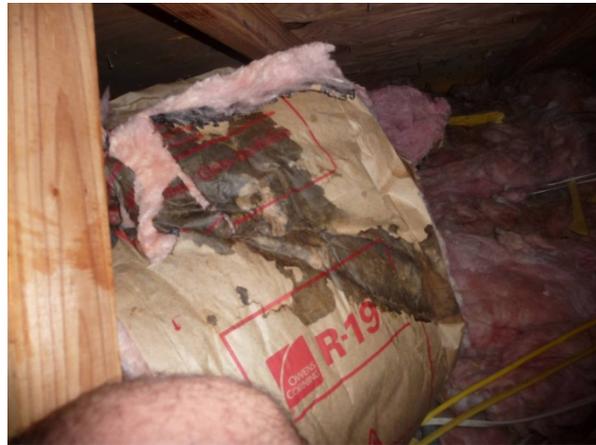
Figure 41. Batt pulled away from duct shows it is soaked where dark areas are seen on paper facing.

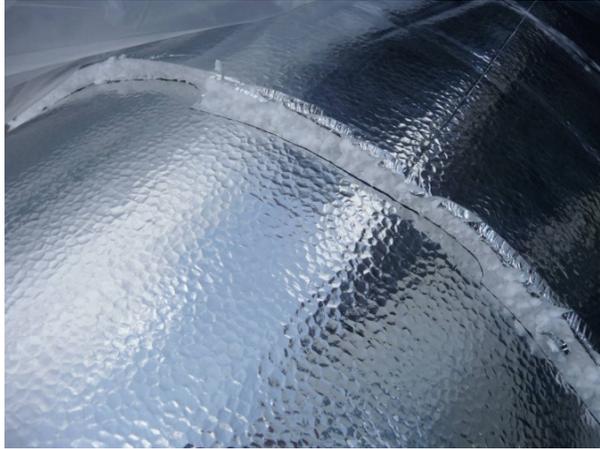
Figure 42. 3/8-in. beadboard insulation with foil face on one side and plastic film on the other.

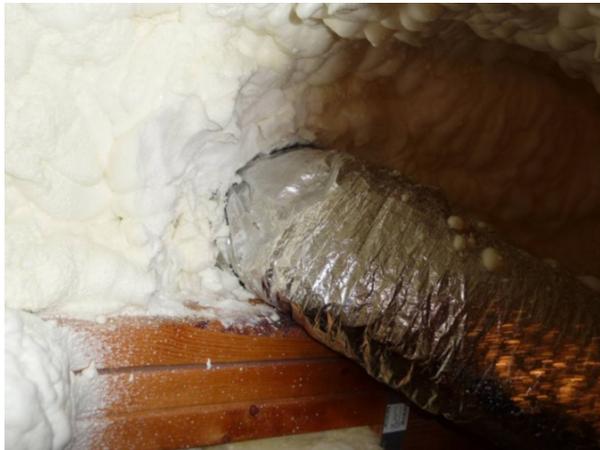
Figure 43. Supply duct from attic into floor cavity has insulation wrapped around duct before blown foam is applied.

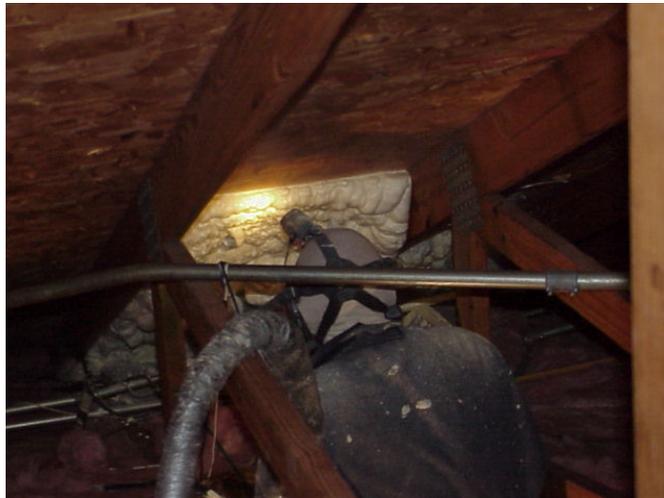
Figure 44. To encapsulate the attic space, spray foam is applied to vents and roof deck. Foam application starts low, at the top of exterior wall, sealing off the vented eave from the attic then continues to completely cover the entire roof deck.

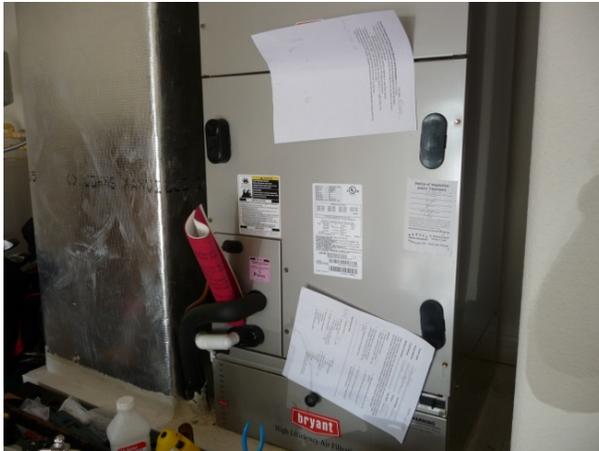
Figure 45. AHU panel leaks are strong enough to hold sheets of paper.

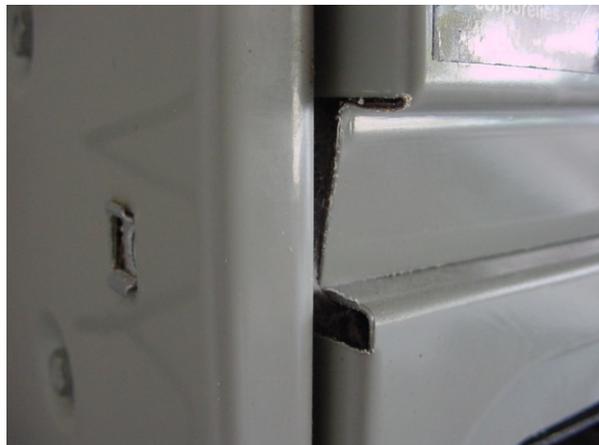
Figure 46. Close-up view of lower corner AHU panel leakage.

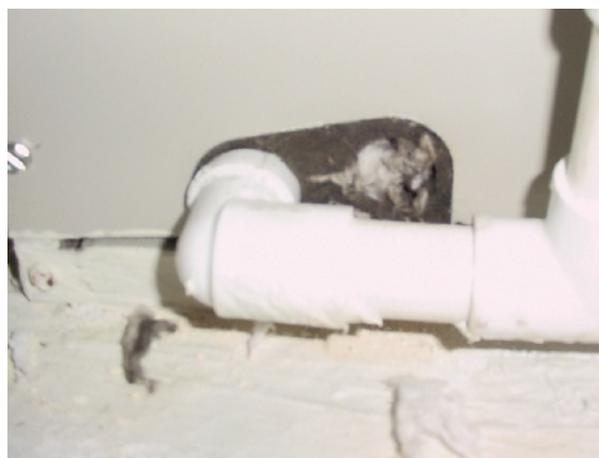
Figure 47. Loose-fill insulation has been sucked into condensate drain penetration leak.

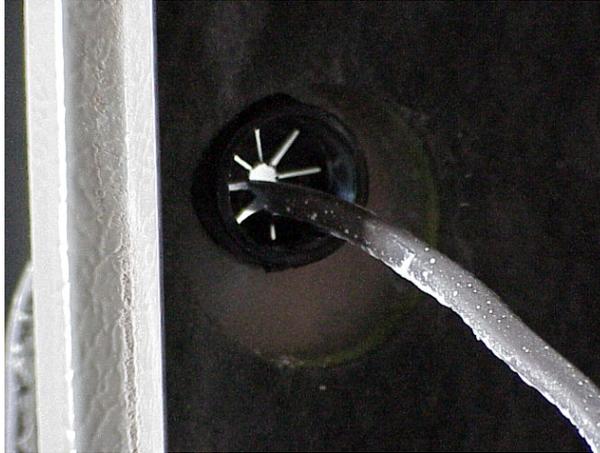
Figure 48. Leaky thermostat wire penetration.

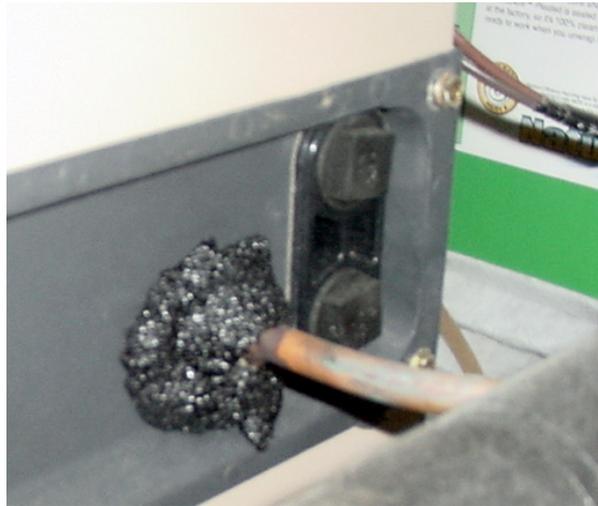
Figure 49. Black cork tape applied around refrigerant line penetration.

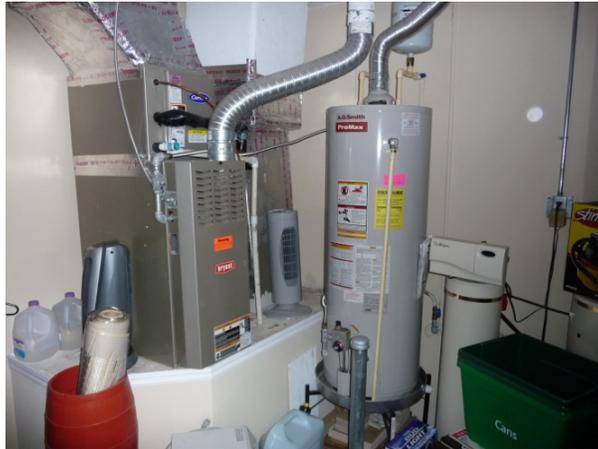
Figure 53. A gas furnace is located on a support platform used as the return plenum located inside a garage next to a gas water heater. Return leakage can depressurize the garage and interfere with proper venting of these atmospherically vented gas appliances.

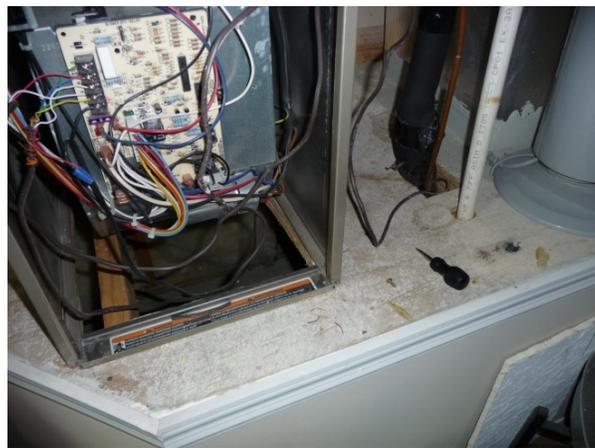
Figure 54. Front panel of furnace is removed for inspection inside the return plenum. Because of limited plenum access, part of the drywall has to be removed to provide access for plenum sealing.

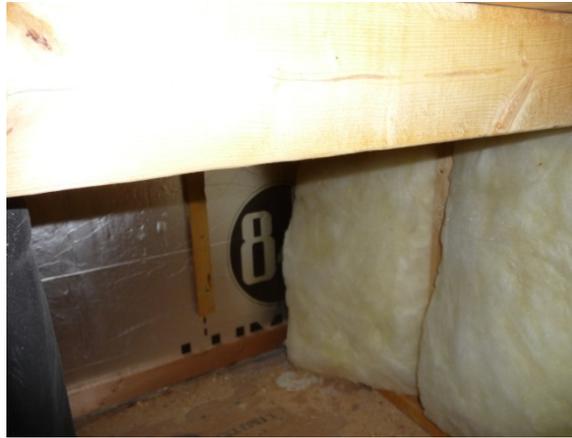
Figure 55. View inside a return plenum located in a second floor closet shows lack of effective duct air or thermal barrier. Attic air could be drawn down leaks in wall cavities and through the floor cavity, which is also well connected to an attic space.

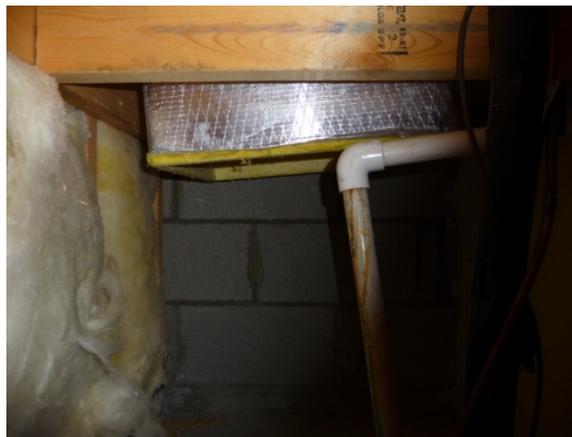
Figure 56. View inside a return plenum located in a garage. Air leaks are drawn primarily from the garage, but a small portion comes from the attic down through the wall cavity where the insulation is located. The block wall in the background is an exterior wall.

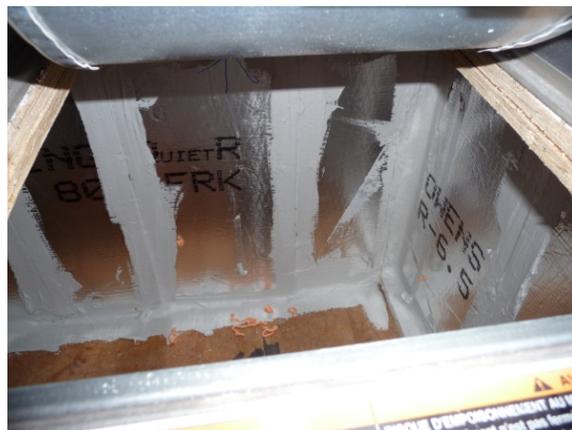
Figure 57. View inside a support platform sealed using ductboard with foil (which is the air barrier) facing inward so seams can be sealed at the foil air barrier with mastic.

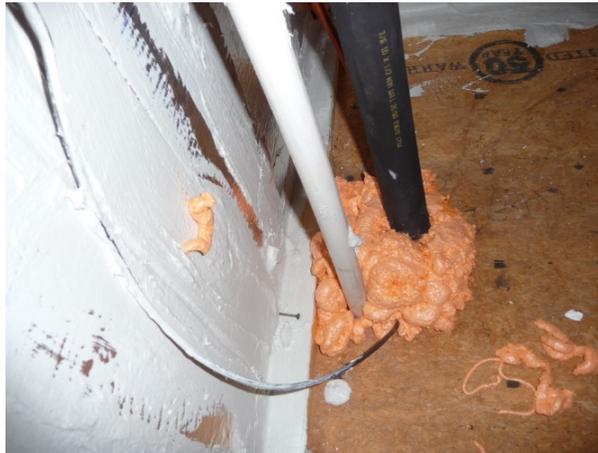
Figure 58. Penetrations in the return plenum are sealed using expansive foam.

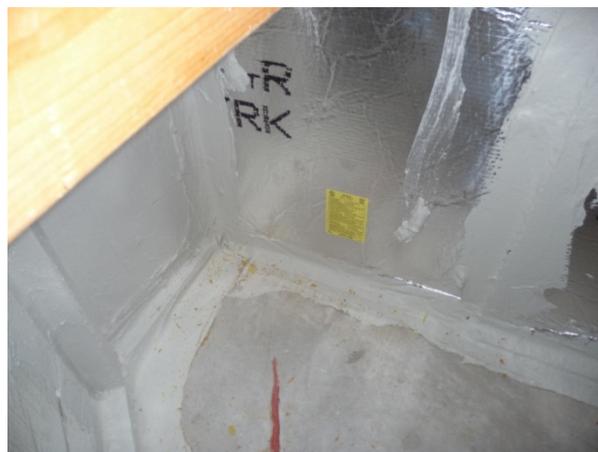
Figure 59. All seams in this support platform return plenum have been sealed using mastic.

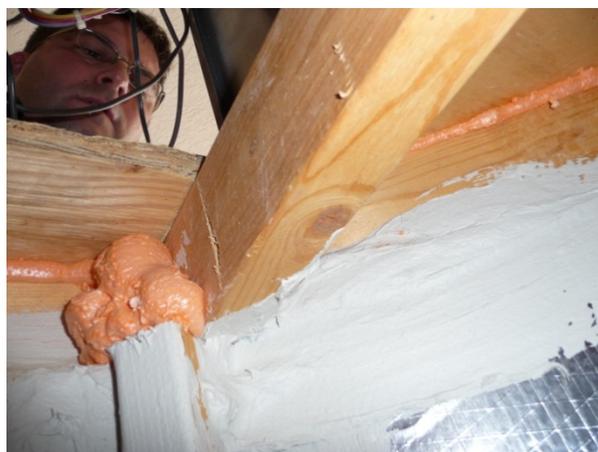
Figure 60. All penetrations and junctions between duct board, structural, and panel components of the return plenum have been sealed.

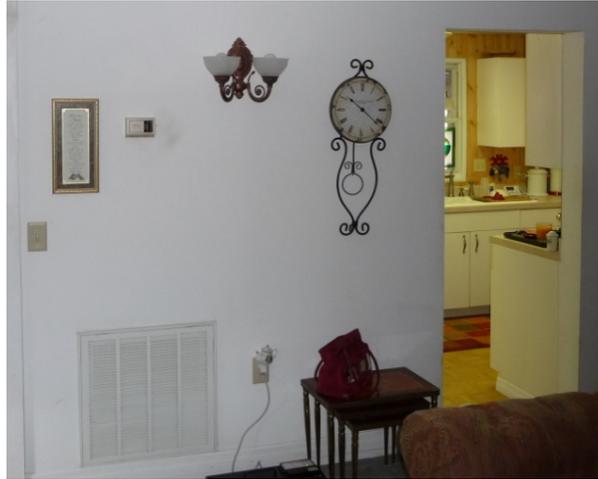
Figure 61. The interior of a return plenum, located under an AHU, can be accessed through the return grille for inspection.

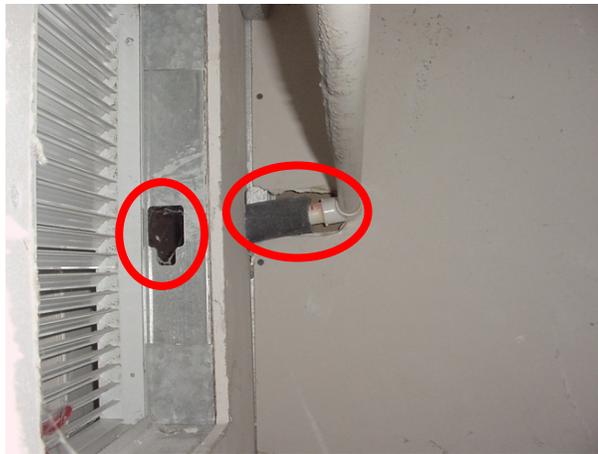
Figure 62. Grille transfer through a wall has leakage into wall cavities that need to be sealed.

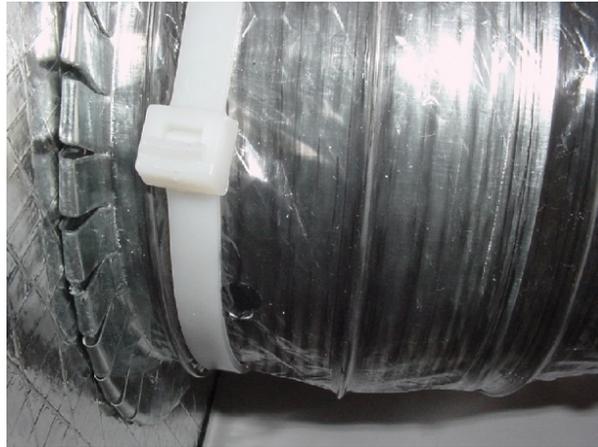
Figure 63. To make this repair, pull back the outer insulation jacket of the flex duct to expose the inner duct connection. Remove the strap and inner duct from metal collar. Remove any loose tape.

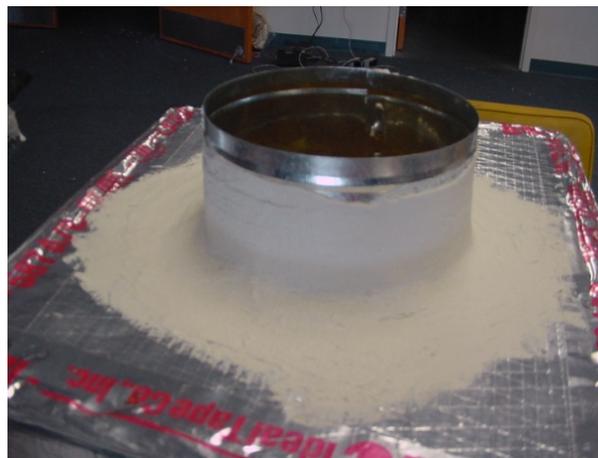
Figure 64. Apply mastic from the foil surface of duct board over and around the metal collar. Mastic can be applied over any securely bound tape.

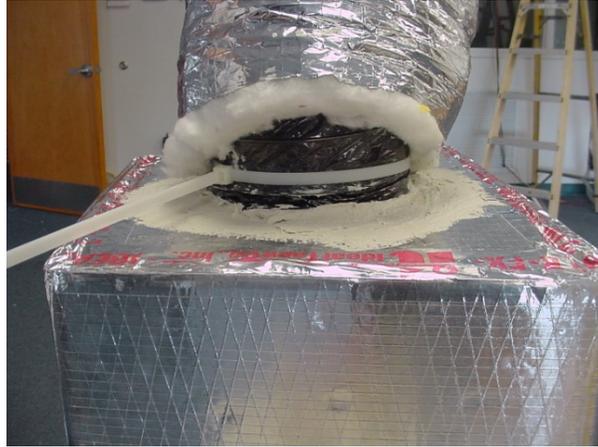
Figure 65. While the mastic is still moist, pull the inner duct liner over the metal collar, then secure tightly with a strap. The strap will pull the inner liner into the mastic and thereby create an airtight seal.
