Managing the Drivers of Air Flow and Water Vapor Transport in Existing Single-Family Homes

*Building America Partnership for
Improved Residential Construction*

Revised October 2012

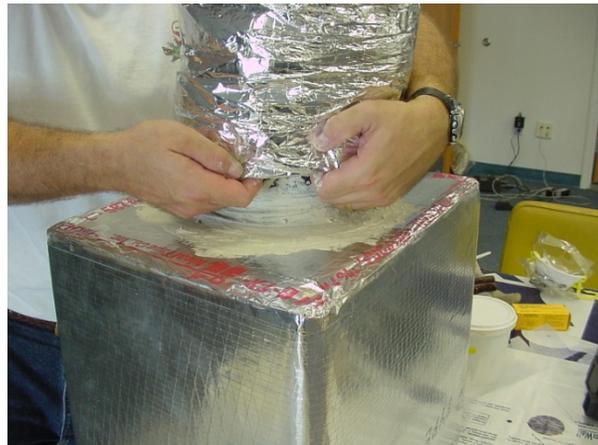
Figure 66. Finally, pull the insulation jacket over the duct inner liner and secure the outer jacket tightly against the foil surface of the duct board. If any sections of the inner duct remain exposed, this may result in unwanted energy losses and potentially moisture condensation when the system is cooling.

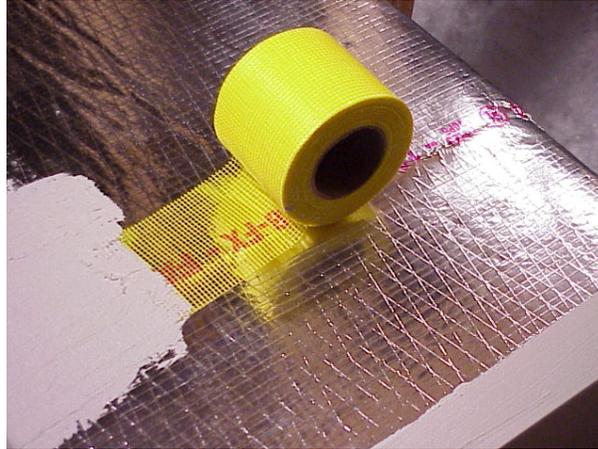
Figure 67. A gap between two sections of duct board was first covered using foil tape. Next, mesh is applied and coated with mastic that overlaps the mesh by 1-½–2 in. on each side.

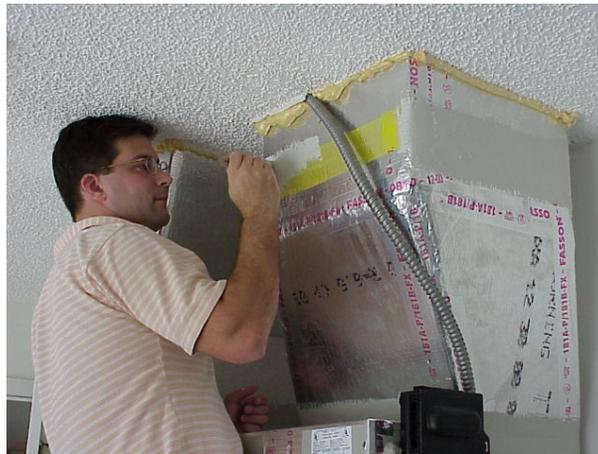
Figure 68. Supply plenum connection being sealed using foil tape, fiberglass mesh tape, and mastic.

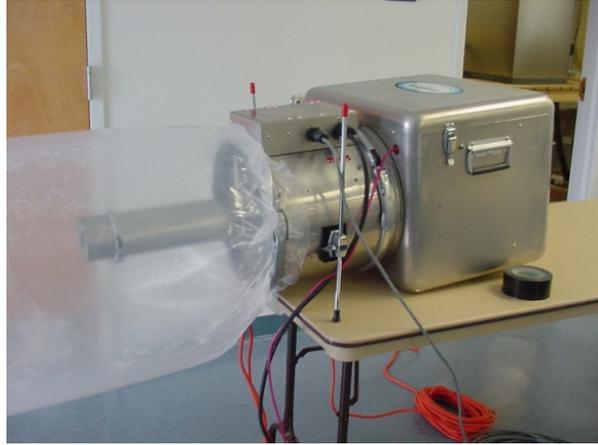
Figure 69. Patented sealing process injects an aerosolized material that builds up on leaks eventually sealing leaks up to about ¼ in. wide.

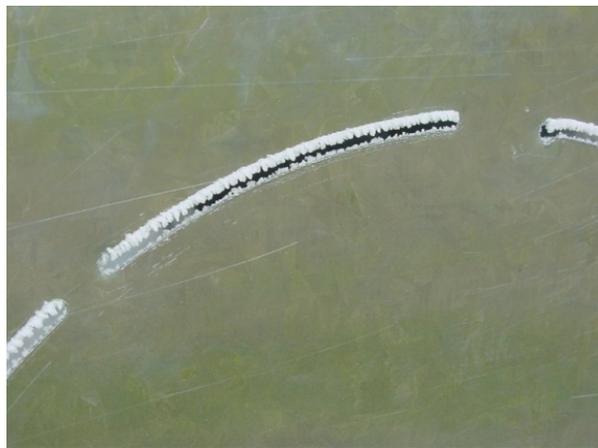
Figure 70. Sealant can be seen building on a demonstration leak.

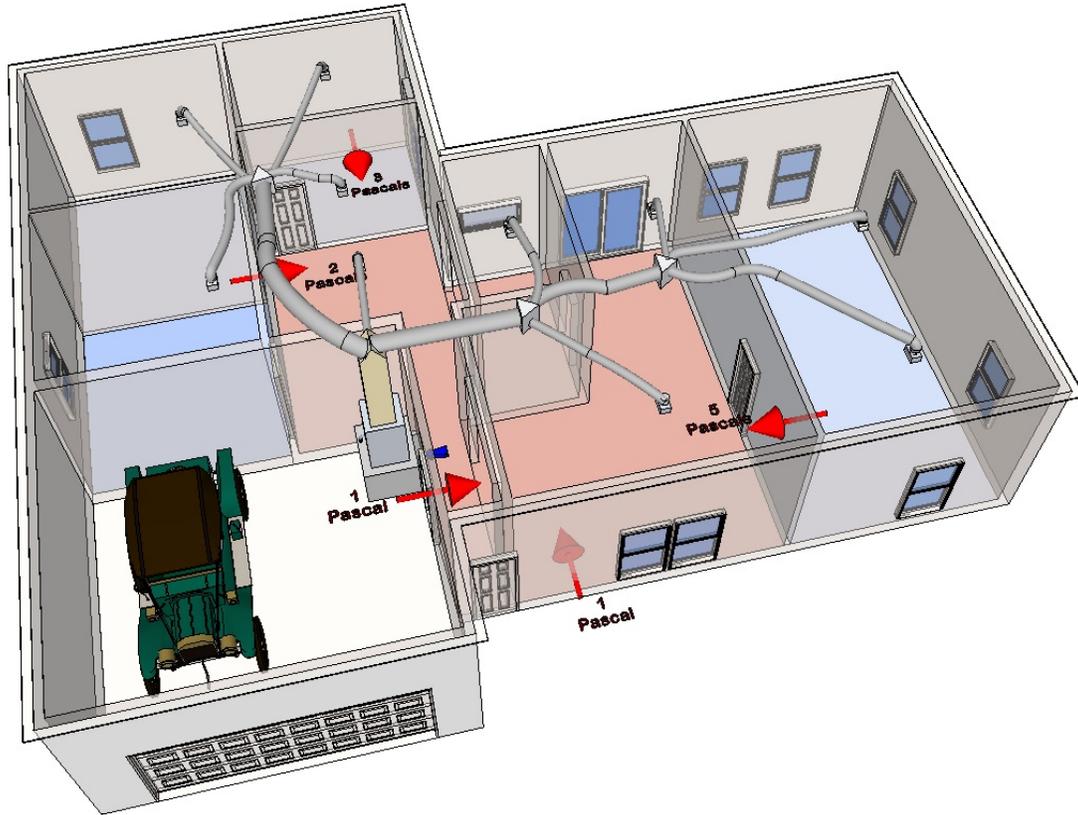
Figure 71. This house has supply ducts to each room, but only a central return grille. Door closure without adequate return air pathway results in negative pressure in the central zone wrt to outside and positive pressure in the closed rooms.

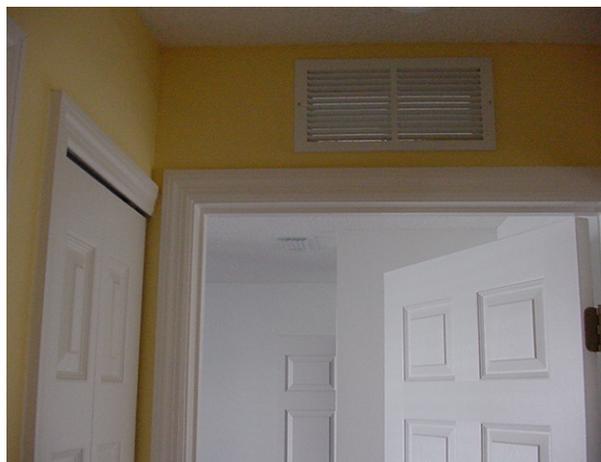
Figure 73. Through-the-wall return transfer from bedroom to hallway.

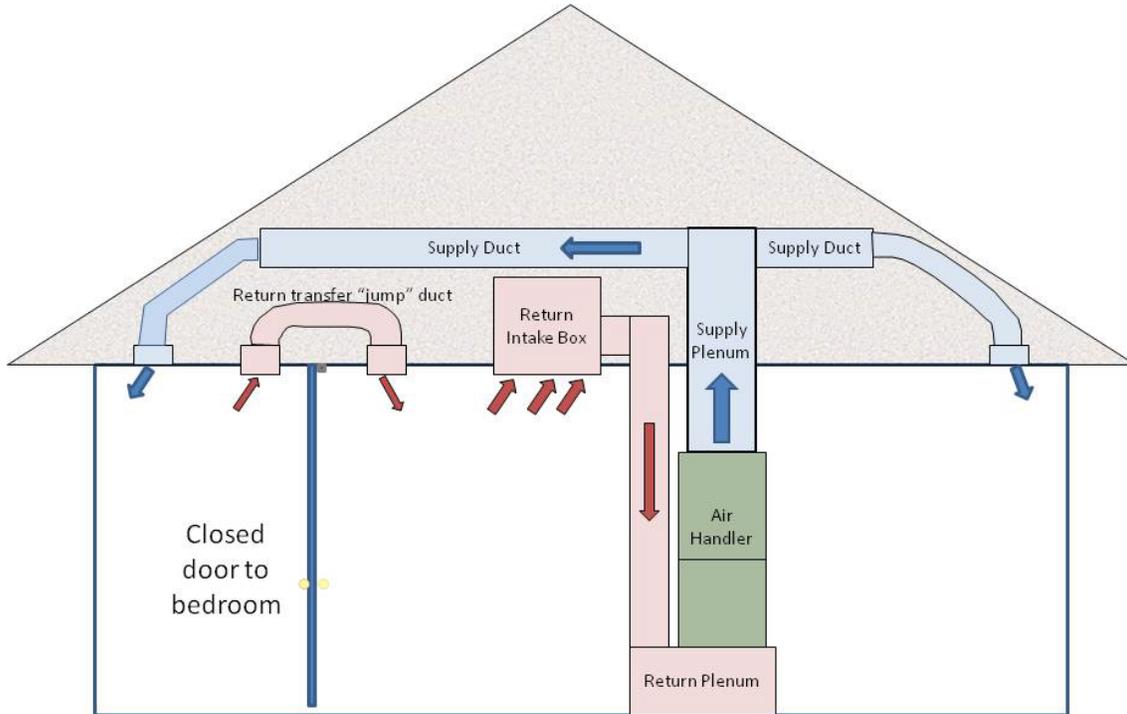
Figure 74. Illustration of return jump duct.
